**DOCUMENT OF  
ENVIRONMENTAL PROTECTION**

**ACTIVITY:  
DREDGING AND FILLING**

**CONTROL NUMBER DEP-16-001.0**

**UNITED STATES ARMY GARRISON - KWAJALEIN ATOLL/  
RONALD REAGAN BALLISTIC MISSILE DEFENSE TEST SITE  
IN THE  
REPUBLIC OF THE MARSHALL ISLANDS**

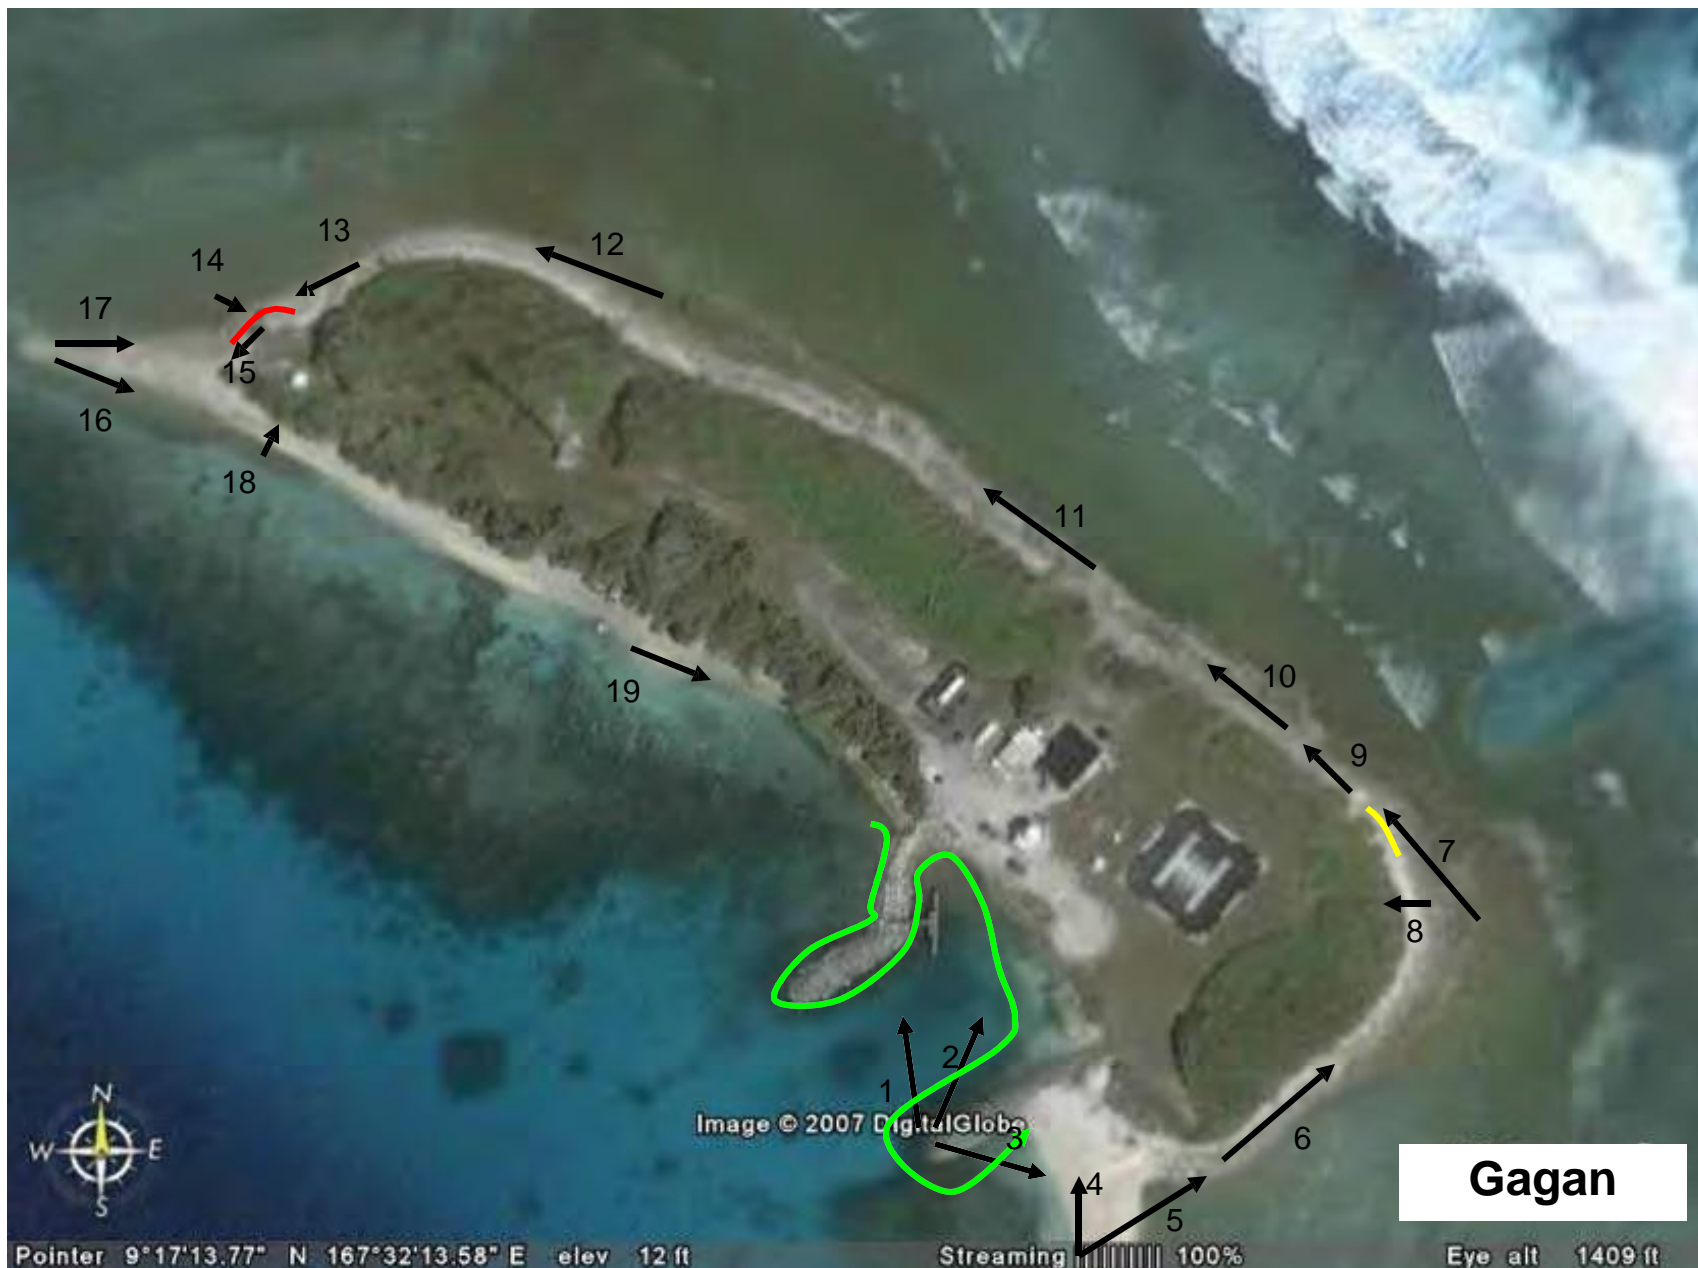
- Photo GA-07-Ledging at southwest tip of island

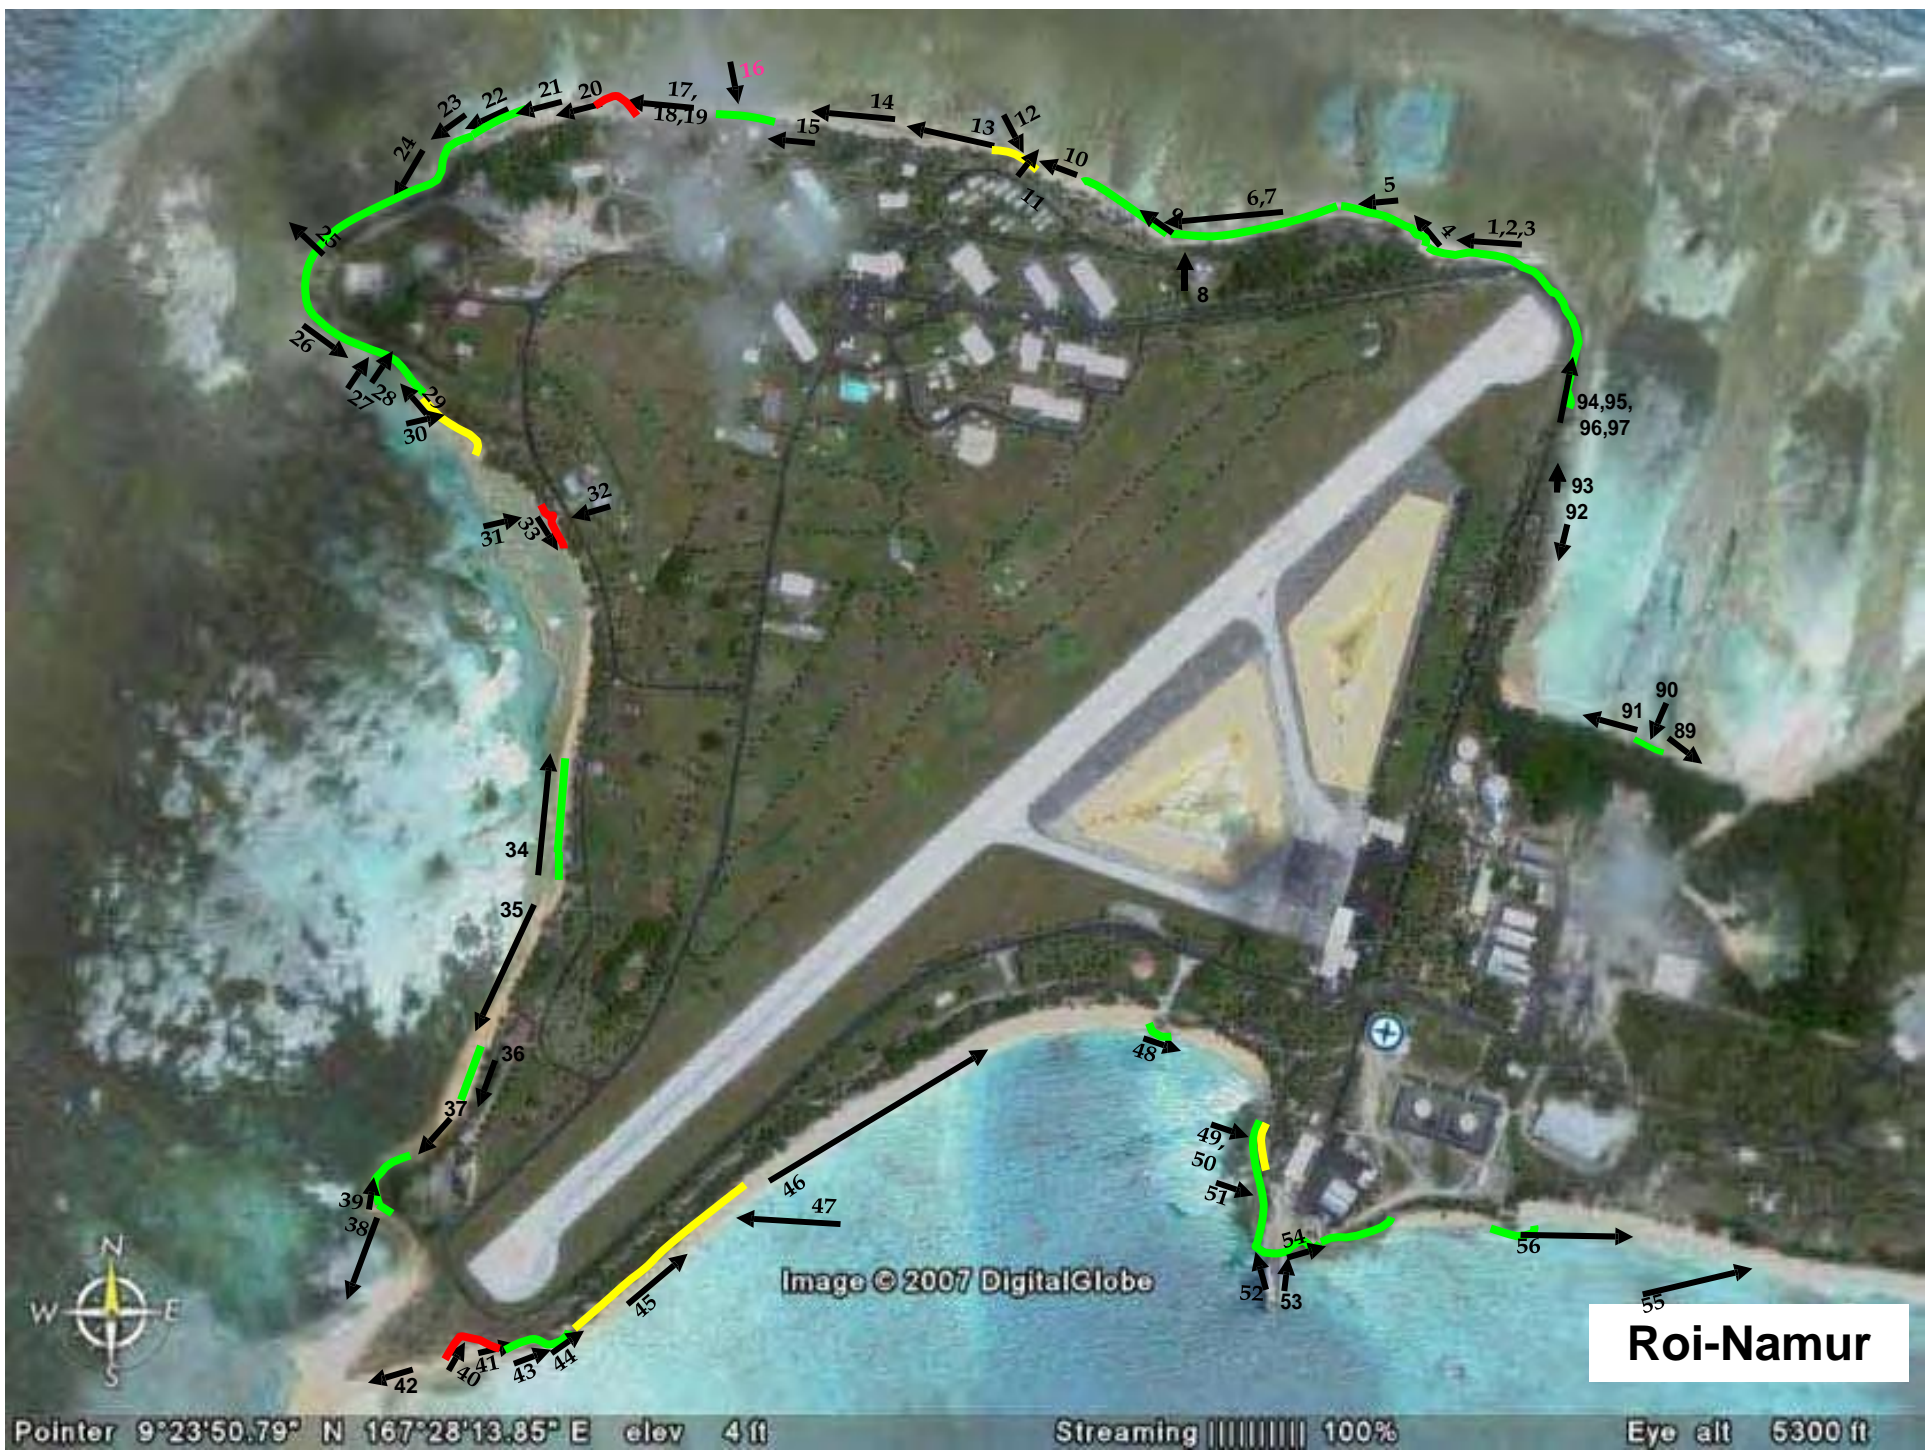
- RN-1, Photo 12 – Non-critical erosion evident at tree line
- RN-3, Photo 30 – Northwest shore with evidence of erosion; 30 inch ledge has formed due to loss of soil
- RN-4, Photo 44 – Seawall with some erosion evident
- RN-4, Photos 45 & 47 – Non-critical erosion at tree line
- RN-4, Photos 49 - 51 – Shoreline west of main port terminal
- RN-5, Photo 59 – Erosion at beach east of Yokahoma pier
- RN-9, Photos 85 & 86 – North shore of Namur looking southwest; ledge caused by erosion
- RN-9, Photos 94 - 97 – North shore near end of runway; bottom of seawall undercut

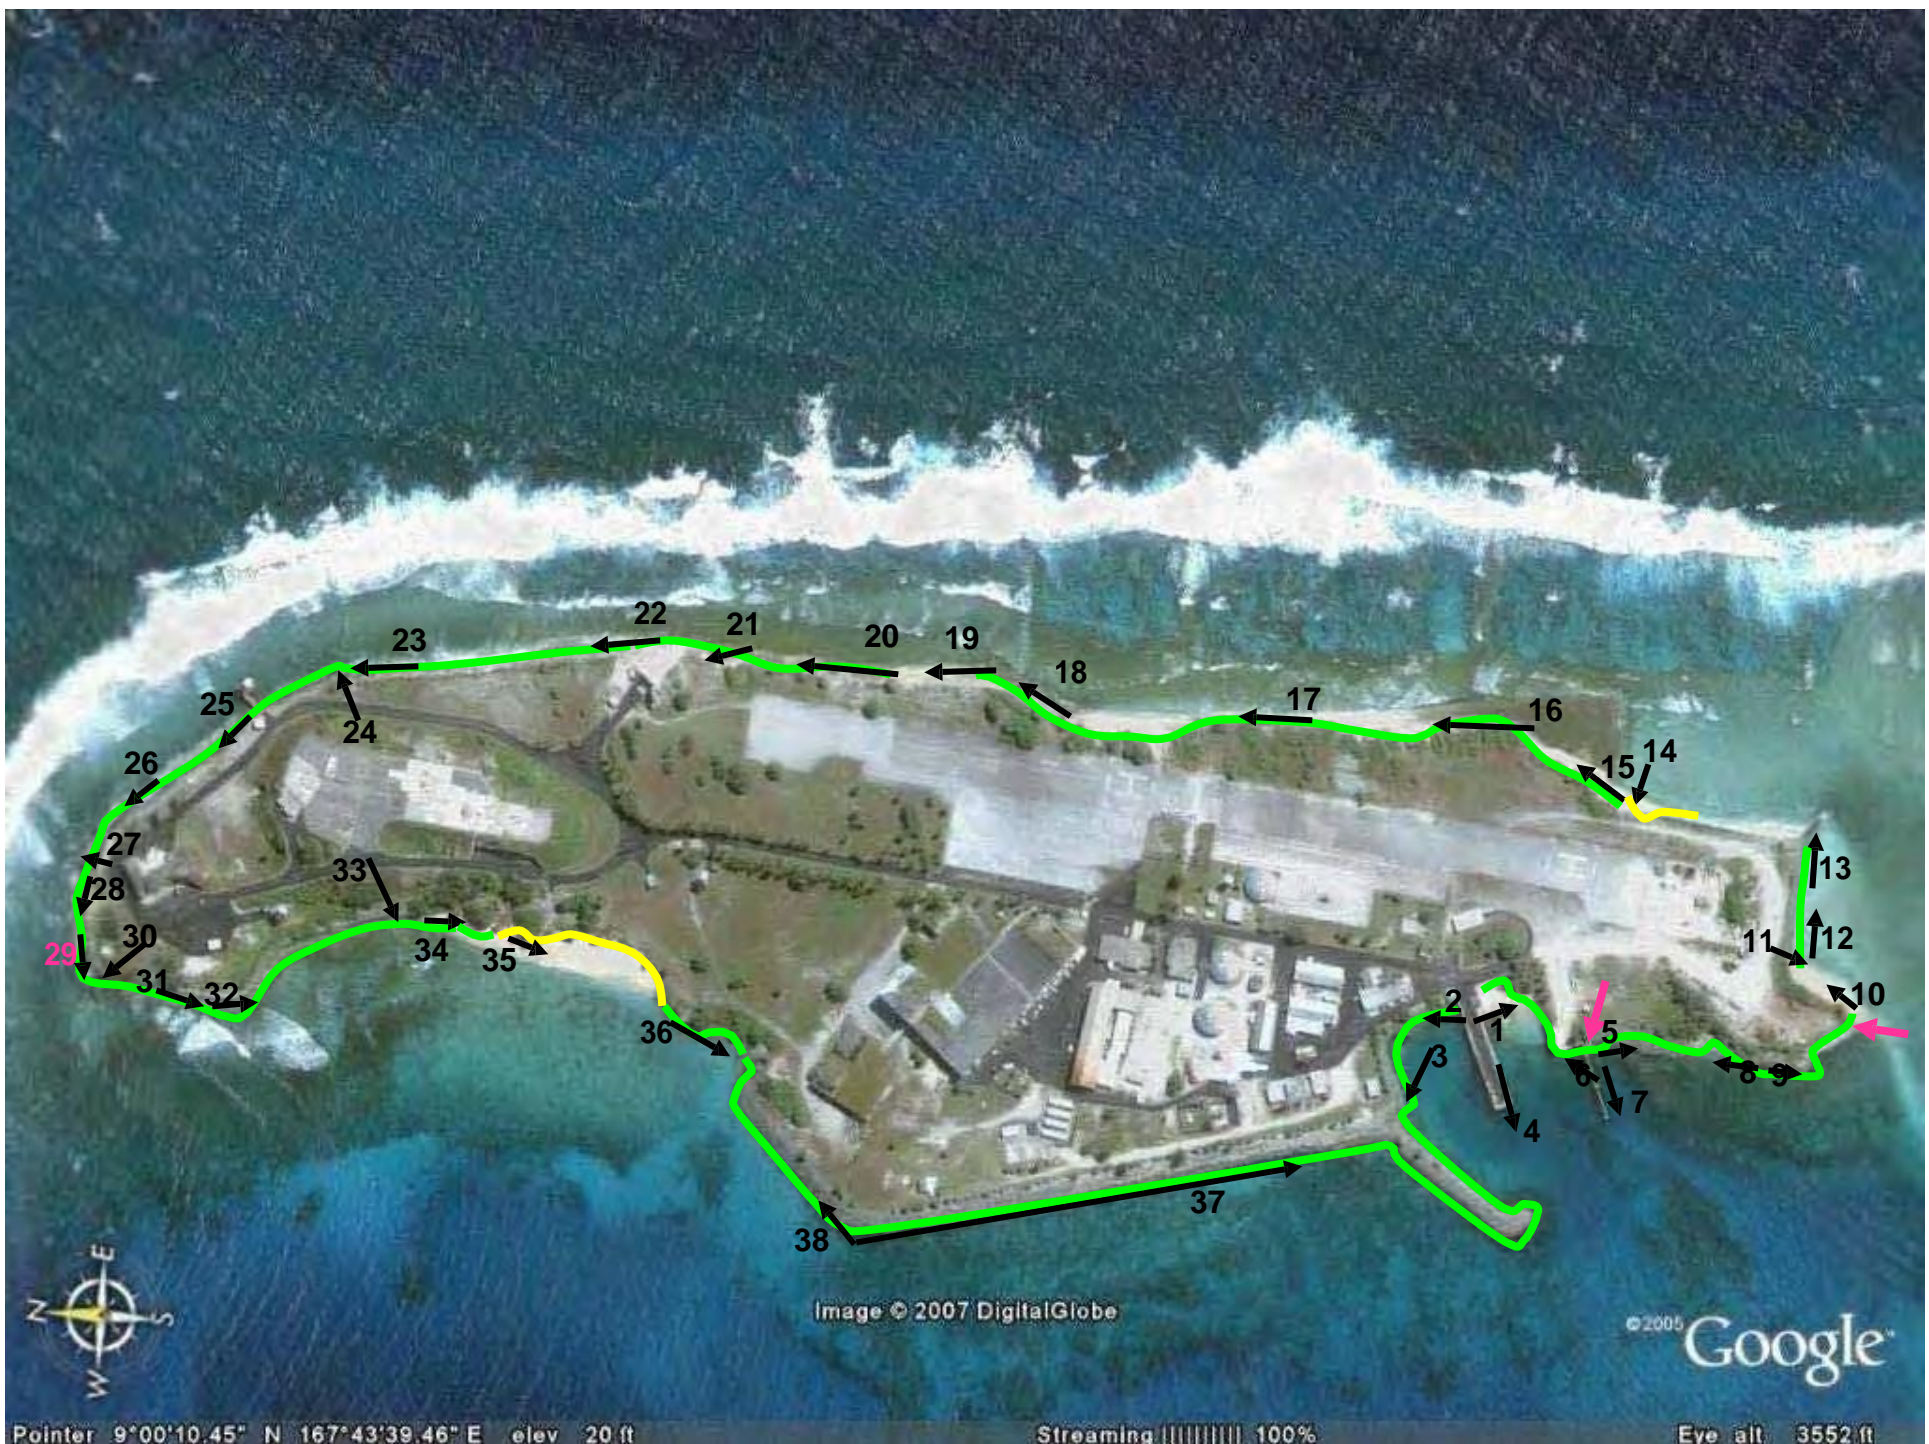
- MK-6, Photo 14 – Southeastern Point; non-critical erosion with ledge
- MK-3, Photo 35 – Erosion at beach and vegetation boundary

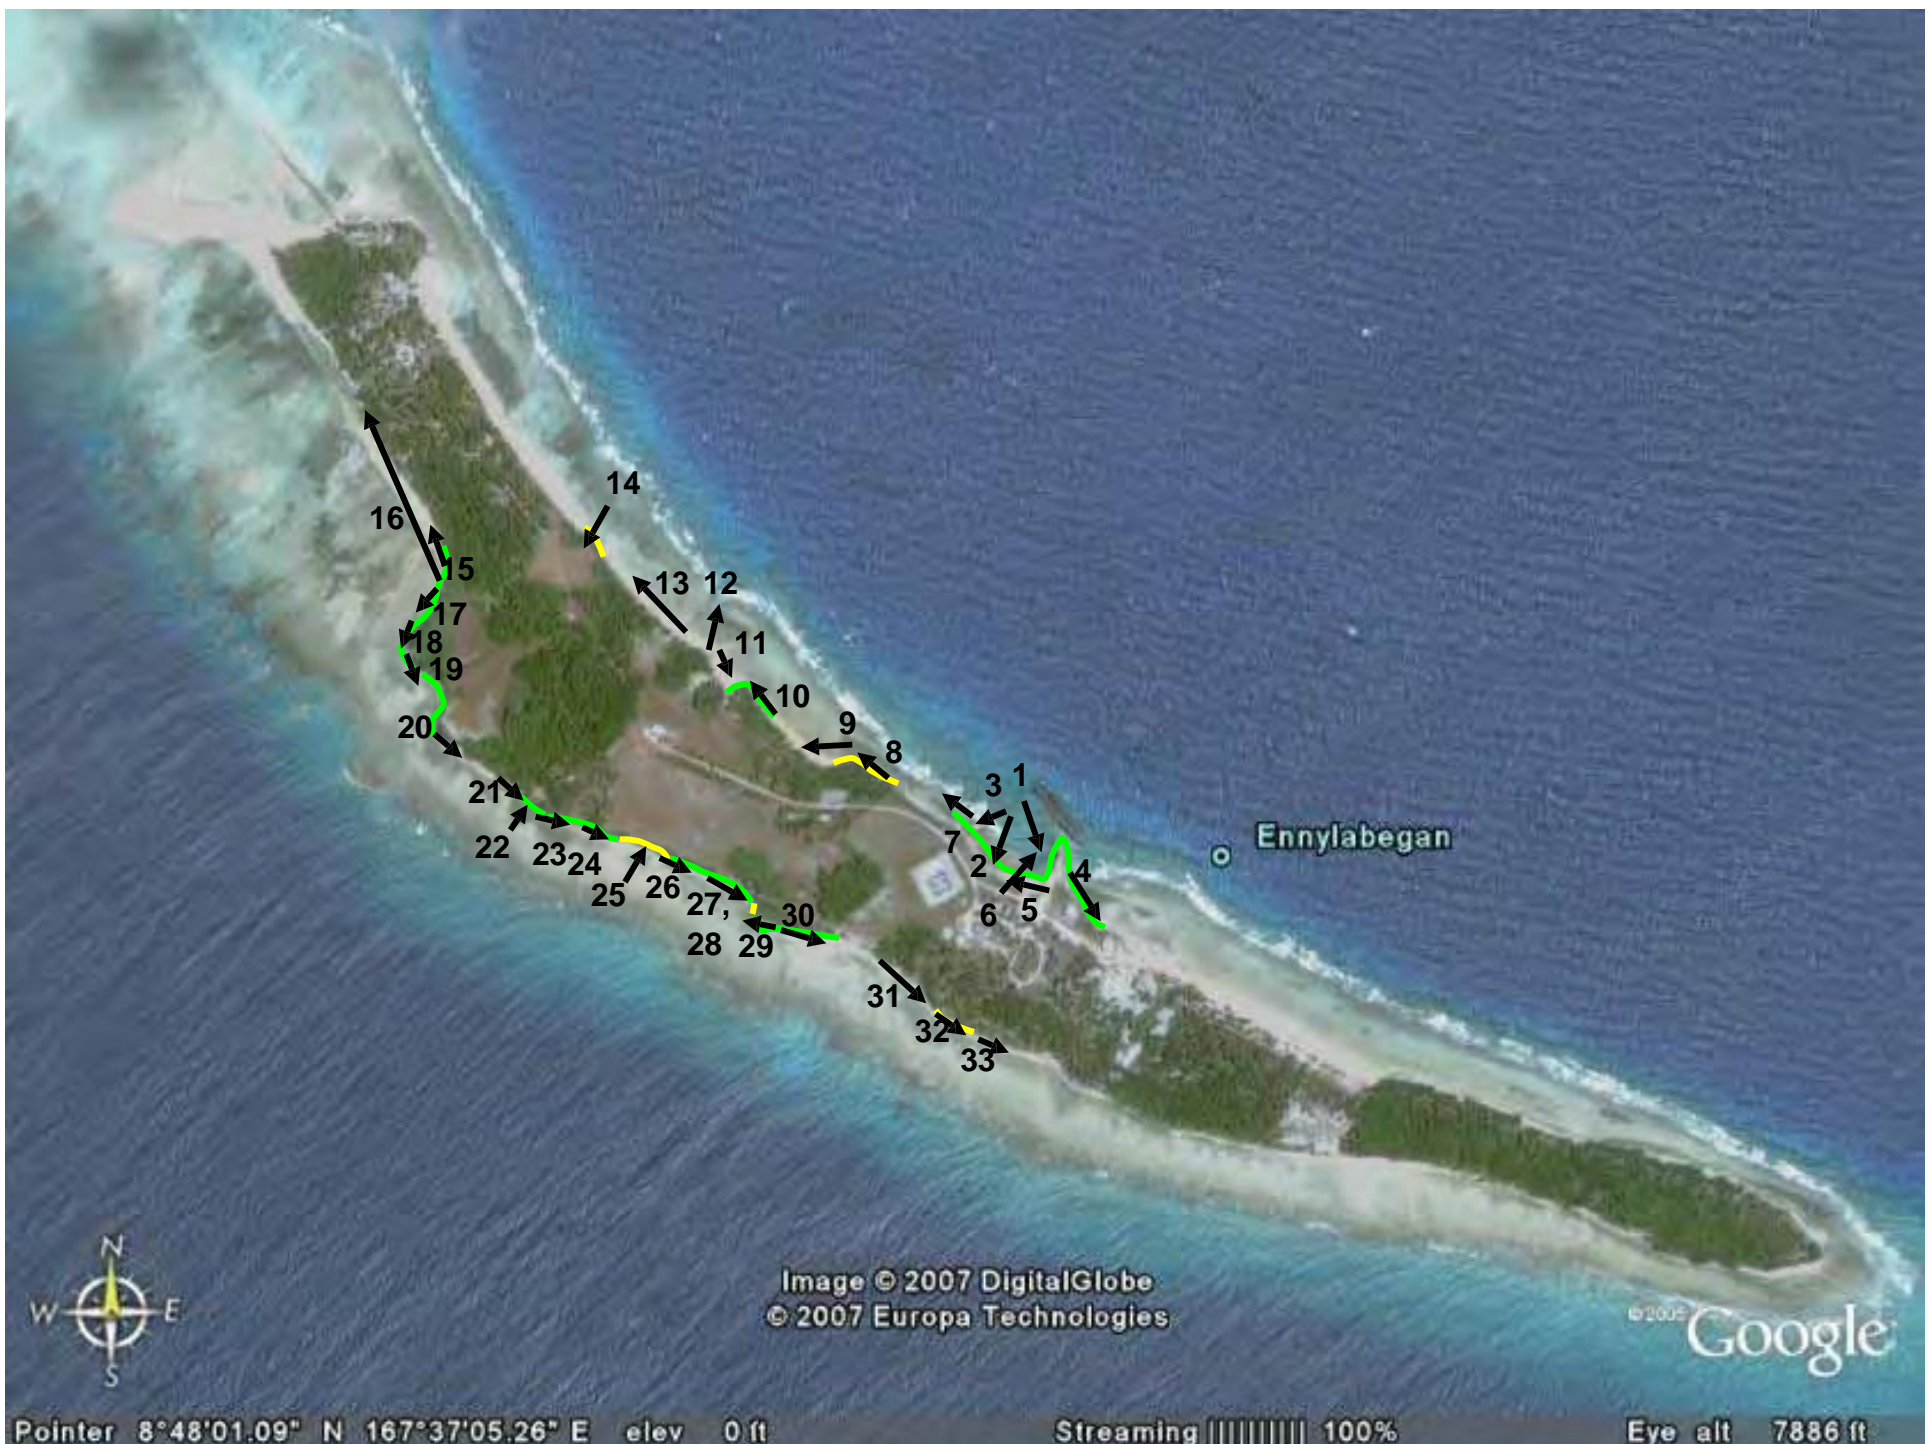
- EL-2, Photo 8 – Tree roots exposed
- EL-2A, Photo 14 – North end of leased area near antenna; erosion of sandy beach
- EL-3, Photo 25 – Sandy beach is eroding and creating a ledge; on western shoreline
- EL-3, Photo 28 – Some erosion evident; sand and gravel beach in between armor stone protected areas
- EL-3A, Photo 32 – Areas of beach erosion (ledge forming) at the tree line

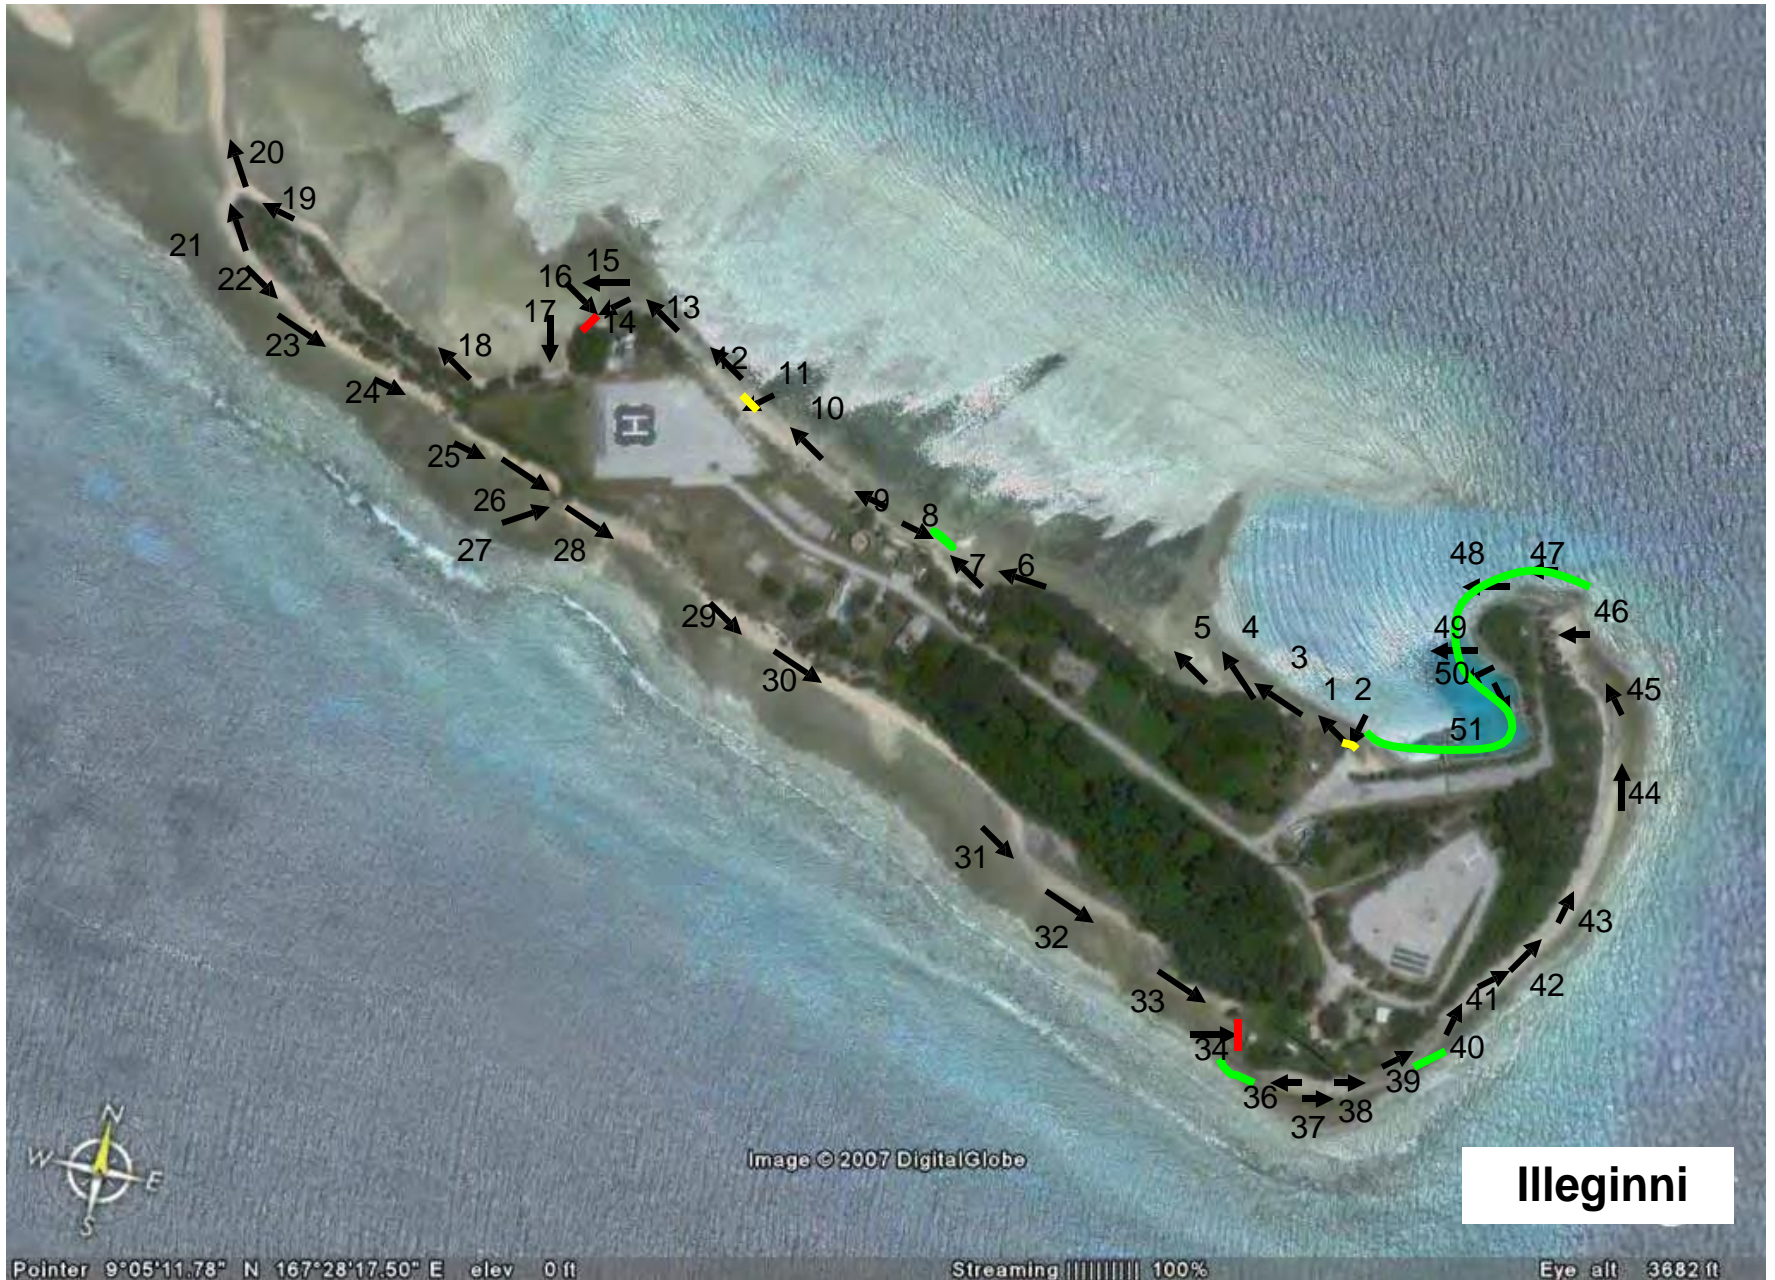
- IL-1, Photo 2 – Ledging north of harbor
- IL-1, Photo 11 – Ledging on lagoon side of helipad

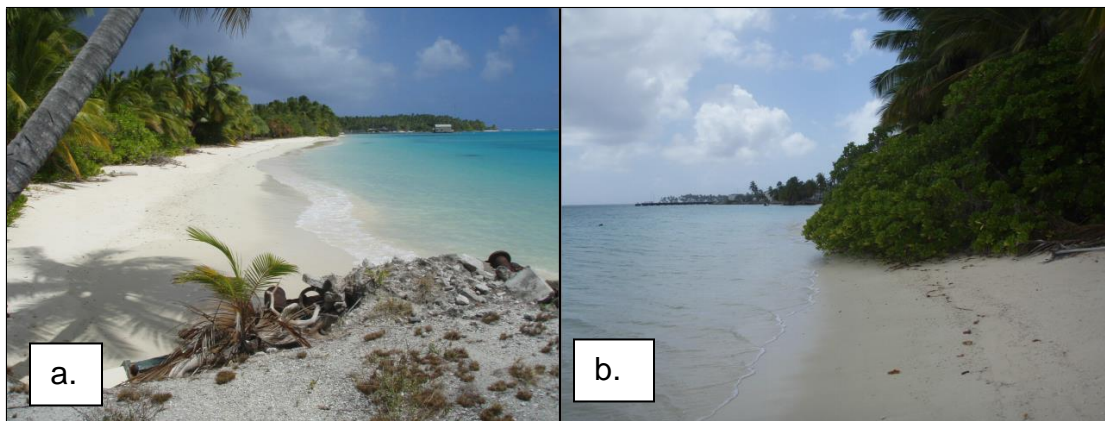
4. Reach R1 is 891 feet of shoreline located on the lagoon side of the island and is classified as a “Non-Critical Stable Beach”. Figure 1a and Figure 1b show the beginning of the reach looking left at R1 and the end of the reach looking from R2, respectively. No short- or long-term actions are recommended for this reach. Reach R2 (687 feet) is a continuation of the beach in reach R1, but it appears to be actively eroding based on observable undermining of shoreline vegetation in the reach (see Figure 2a and 2b). No short- or long-term actions are recommended for this reach.

Figure 1a and 1b: The figures show the beginning and end of the non-critical stable beach located in reach R1, respectively.

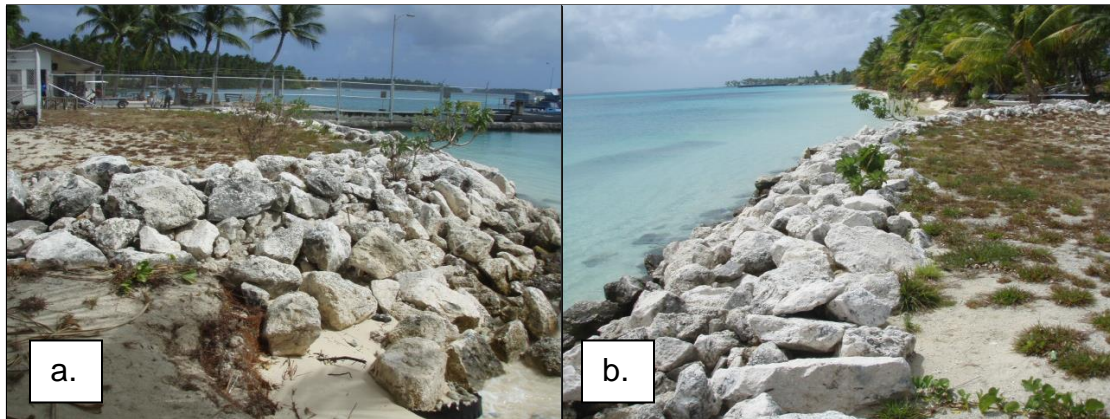
Figure 3a and 3b: The beginning and end of the low crested revetment located in reach R3, respectively.

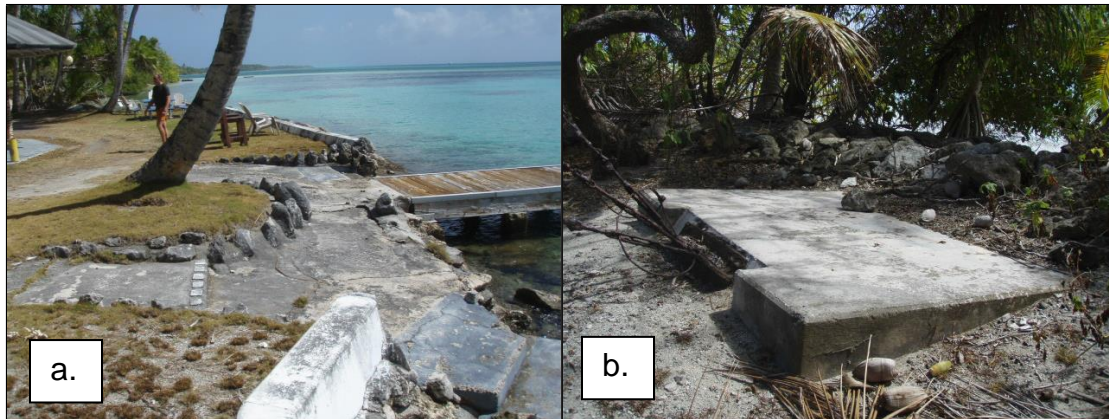
Figure 5a and 5b: Figure 5a is a picture of the low-crested seawall that has been constructed to stabilize the shoreline in front of the scuba club property. Figure 5b shows the antenna guy wire and anchor block that is protected by an engineered revetment.

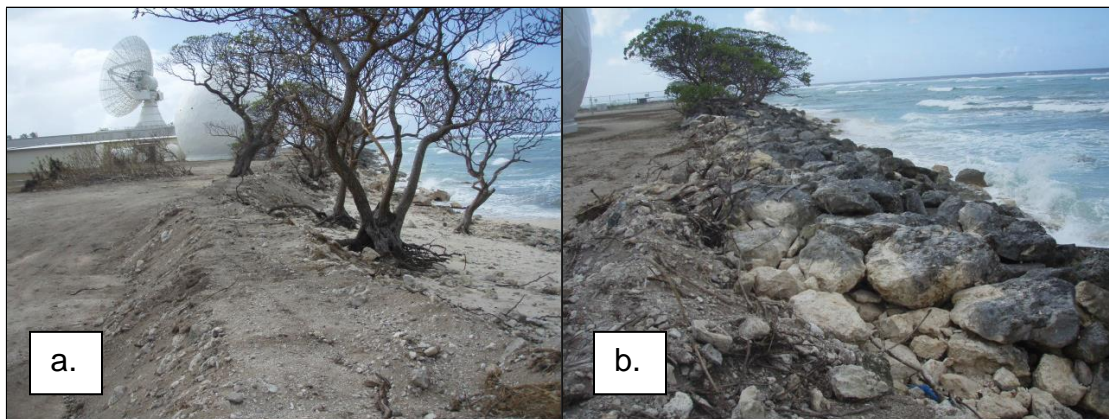
Figure 6a and 6b: Figure 6a displays the earth berm that was constructed after the December 2008 wave event. Figure 6b shows the start of reach R13 in which the existing revetments tie backs and crest sustained significant damage.

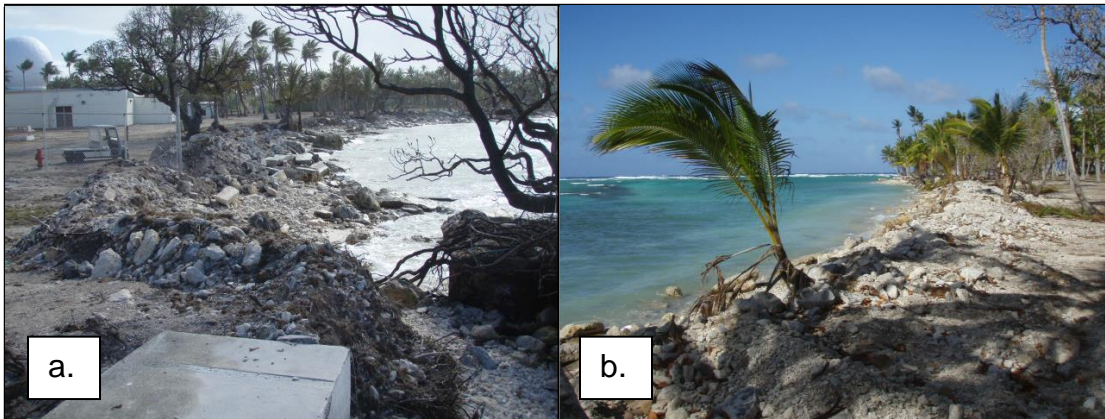
Figures 7a and 7b: The figures show the limits of a 1,530-foot length of critical shoreline where limestone and concrete rip rap has been dumped to slow erosion and reduce inundation. Construction of a tri-bar revetment is recommended in this area.

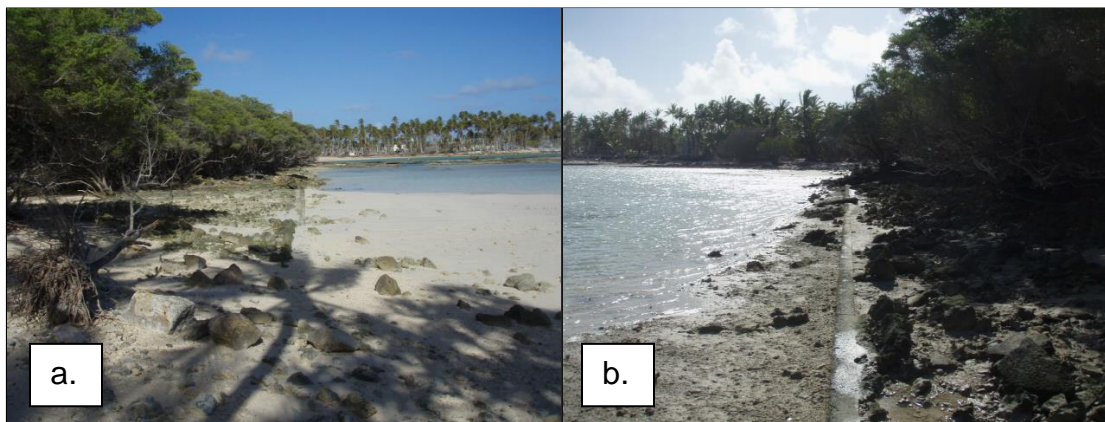
Figures 8a and 8b: The figures provide perspective on how low the backshore elevation is between the points R16 and R18. Construction of a steel sheet pile seawall is recommended in this area.

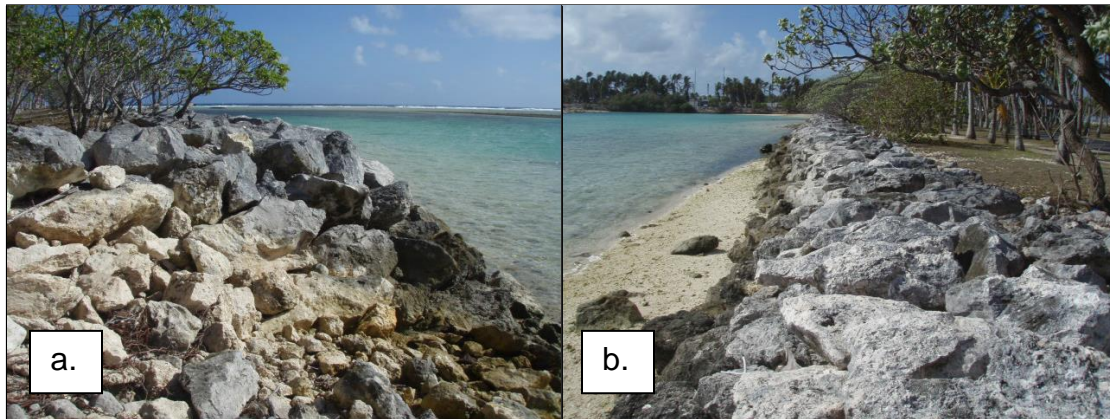
Figure 9a and 9b: Figure 9a shows existing condition of the tie back at the start of R19. Armor stones in this area need to reset to ensure that the structure does not continue to unravel. For the most part, the revetment in R19 is in good conditions as evidenced by Figure 9b.

be reset in order that the structure does not continue to unravel (see Figures 9a and 9b).

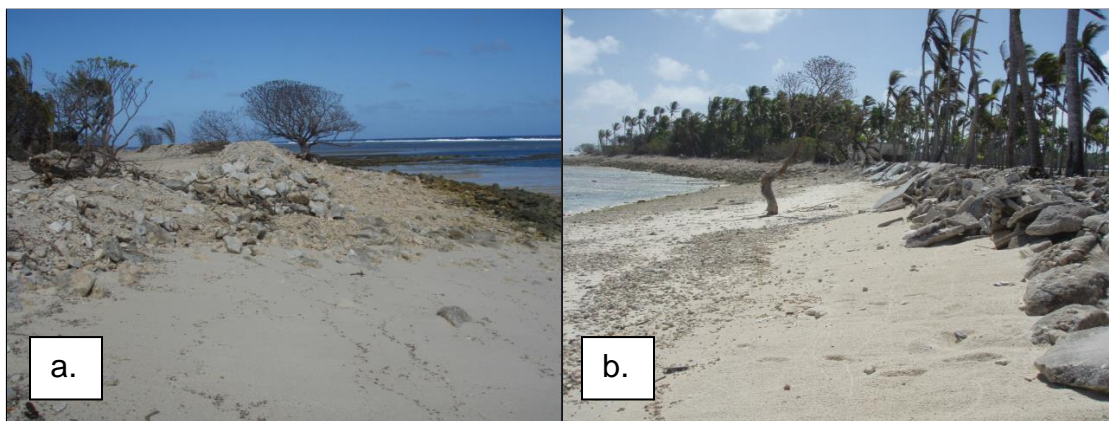
Figures 11a and 11b: The extent of the rip rap material that has been pushed into the shape of an earth berm along the R23 through R24 shoreline are shown in the figures.

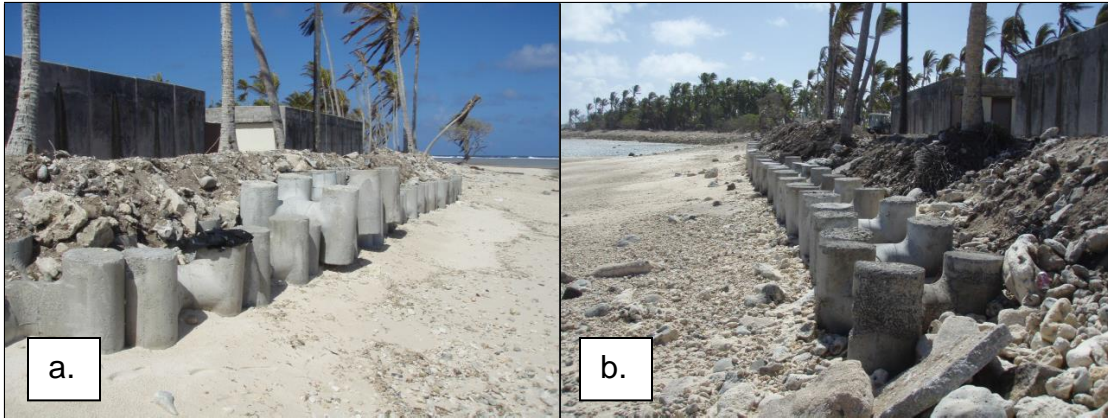
12. Excess tri-bar concrete armor units have been randomly stacked in a horizontal alignment and an earth berm has been pushed up behind the units as temporary shore protection for threatened building in reach R25 (see Figure 12a,b). The tri-bars appear to weigh approximately 2 tons each. Considering the way in which the units were placed, the overall structure will only be as effective as dumped rip rap in providing short-term protection to upland development. It is recommended that an engineered tri-bar concrete armor unit tri-bar revetment be constructed along reach R25 (167 feet) and the adjoining 300 feet of reach R26.

Figures 12a and 12b: The figures were taken along reach R25 where tri-bar concrete armor units have been randomly placed. An earth berm can also be seen on the landward side of the tri-bars. This area is classified as critical and in need of emergency shore protection designed to protect existing infrastructure.

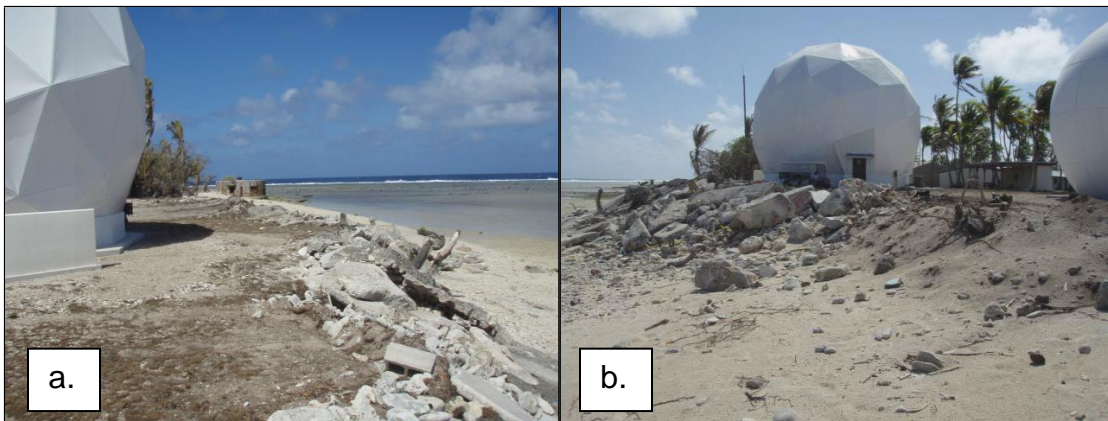
13. Reach R27 is one of the most critical lengths of shoreline on Roi-Namur as can be seen in Figures 13a and 13b. The shoreline in this reach is unstable and rip rap has been dumped to slow recession, attenuate wave energy and reduce coastal inundation. Telemetry domes located near the shoreline have a low foundation elevation and are in danger of being damaged by the next significant wave event. Similar to all of R25 and a portion of R26, this area is classified as critical and is in need of emergency shore protection designed to protect existing infrastructure.

Figures 13a and 13b: Critical erosion can be seen in the figures. Concrete rip rap has been dumped in reach R27 in an attempt to protect telemetry domes located close to the shoreline.

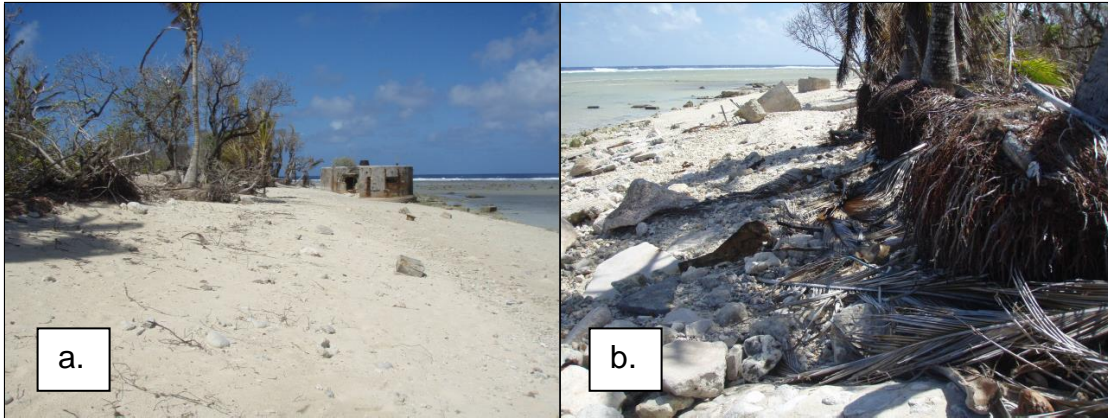
14. Non-critical erosion extends along the 718 feet of shoreline between R28 and R30. A Japanese pill box is situated at the water's edge near the start of R28. Wave action has scarped the backshore and shoreline vegetation is being undermined and destroyed. No action is recommended in these reaches at this time, but if the dump site located upland of this area loses significant capacity due to shoreline erosion, remedial action may be required in the future.

Figures 14a and 14b: The 718-foot length of shoreline between reaches R28 and R30 is generally unstable, but since there are no upland facilities being threatened, the area is considered to be non-critical. Figure 14a shows a Japanese pill box located close to the shoreline and active erosion is apparent in Figure 14b as evidenced by newly exposed palm tree root balls.

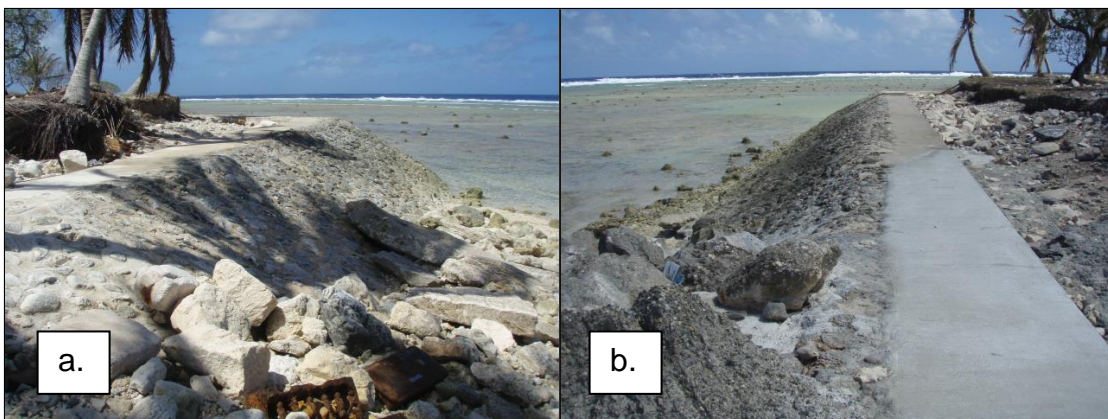
15. The next set of critical reaches includes R31 through R35. Unlike the other critical reaches discussed previously, this area has been stabilized with engineered shore protection structures. R31 and R32 include 211 feet of Japanese seawall that was not directly damaged by the December 2008 wave event, but significant scour and scarping did occur behind the structure. This area is in need of emergency repair to ensure that the backfill behind the seawall is not lost. If this material does scour further, the seawall will most likely collapse inward on itself. In Figure 15a, the eroded backfill on the crest of the seawall is evident. It should also be noted that the large pieces of concrete rip rap shown in Figure 15a should be removed to reduce the threat of impact load damage to the seawall. Figure 15b also shows the extent of erosion that occurred behind the Japanese seawall as a result of the December 2008 wave event.

Figure 15a and 15b: Japanese seawall with leeside damage and unwanted concrete rubble. Armor stones for the adjacent rock revetment can be seen scattered across the reef in the background of both figures.

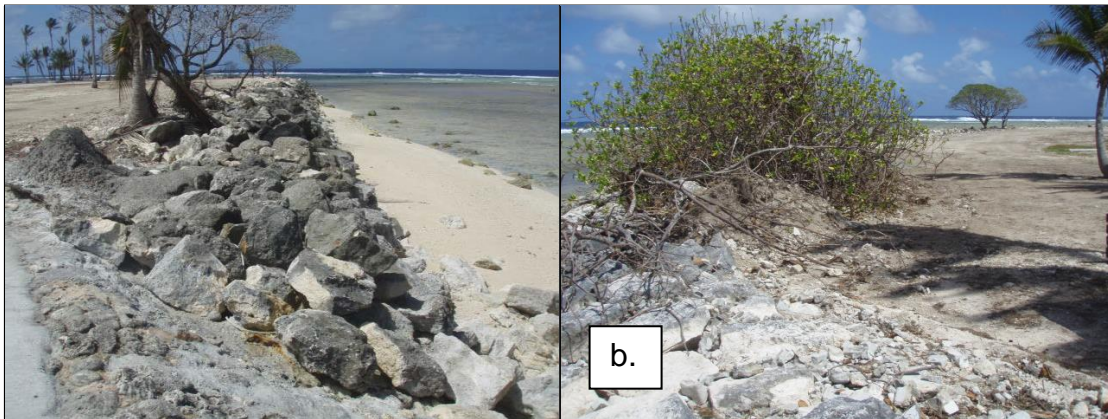
16. An engineered revetment extends along the next 1,071 feet of critical shoreline located within R33 through R35 (Figures 16a and 16b). The revetment was significantly damaged by the recent wave event and requires emergency repair to restore an adequate level of protection to the “Speed Ball” launch complex. Armor stones that were dislodged during the event can be seen scattered on the reef in the previous set of figures. It is assumed that the existing armor stone (both from the structure footprint and out on the reef) can be used to rebuild the revetment. The revetment will need to be tied into the Japanese seawall at one end and a tie back will need to be constructed on the other end. Toe stones should be grouted into a notch in the reef with at least 2/3 imbedment.

Figures 16a and 16b: Rock revetment that was significantly damaged during the December 2008 wave event (R33 through R35). The revetment requires emergency repair utilizing existing armor stones.

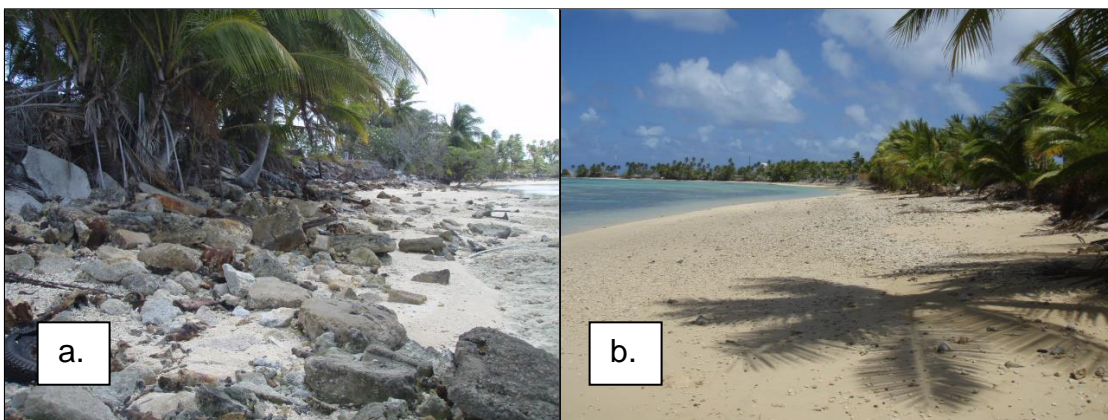
17. R36 is a 2,218-foot reach of mainly unstable shoreline along which a large quantity of concrete rip rap has been dumped (Figures 17a and 17b). The reach starts with dumped rip rap (Figure 17a) and ends with a relatively wide sandy beach (Figure 17b). There is also a vegetated earth berm located along the backshore in much of the reach.

Figures 17a and 17b: The beginning of reach R36 contains a large quantity of

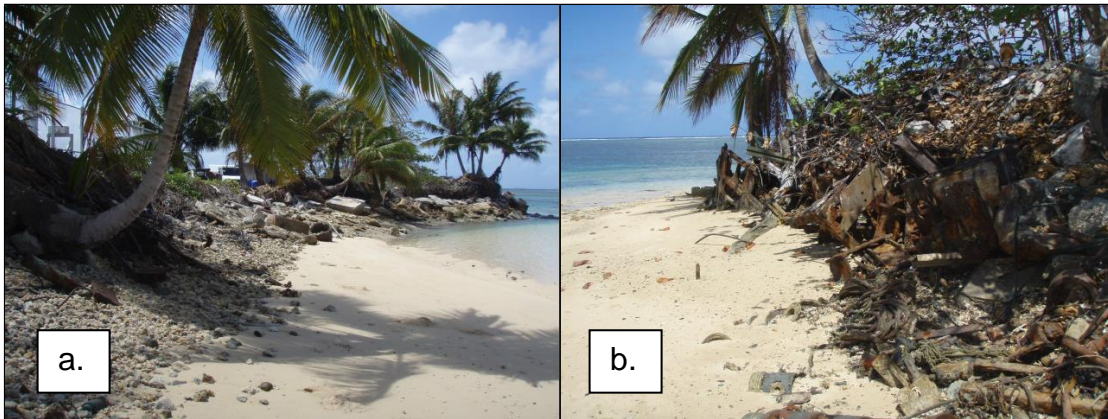
18. Reach R37 is the location of an old landfill area which is currently being used as a hazardous materials handling area. Much of the landfill debris is being exposed by active erosion along the reach. Figure 18a shows the extent of shoreline erosion with palm trees falling over along the backshore and debris exposed on the beach face. Around the point, large pieces of metal extrude from the beach face and backshore as displayed in Figure 18b. This 316-foot of shoreline is considered to be in potentially critical condition due to the sensitive nature of the hazardous material facility in its lee.

Figures 18a and 18b: Active beach erosion and exposed landfill debris exist along both sides of the point of land in Reach R37 as shown in Figure 18a and Figure 18b.

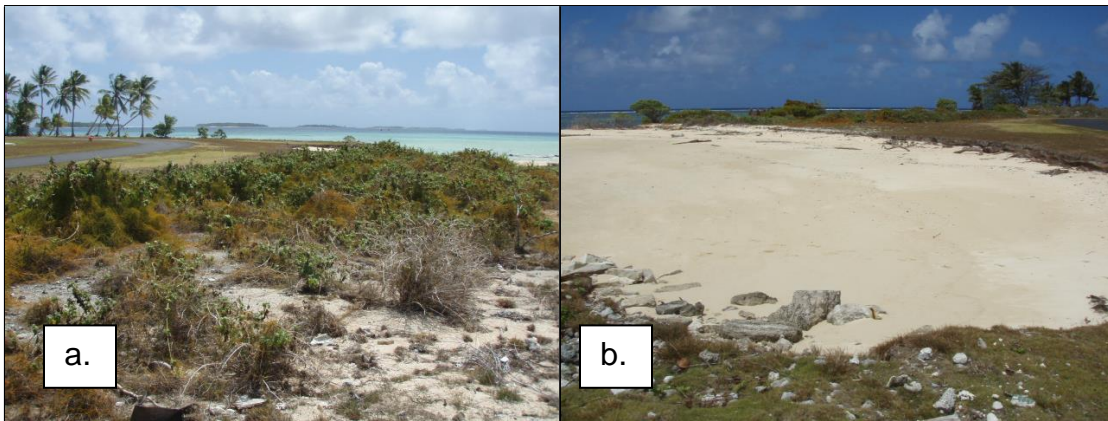
Figures 20a and 20b: Figure 20a shows how close recent shoreline recession has gotten to the runway perimeter road in reach R39. Figure 20b is evidence that the sand spit which existed prior to the December 2008 wave event is starting to reform.
