**DOCUMENT OF  
ENVIRONMENTAL PROTECTION**

**ACTIVITY:  
DREDGING AND FILLING**

**CONTROL NUMBER DEP-16-001.0**

**UNITED STATES ARMY GARRISON - KWAJALEIN ATOLL/  
RONALD REAGAN BALLISTIC MISSILE DEFENSE TEST SITE  
IN THE  
REPUBLIC OF THE MARSHALL ISLANDS**

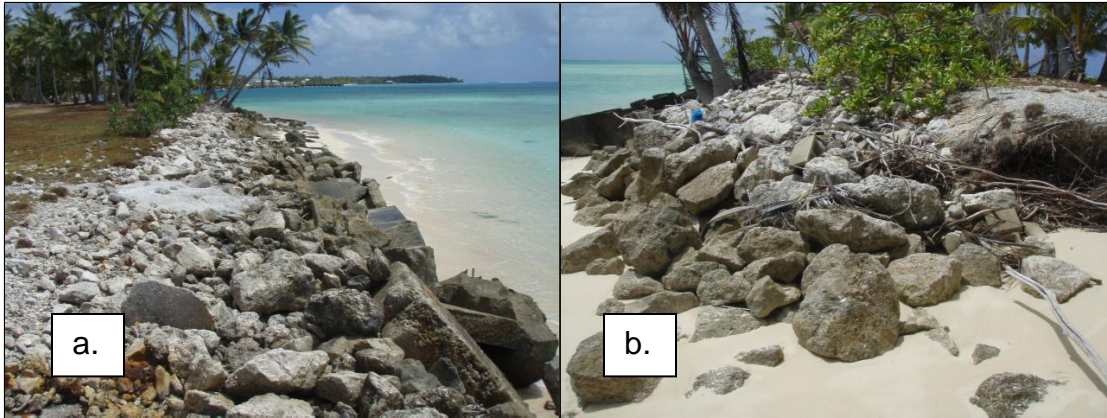
Figures 21a and 21b: The figures show the dumped rip rap located in reach R40.

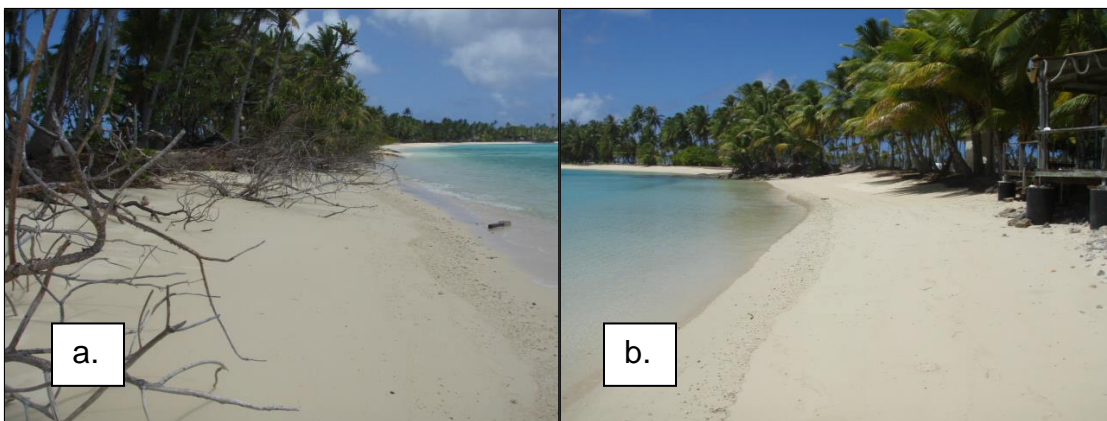
Figures 22a and 22b: Active shoreline recession at the beginning of R41 and the relatively wide sandy beach at the end of R43 are shown in Figure 22a and Figure 22b, respectively.

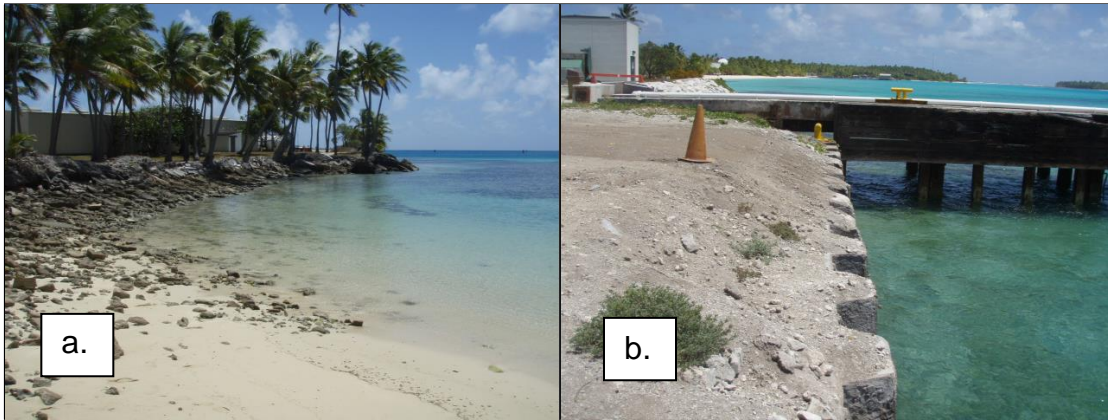
Figures 23a and 23b: Figure 23a displays the dumped rip rap that has been placed in R44 while Figure 23b shows the fill that has been placed above the top of the steel sheet pile wall in R45.

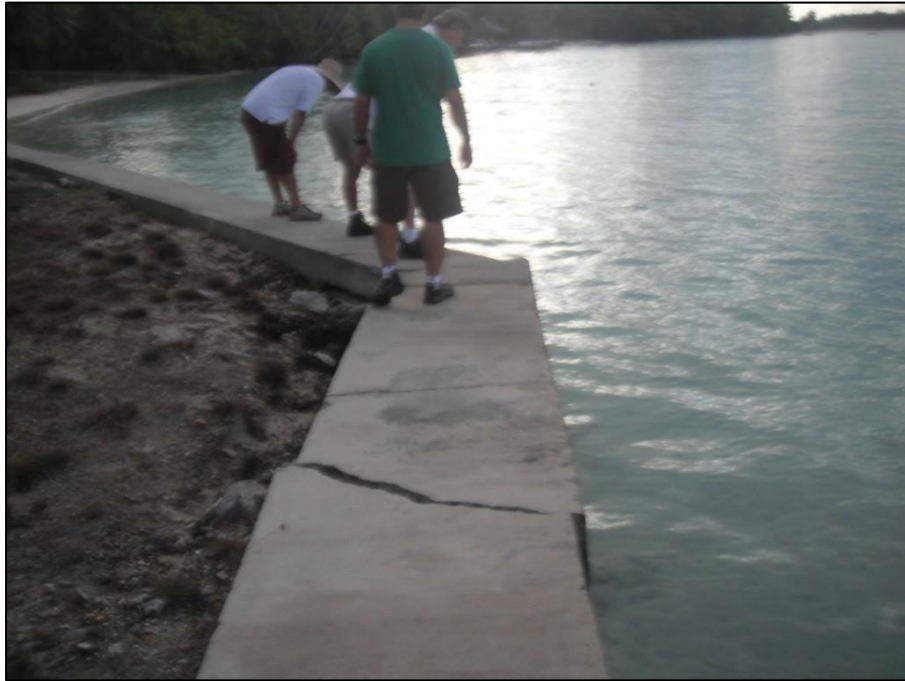
**Figure 2 – Cracking was evident on the abutment near the Yokohama Pier area.**

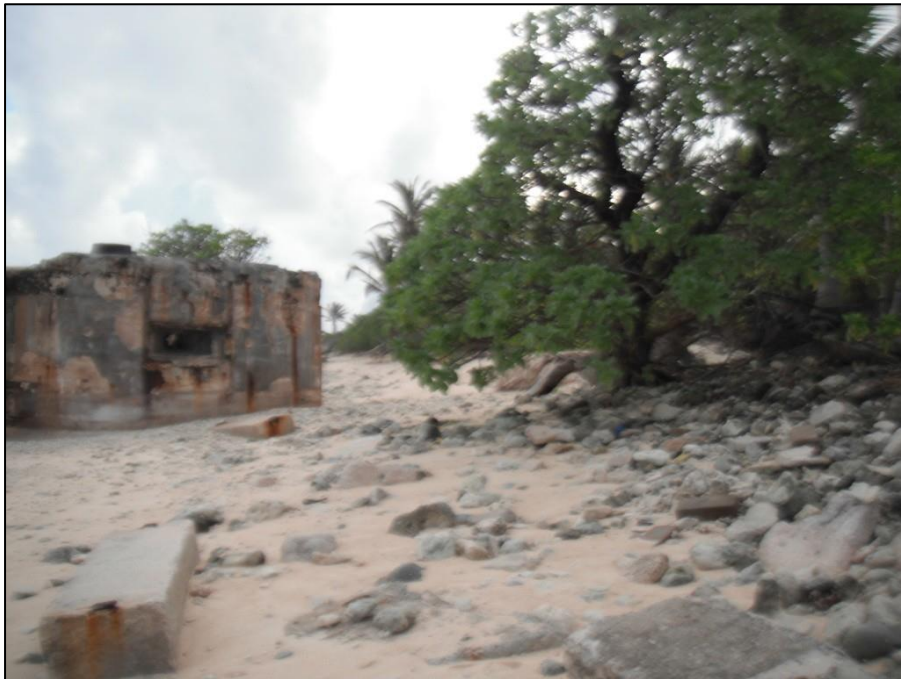
**Figure 3 – Inadequate riprap was observed near the pillbox area.**

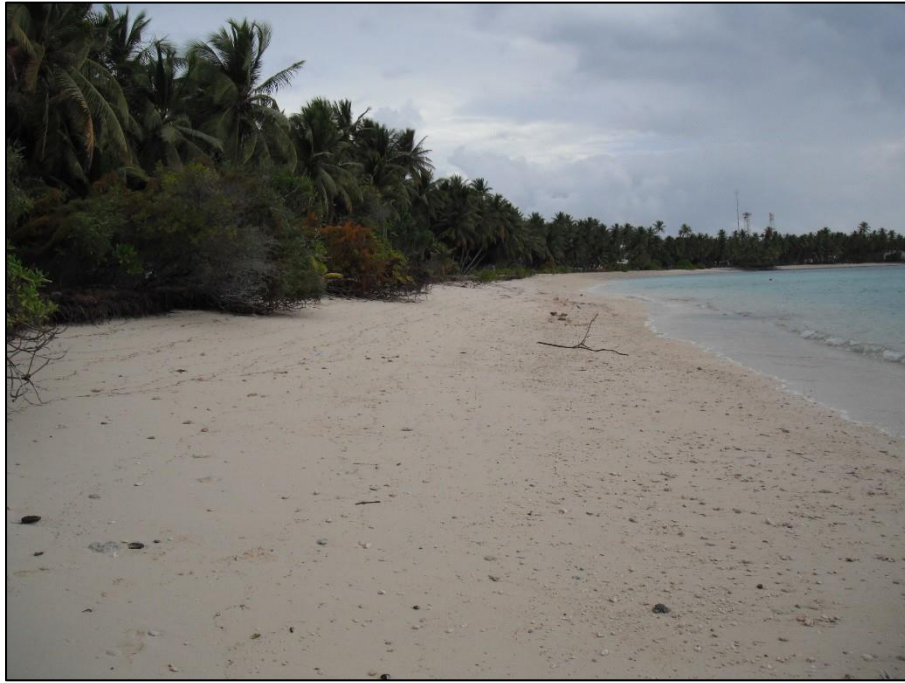
**Figure 4 – Undercutting near the vegetation line and loss of beach sand was apparent.**

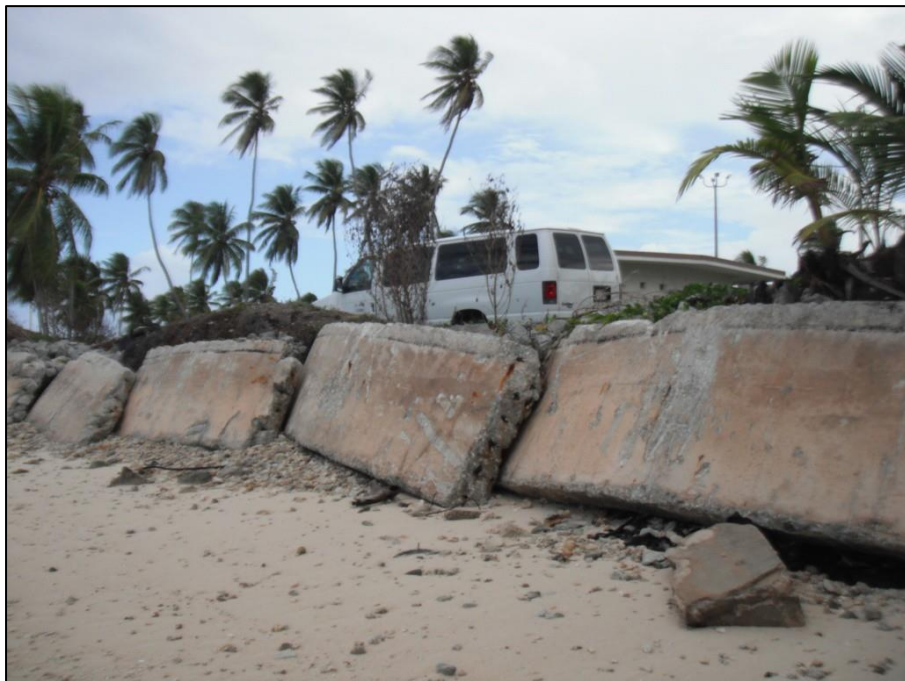
**Figure 5 – Concrete slabs previously placed as emergency shoreline protection.**

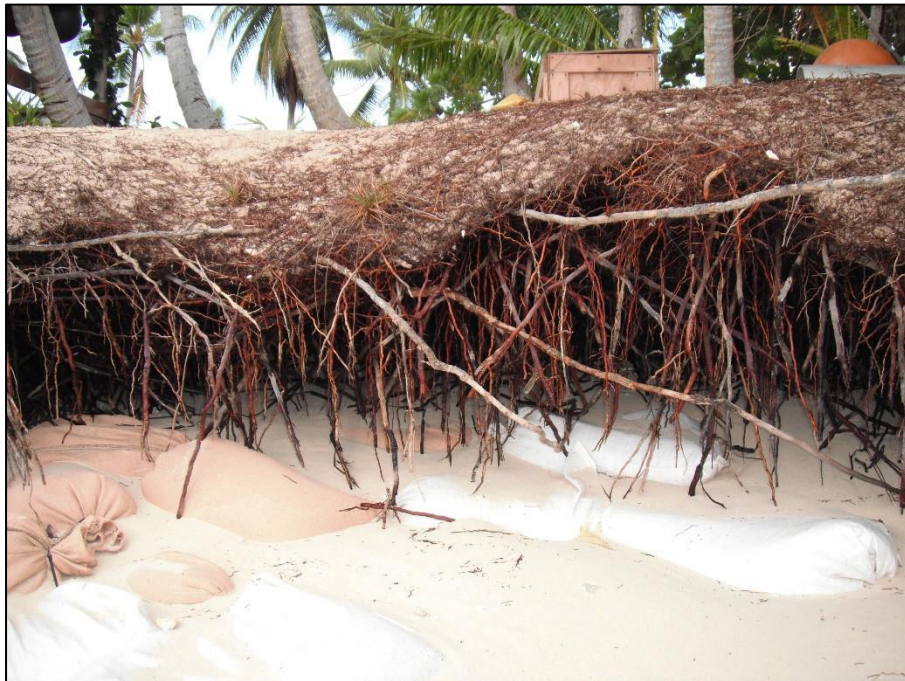
**Figure 7 – Undercutting reveals the roots of the trees above.**

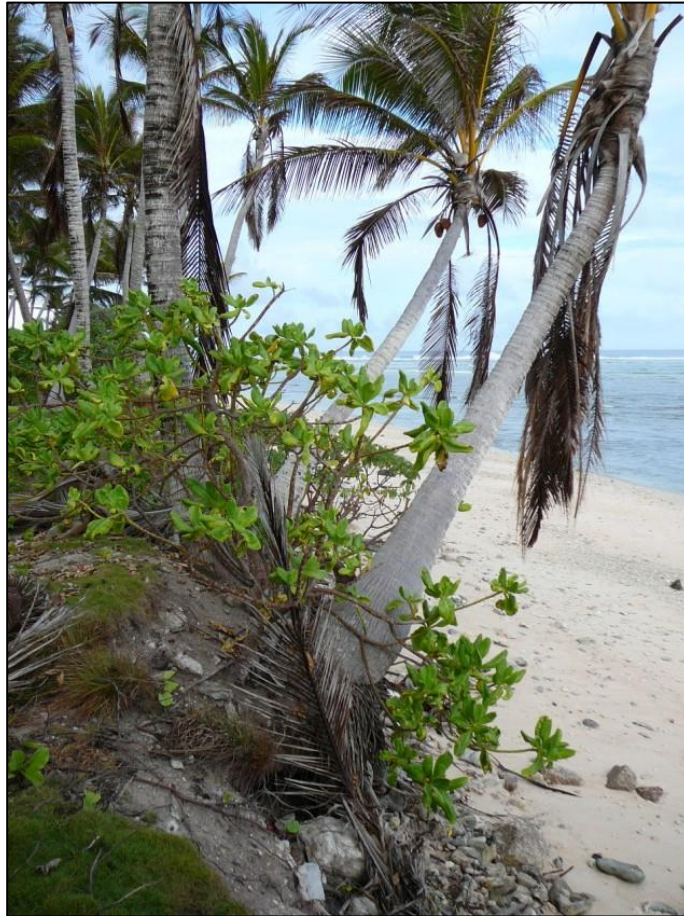
**Figure 8 – Undercutting was observed along the shoreline.**

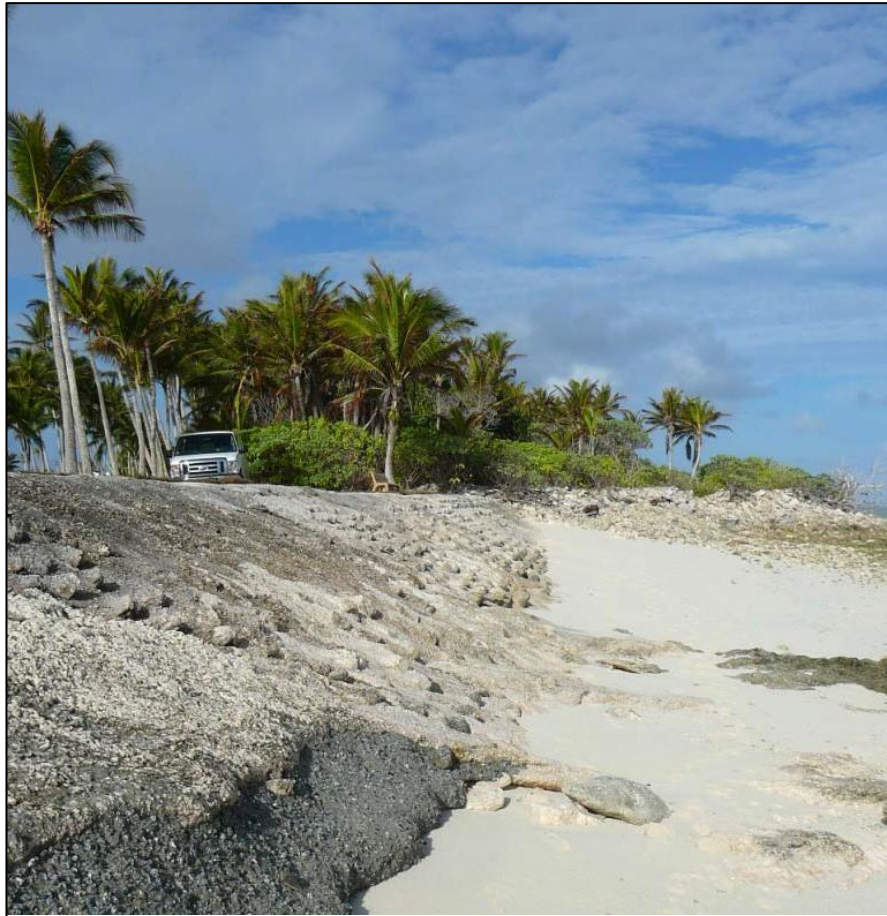
**Figure 9 – Sand acts as a ramp allowing waves to breach near the airfield.**
