FINAL BIOLOGICAL ASSESSMENT FOR REMOVAL ACTION ACTIVITIES ASSOCIATED WITH THE KWAJALEIN LANDFILL

January 2017

**FINAL
BIOLOGICAL ASSESSMENT
FOR
REMOVAL ACTION ACTIVITIES ASSOCIATED WITH THE KWAJALEIN LANDFILL**

**U.S. ARMY GARRISON-KWAJALEIN ATOLL
REPUBLIC OF THE MARSHALL ISLANDS**

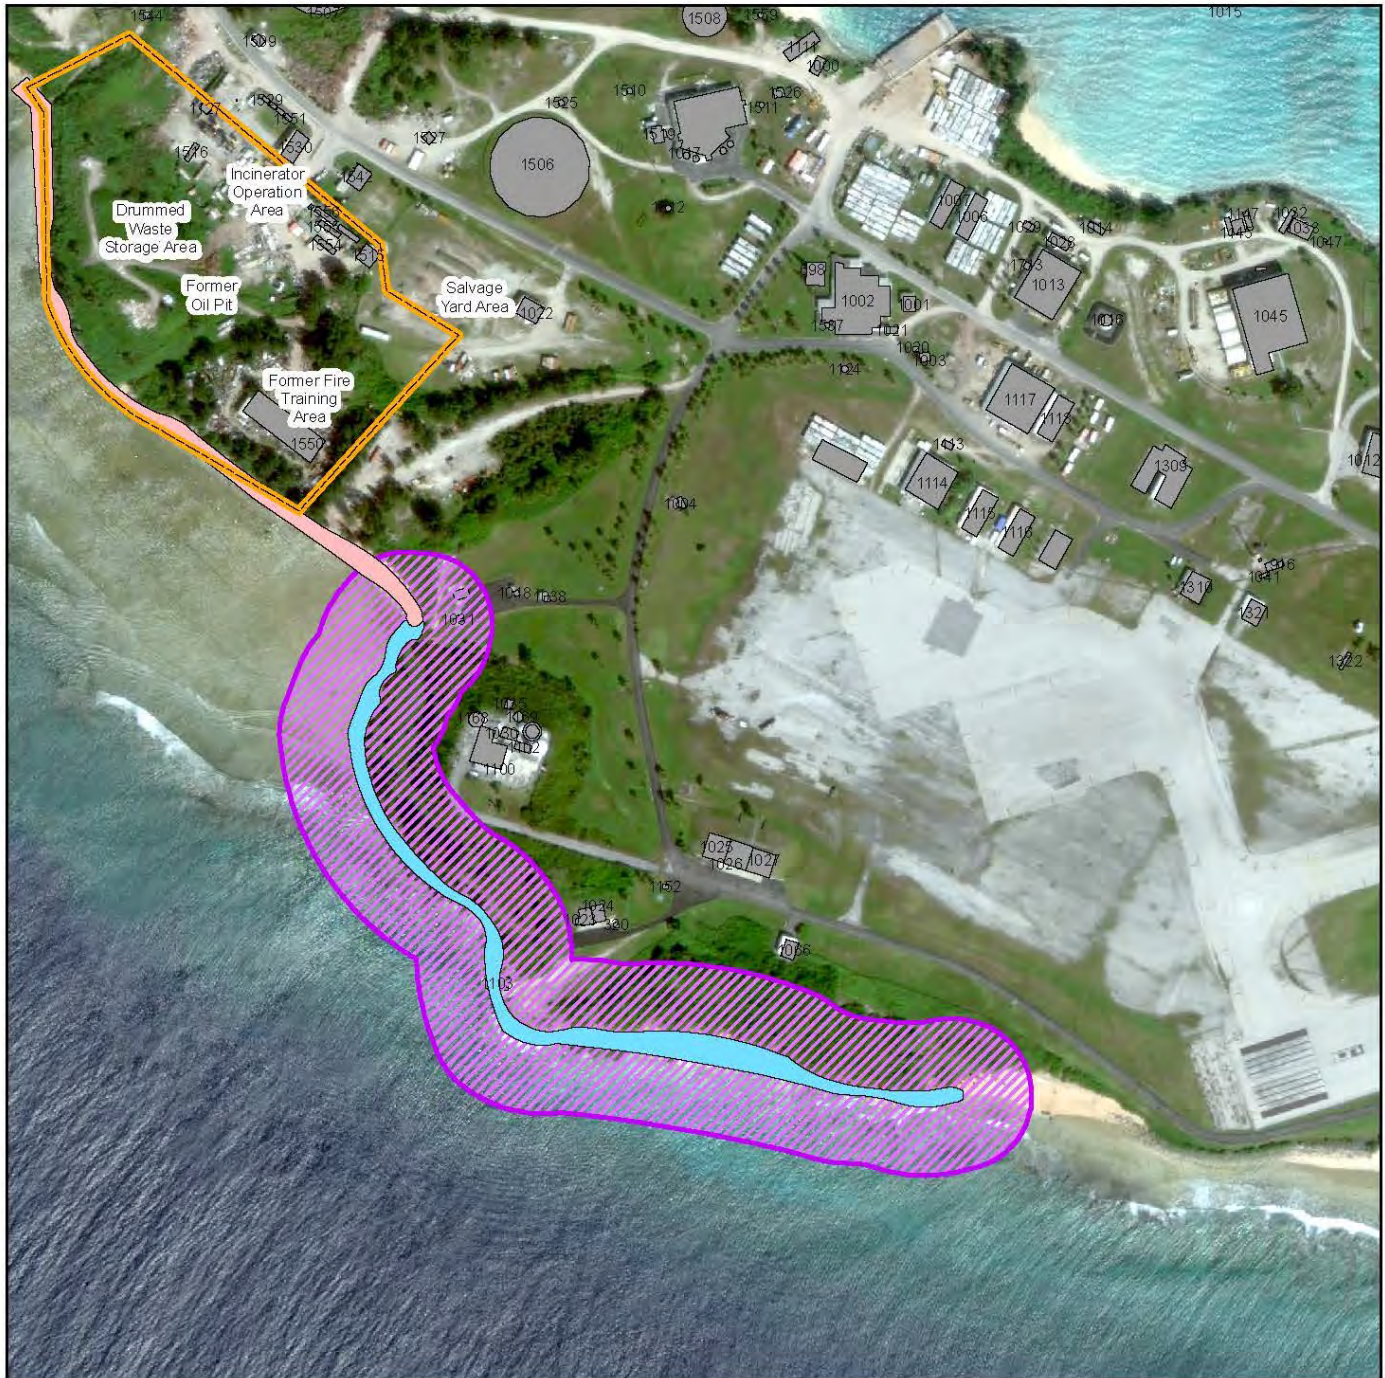
- Current Landfill Boundary Alternative
- Shoreline with Metal Debris (Landfill Area) Alternative
- Shoreline with Metal Debris (Mt. Olympus to Glass Beach) Alternative
- Action Area
- Existing Structure

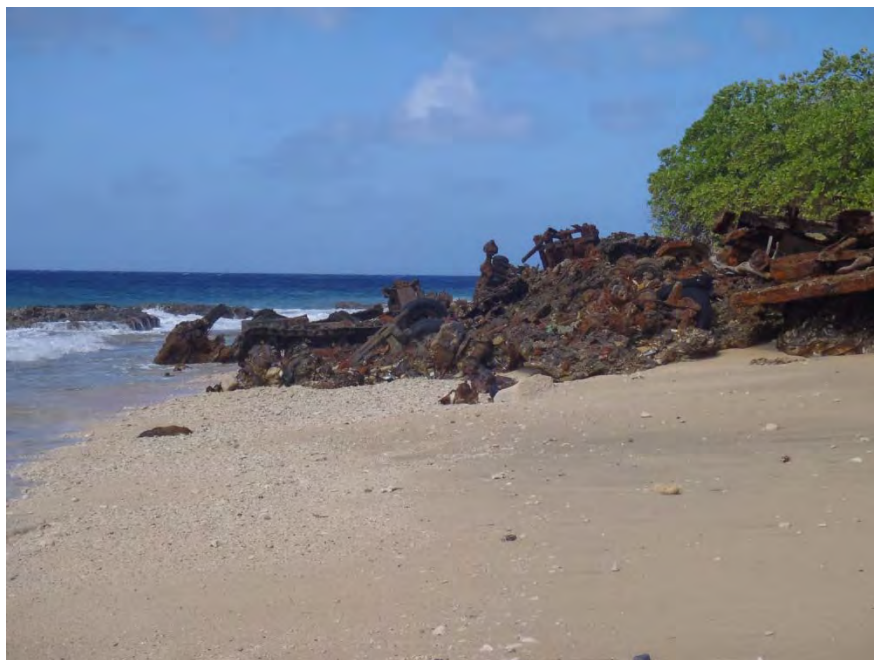
Figure 2-2. Start of metal debris at Glass Beach, looking west.

Metal debris (pipes, vehicle parts, engines, wire, and larger metal pieces) is present throughout most of this reach of the shoreline (see Figures 2-2 and 2-3). In places, the metallic debris extends beyond the toe of the shoreline. This metal debris is being eroded and swept to the west onto the landfill shoreline and is likely a contributing cause of the high copper concentrations measured in the inter-tidal marine water near the landfill.

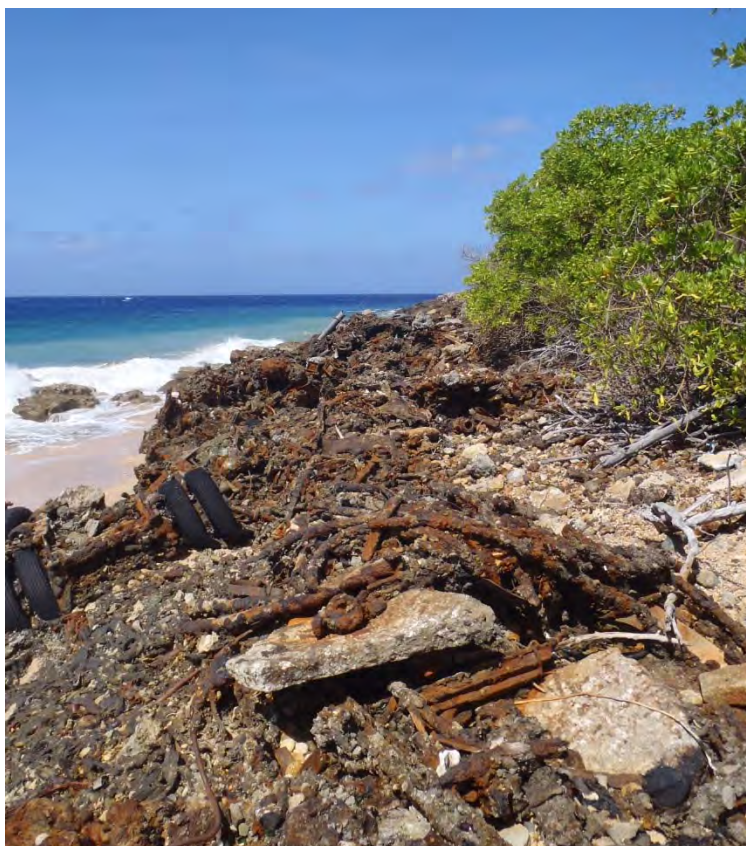
Figure 2-3. Metal debris along shoreline between Glass Beach and the Shark Pit, looking west.

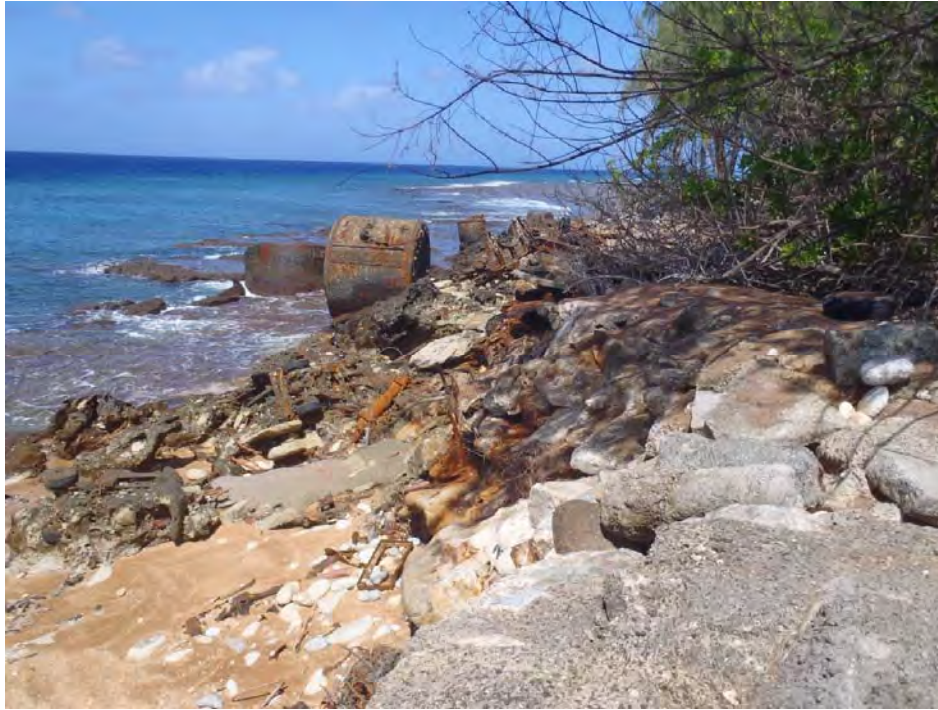
Figure 2-5: Metal debris south of Mount Olympus at low tide.

4. As much as possible, conduct clean-up activities at low tide (see Figure 2-5), which will reduce sound transmittal and the potential for sea turtles and other mobile species of concern to be present in the action area.

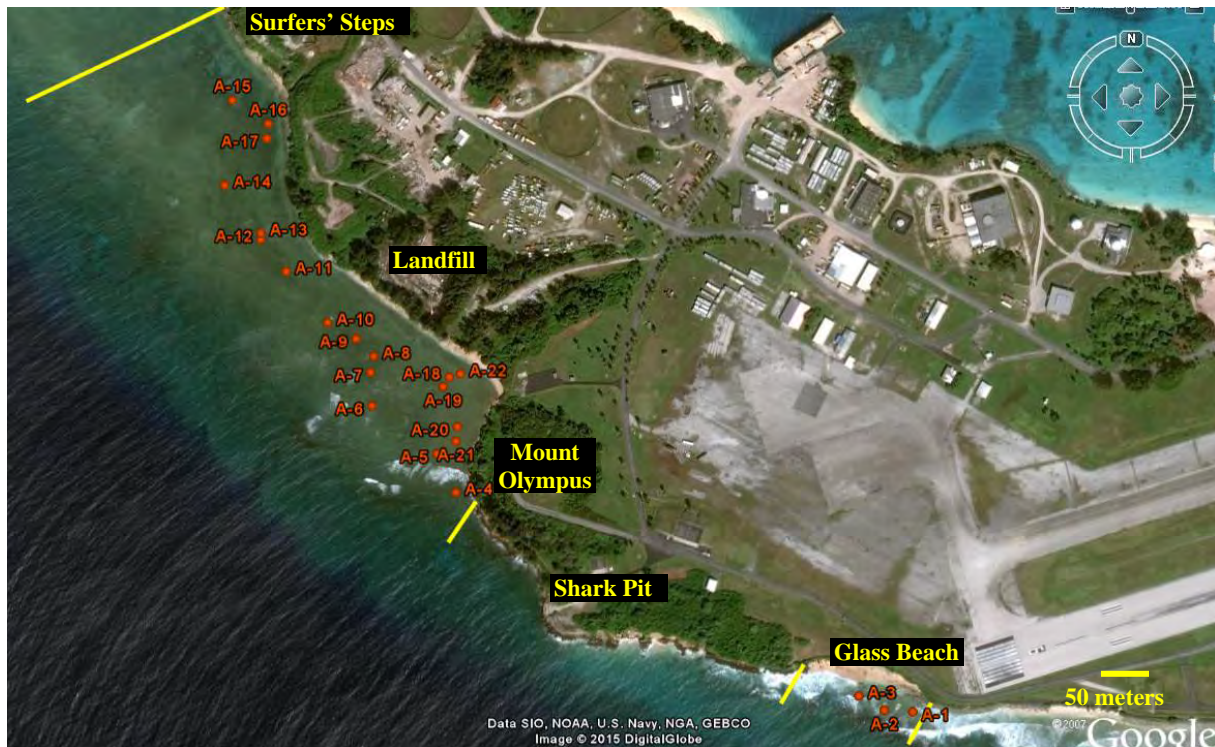
Figure 1. Reef flat areas surveyed for UES consultation and coordination species, from Glass Beach to the Surfers' Steps, Kwajalein Islet. Red-labeled points indicate locations of observed metal debris at distances greater than 10 to 20 m from shore (see Appendix).

The reef flat at Glass Beach extended out from shore approximately 25 m, with the length of shoreline surveyed approximately 160 m (Figure 1). The bottom substrate consisted mainly of consolidated limestone pavement with accumulated sands on the western end (Figure 2). Metal

debris appeared most dense along the western portion of the beach, but was limited on the outer portion of the reef flat, with a total of 3 small items recorded (Figure 1; Figures A-1 to A-3, Appendix). No UES consultation species were observed in the area. A few scattered UES coordination coral species were present on the outer reef flat and reef crest areas and included *Porites* sp. (lobate) and *Pocillopora meandrina* (Figure 2). All metal items observed appeared readily removable by hand with no risk to UES coordination species.

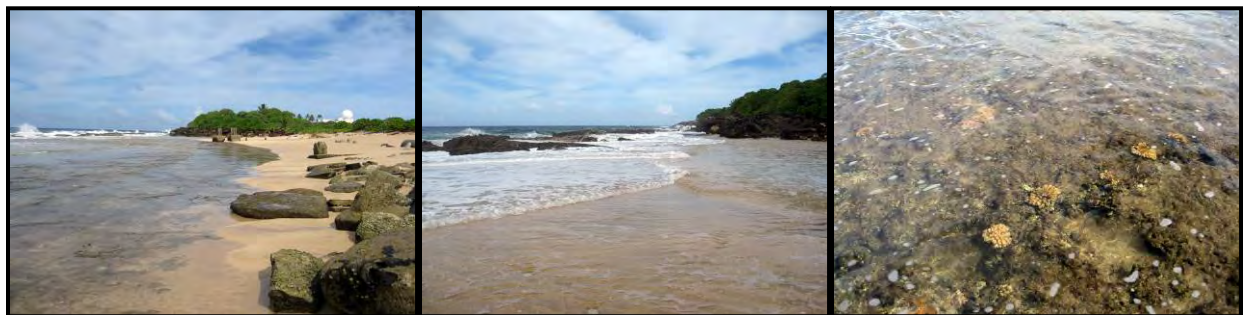
Figure 2. Glass Beach at low tide (left and center), with scattered UES coordination corals located mainly on the outer reef flat away from metal debris (right)

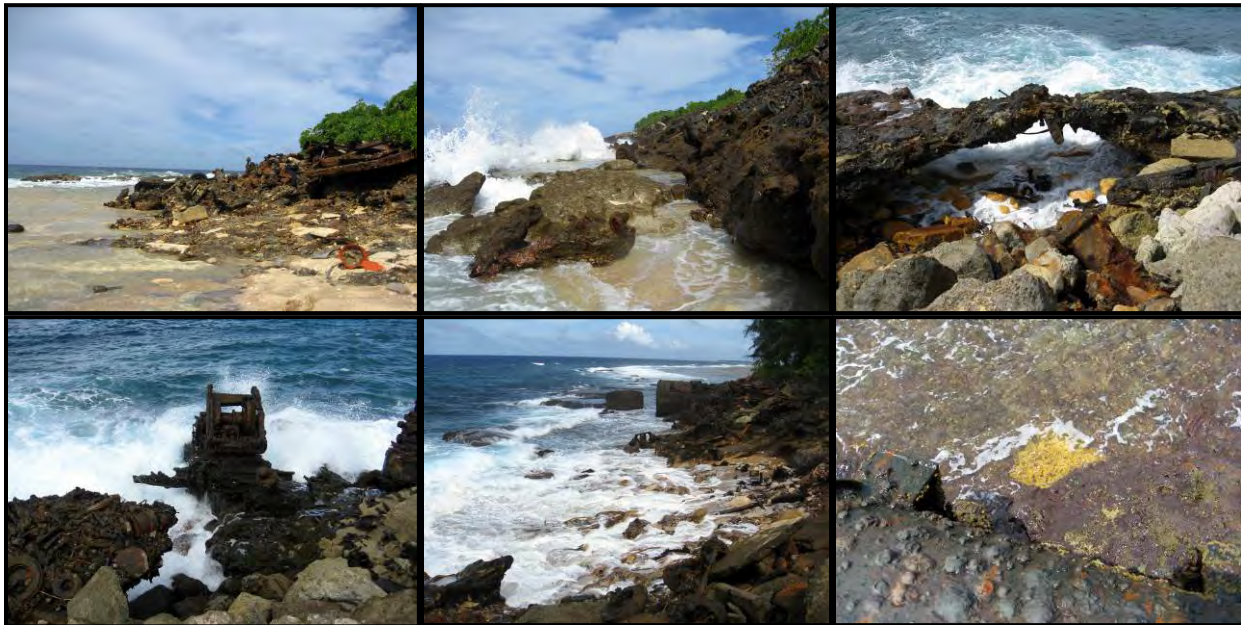
Figure 3: Main metal debris area along southwest Kwajalein Islet. Dark formations in the images are eroded metal. UES coordination coral species (*Porites* sp.) shown off eroded metal edge in lower right image.

Coastline from the western edge of Glass Beach to Mount Olympus (approximately 525 m linear distance; Figure 1) contained the vast majority of metal shoreline debris at Kwajalein Islet, with aggregation and heavy erosion forming metal cliff-like shore-break structures. The majority of

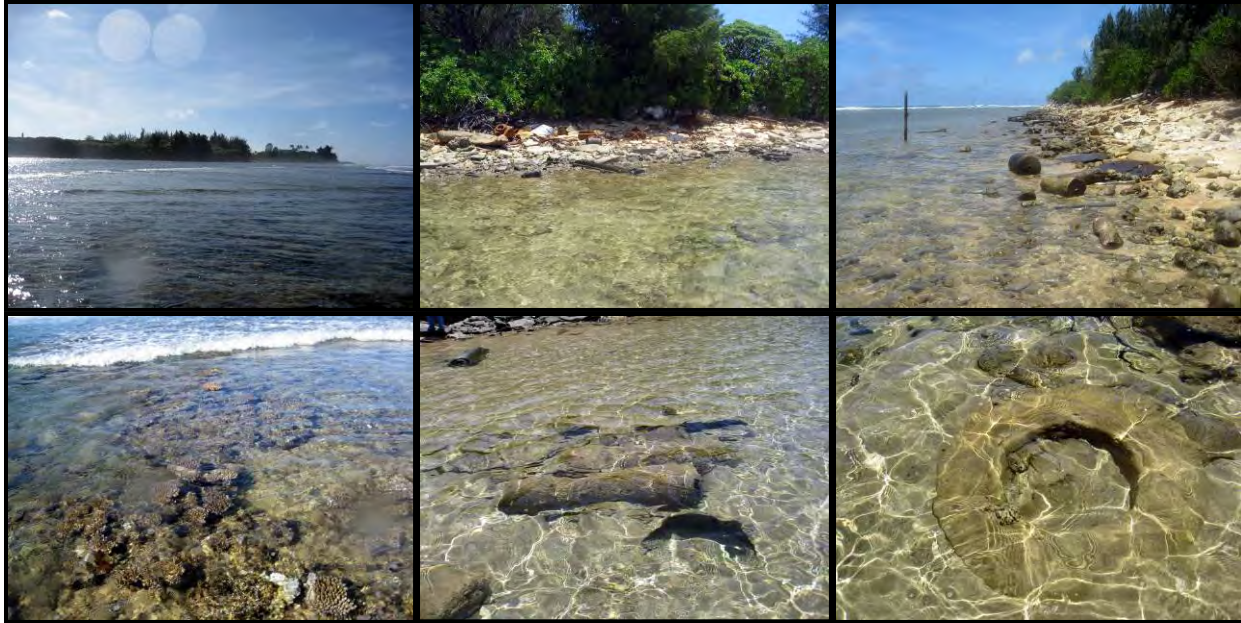
Figure 4: Reef flat along southwest Kwajalein Islet between the Surfers' Steps and Mount Olympus. Coral cover and diversity increases on the outer reef flat (lower left). *Pocillopora damicornis* coral colony observed growing on tire (lower right).

The reef flat between the Surfers' Steps and outer landfill region of Mount Olympus extended up to approximately 225 m from shore with a length of shoreline approximately 660 m (Figure 1). The bottom substrate along the inner reef flat consisted mainly of sand, algae and scattered corals with consolidated limestone pavement and an increase in coral cover and diversity occurring in the outer reef flat areas (Figure 4). Metal debris in this region was located mainly on and within 20 m of the shoreline; however, a total of 19 metal items/aggregations were identified further out (Figure 1; Figures A-4 to A-22, Appendix), with the furthest-most item resting approximately 100 m from shore. The only UES consultation species observed was *Tectus (Trochus) niloticus*, which was seen on outer reef flat areas approximately 180 m from shore. A variety of UES coordination species were observed, including the giant clam *Tridacna squamosa* and the corals *Acropora abrotanoides*, *A. digitifera*, *Hydnophora microconos*, *Leptastrea purpurea*, *Montipora digitata*, *Pocillopora damicornis*, *P. eydouxi*, *P. meandrina*, *P. verrucosa*, and *Porites* sp. (lobate). Coral distributions on and in the vicinity of metal debris were very limited. All metal items on the reef flat appeared amendable to removal by hand, with impacts to UES coordination species in most cases easily avoidable.
