**DOCUMENT OF  
ENVIRONMENTAL PROTECTION**

**ACTIVITY:  
DREDGING AND FILLING**

**CONTROL NUMBER DEP-16-001.0**

**UNITED STATES ARMY GARRISON - KWAJALEIN ATOLL/  
RONALD REAGAN BALLISTIC MISSILE DEFENSE TEST SITE  
IN THE  
REPUBLIC OF THE MARSHALL ISLANDS**

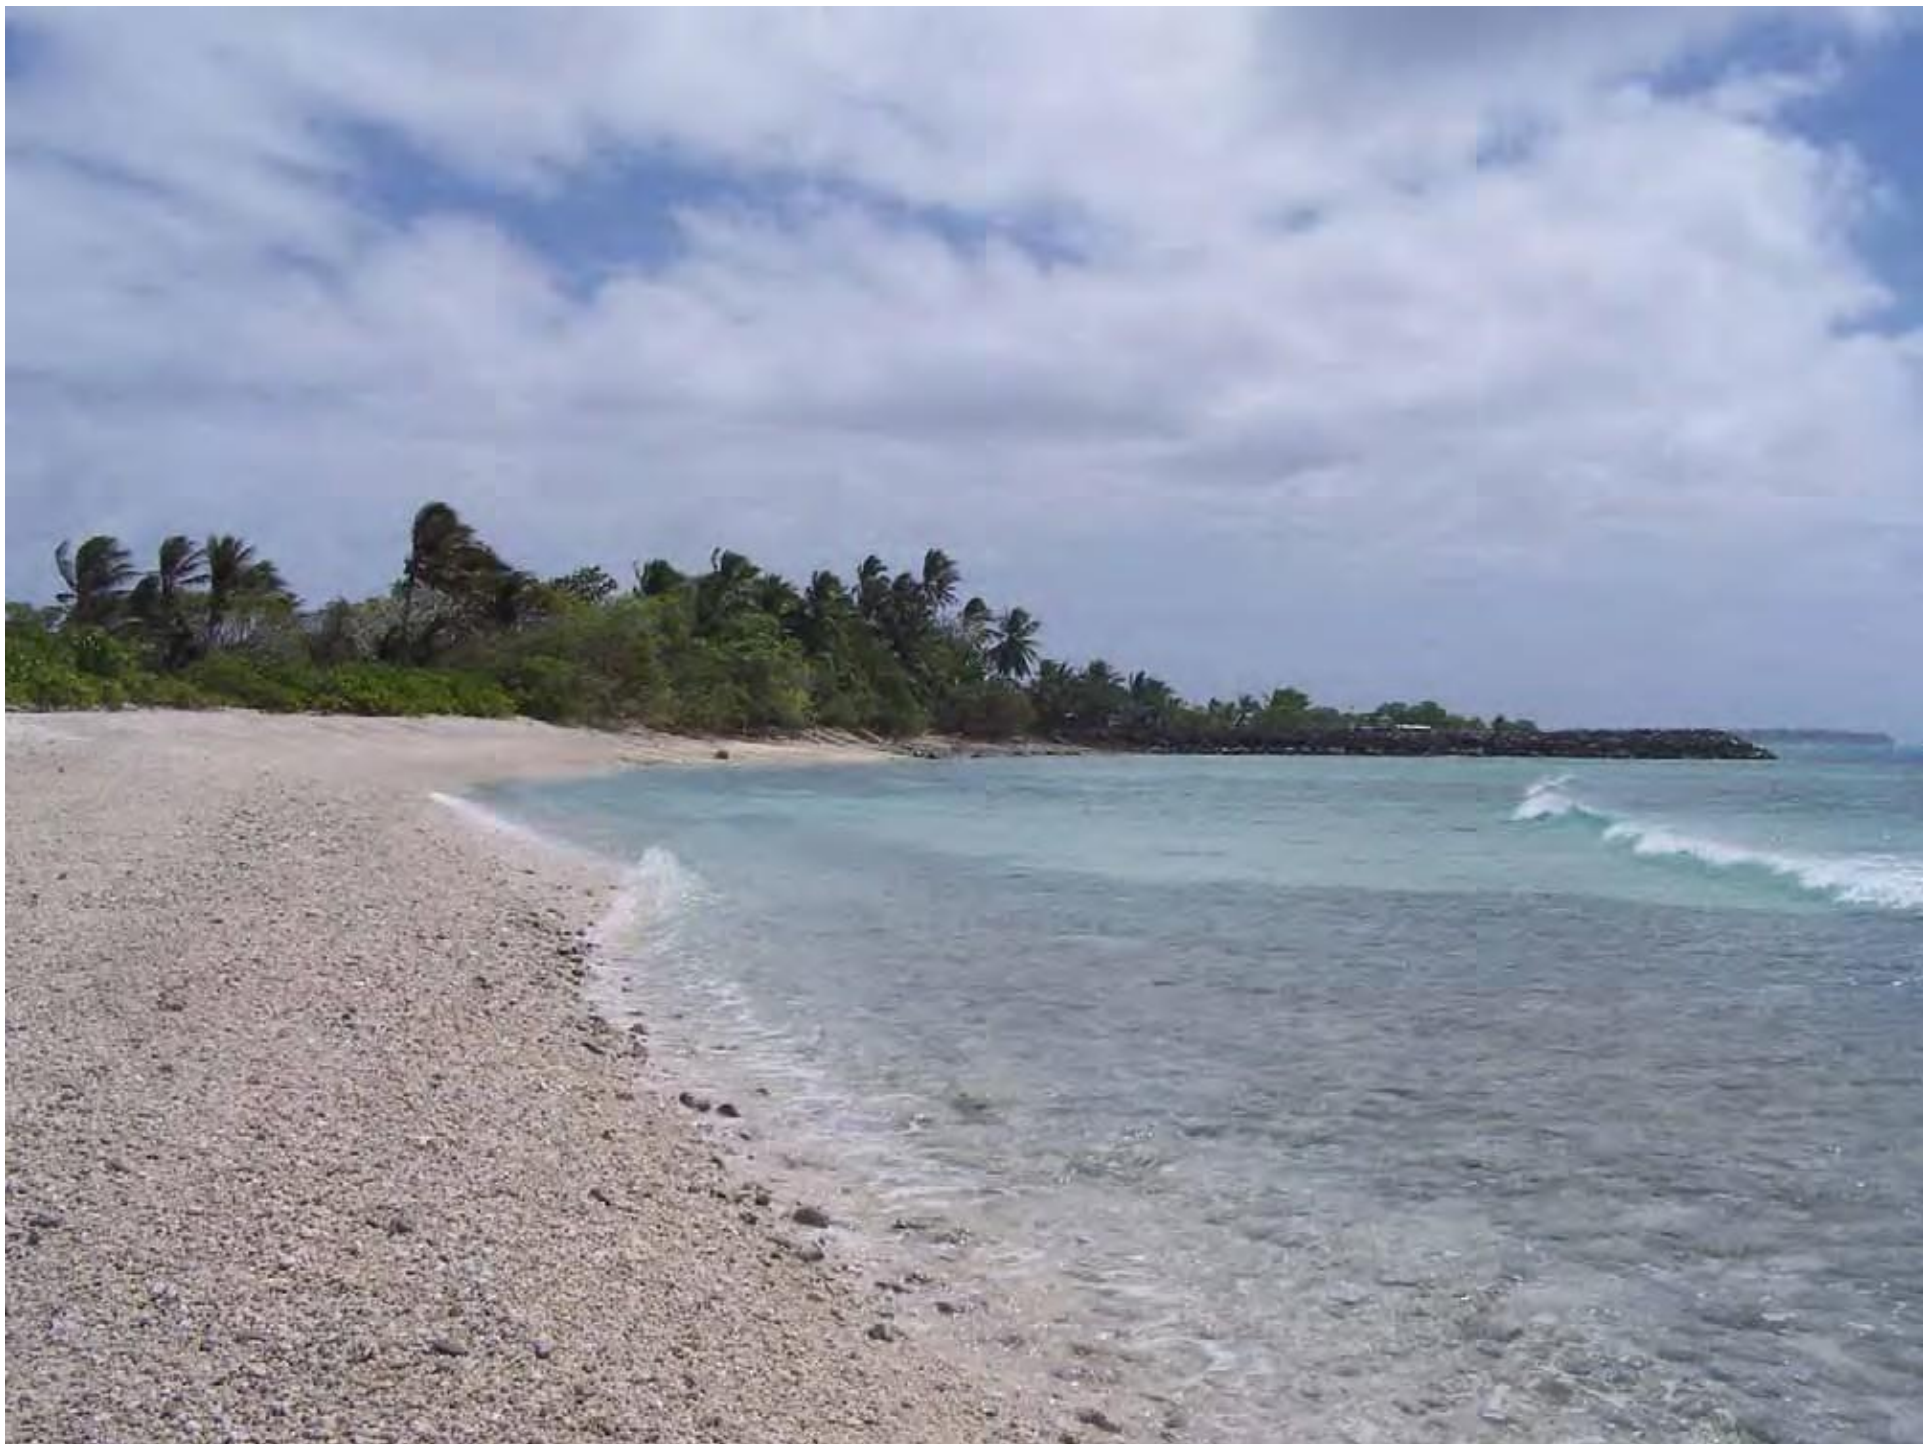
OM-03      Lagoon Side

Description: North of Harbor

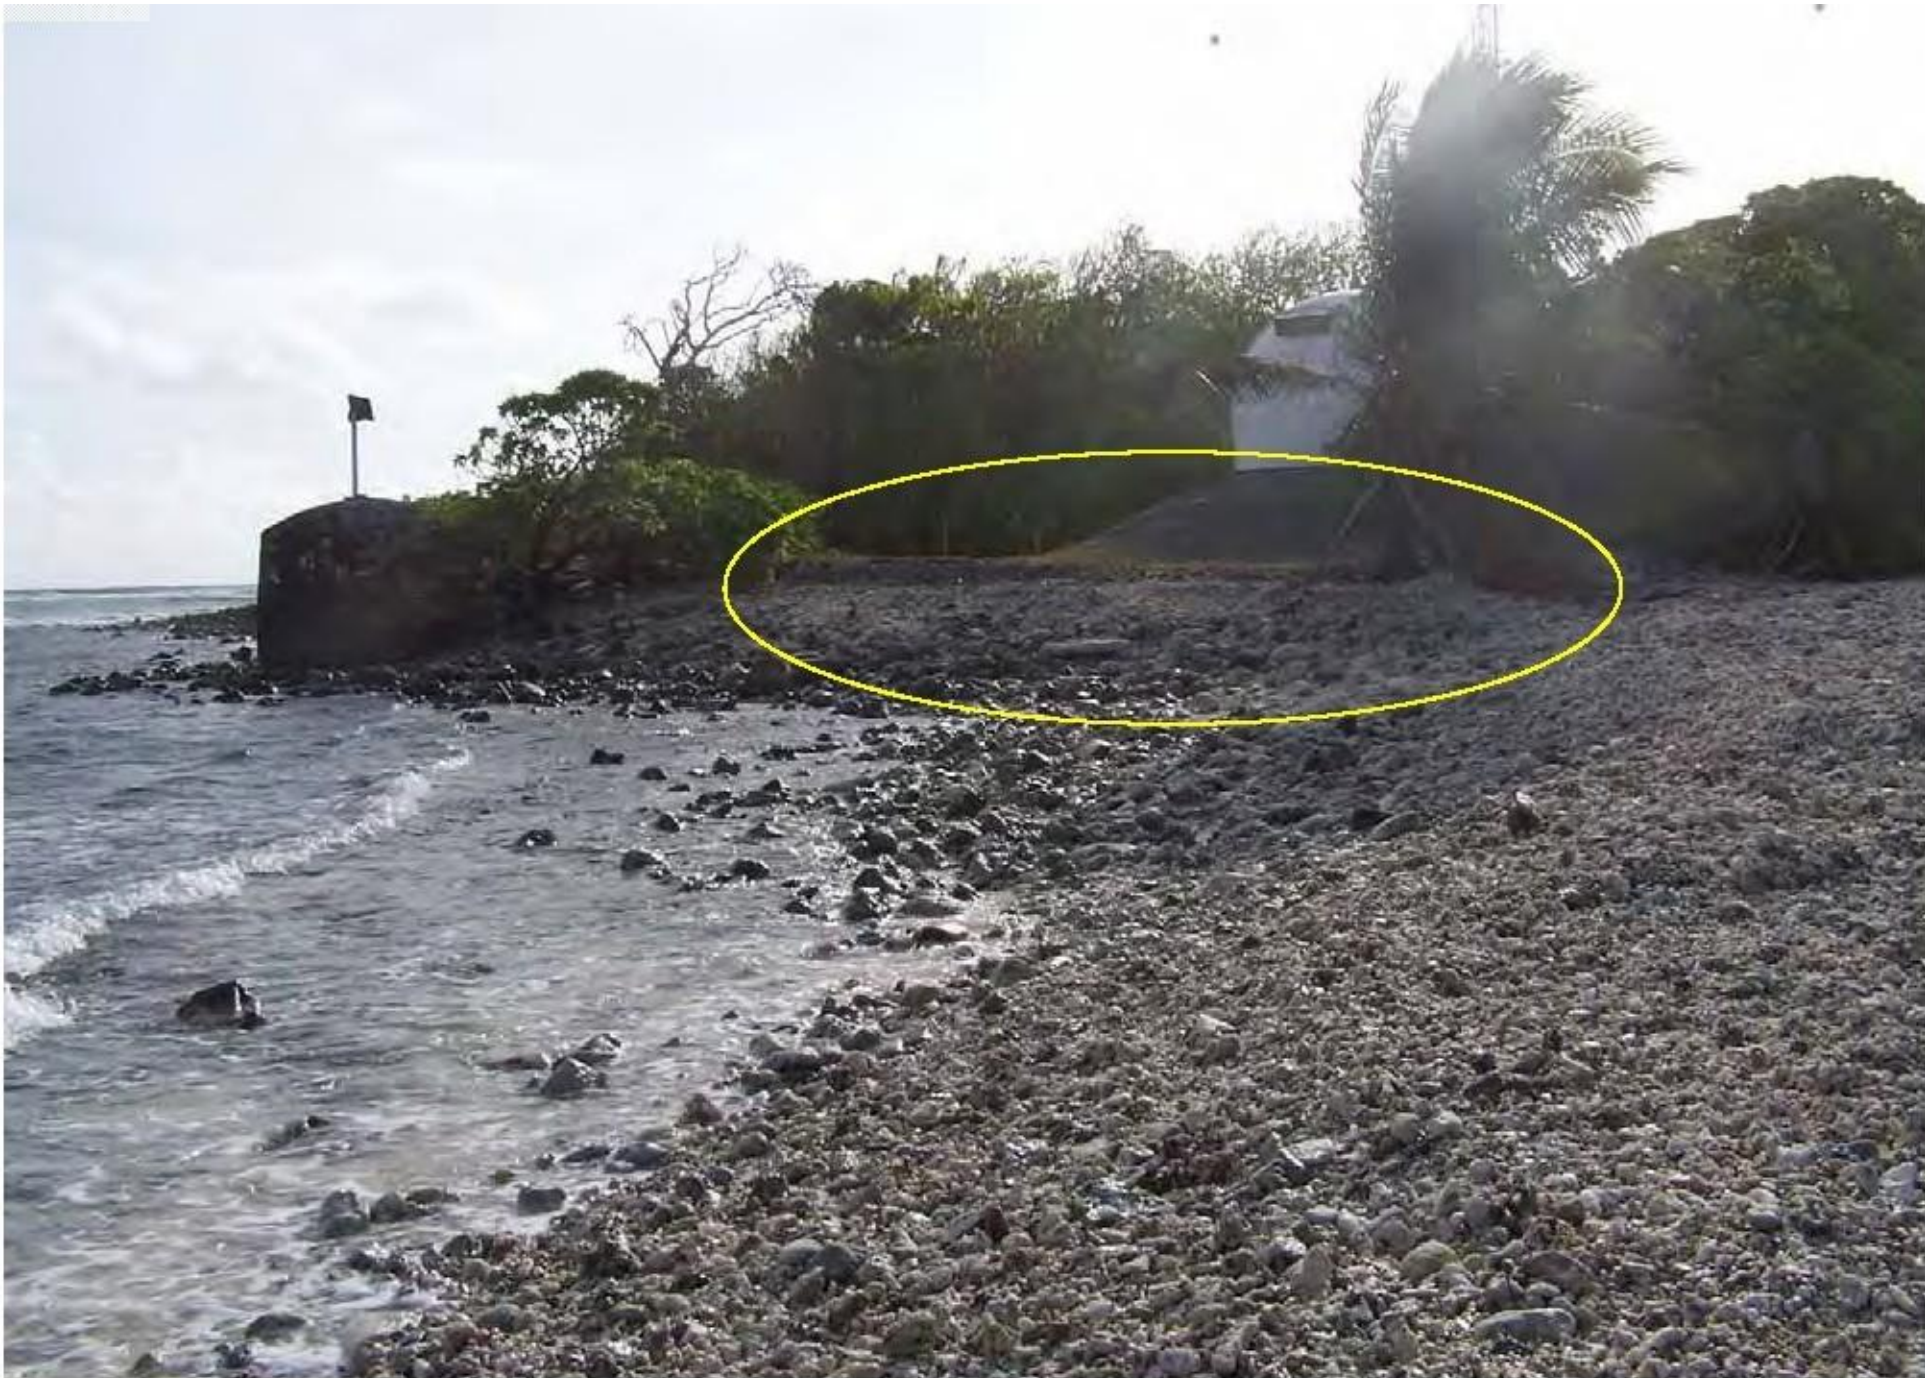
17

GA-04 Gagan Lagoon Side

Description: Northwest portion of island, ledging noted in area of abandoned dome

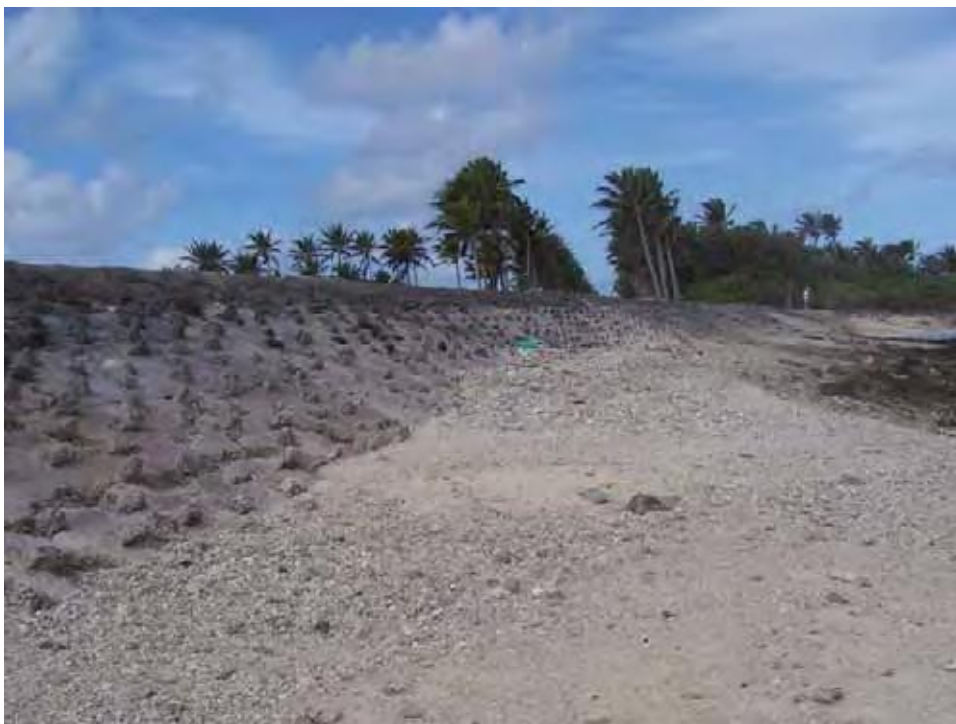
1

RN-01 Ocean Side

Low potential for natural resource impact

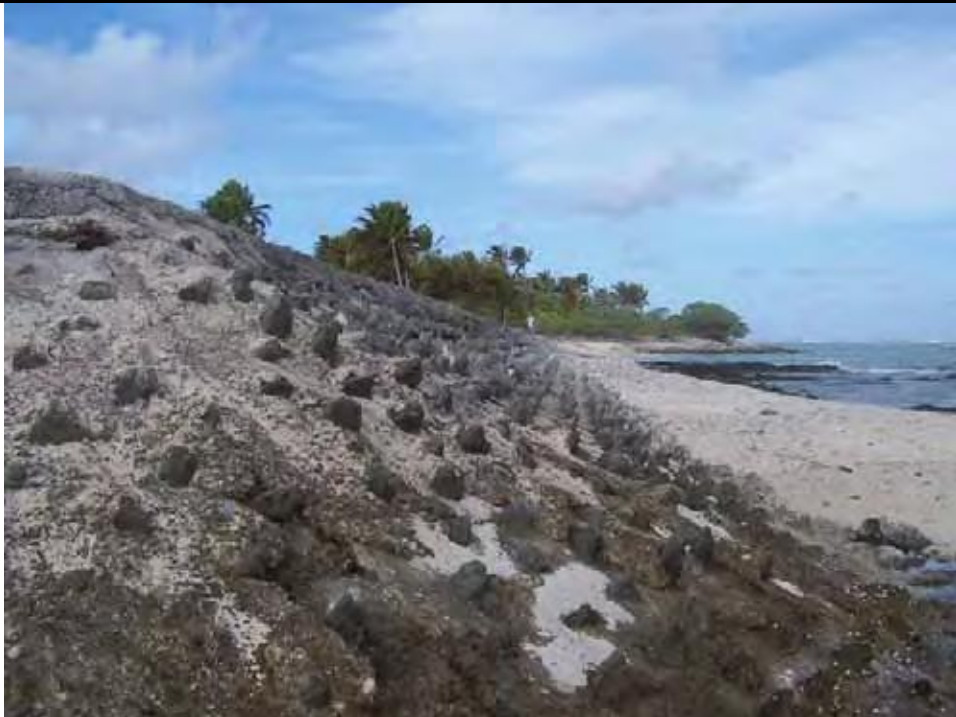
2

RN-01 Ocean Side

Low potential for natural resource impact

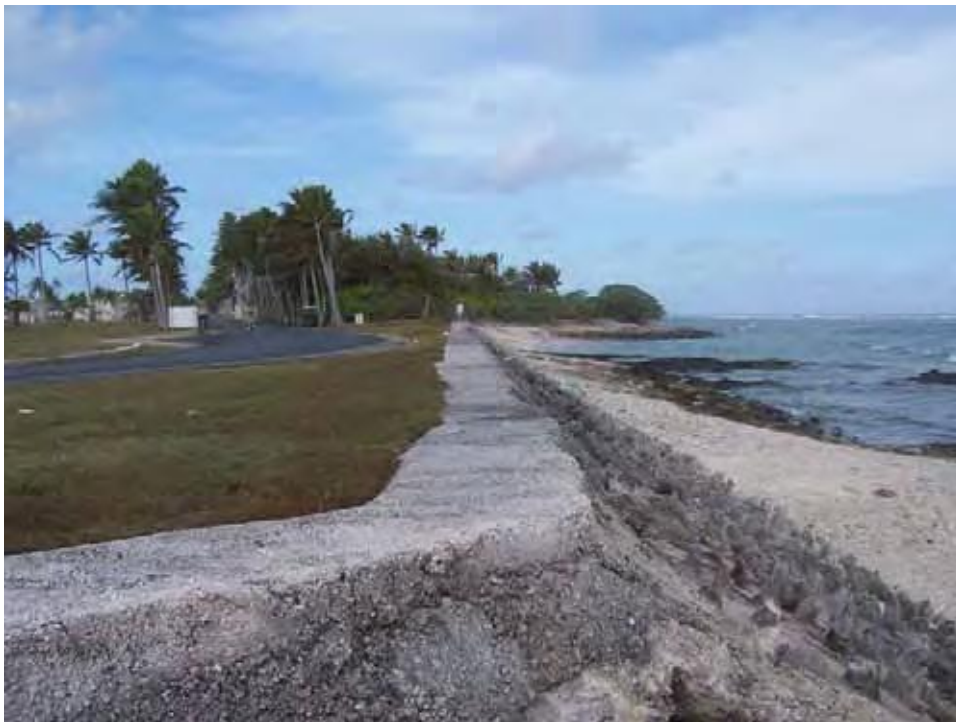
3

RN-01 Ocean Side

Low potential for natural resource impact

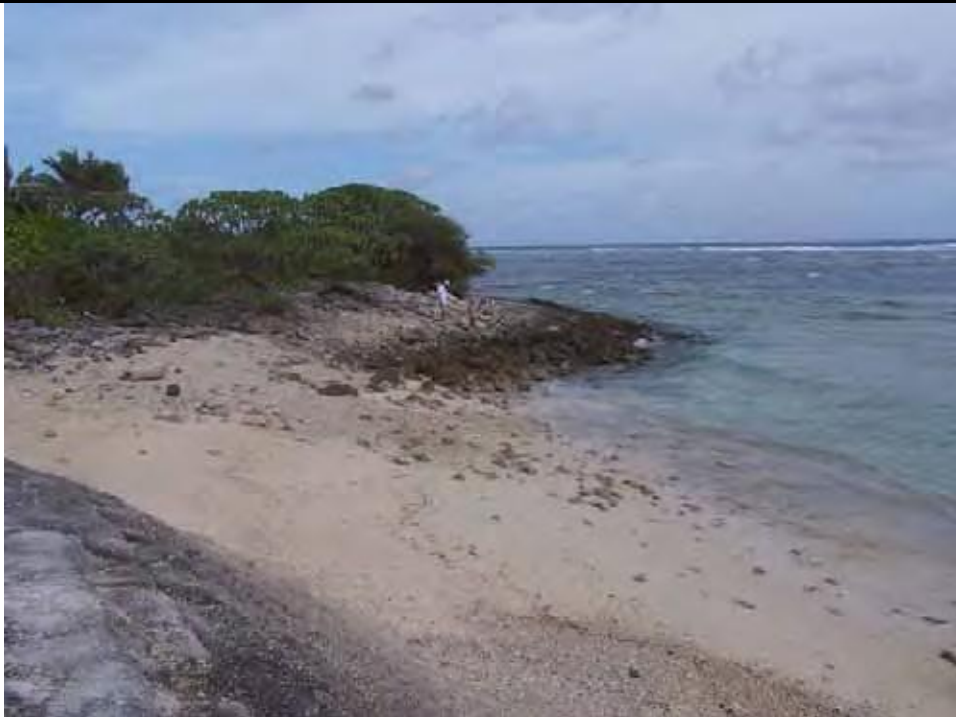
4

RN-01 Ocean Side

Low potential for natural resource impact

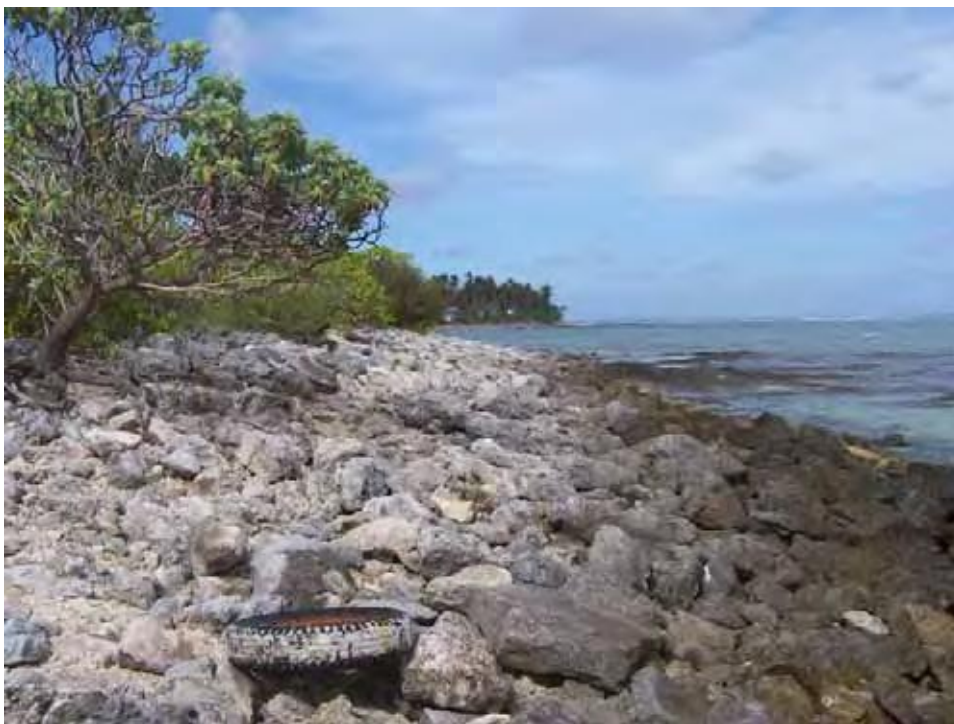
5

RN-01 Ocean Side

Low potential for natural resource impact

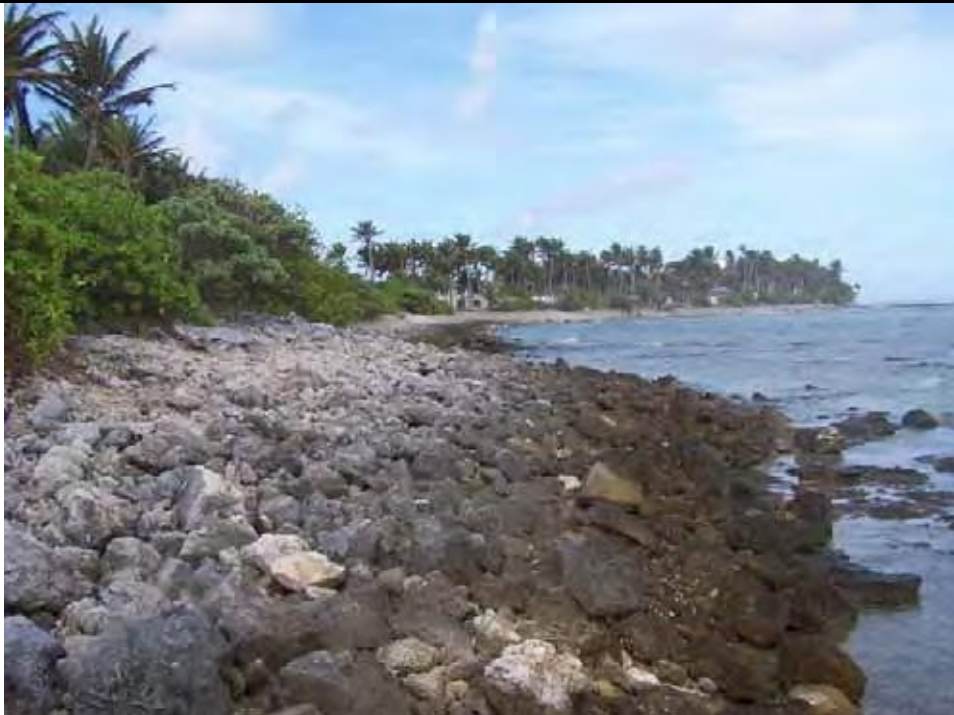
6

RN-01 Ocean Side

Low potential for natural resource impact

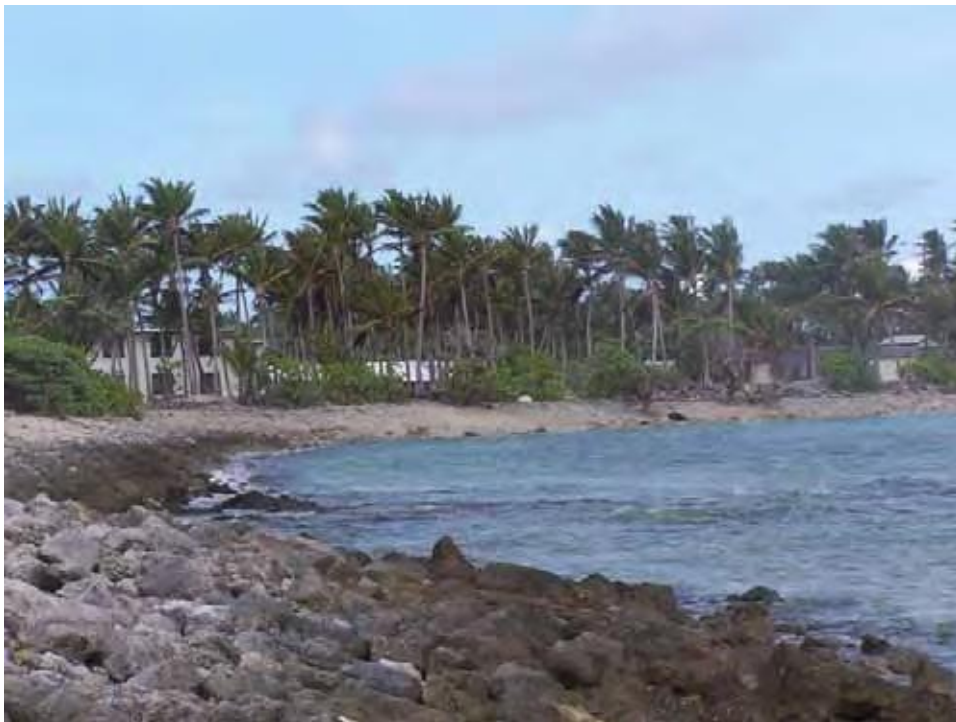
7

RN-01 Ocean Side

Low potential for natural resource impact

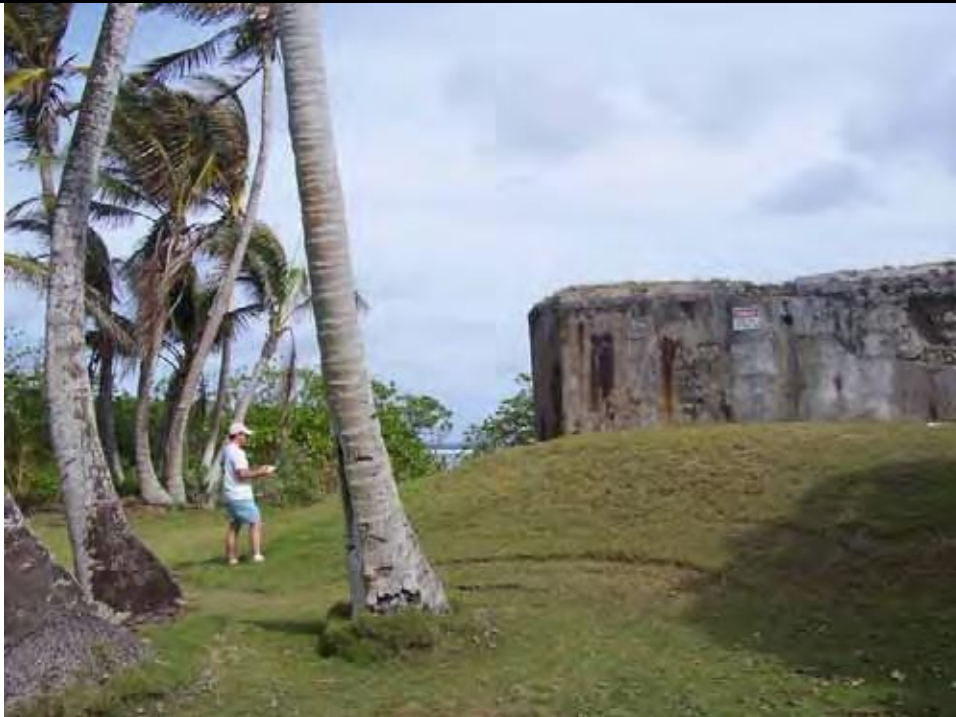
8

RN-01 Ocean Side

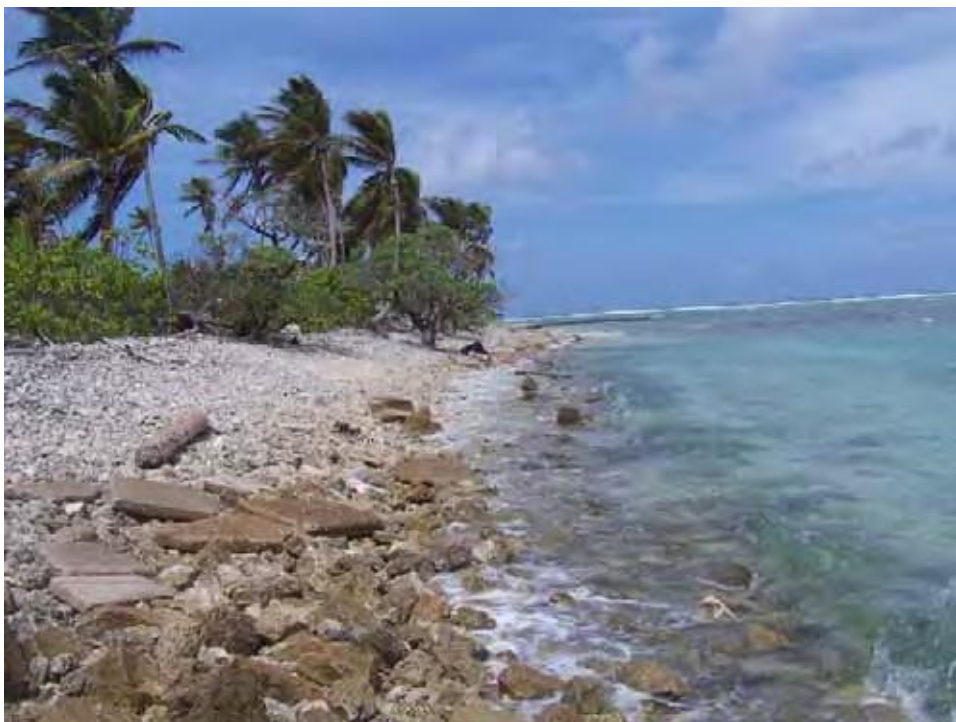
9

Low potential for natural resource impact

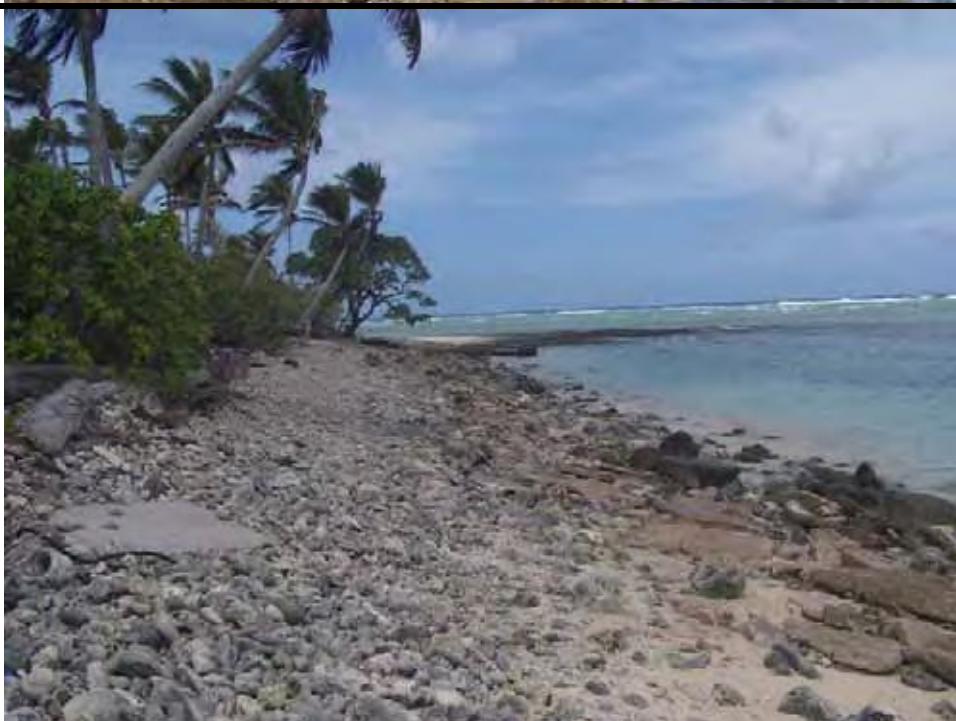
10

Low potential for natural resource impact

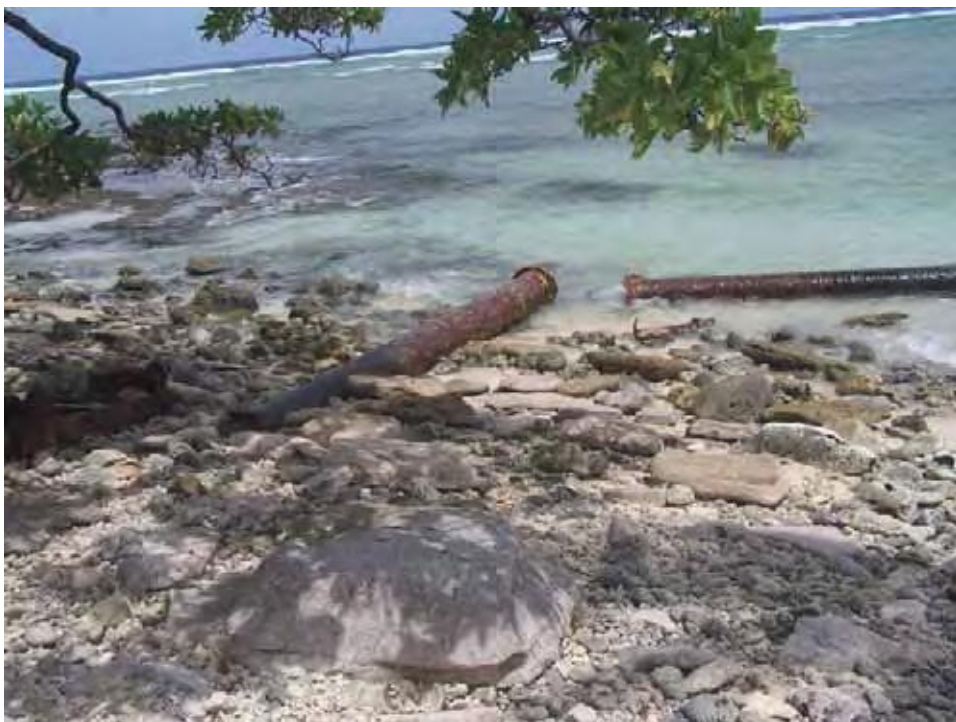
11

Shoreline protection: Some loose concrete and metal debris

Low potential for natural resource impact

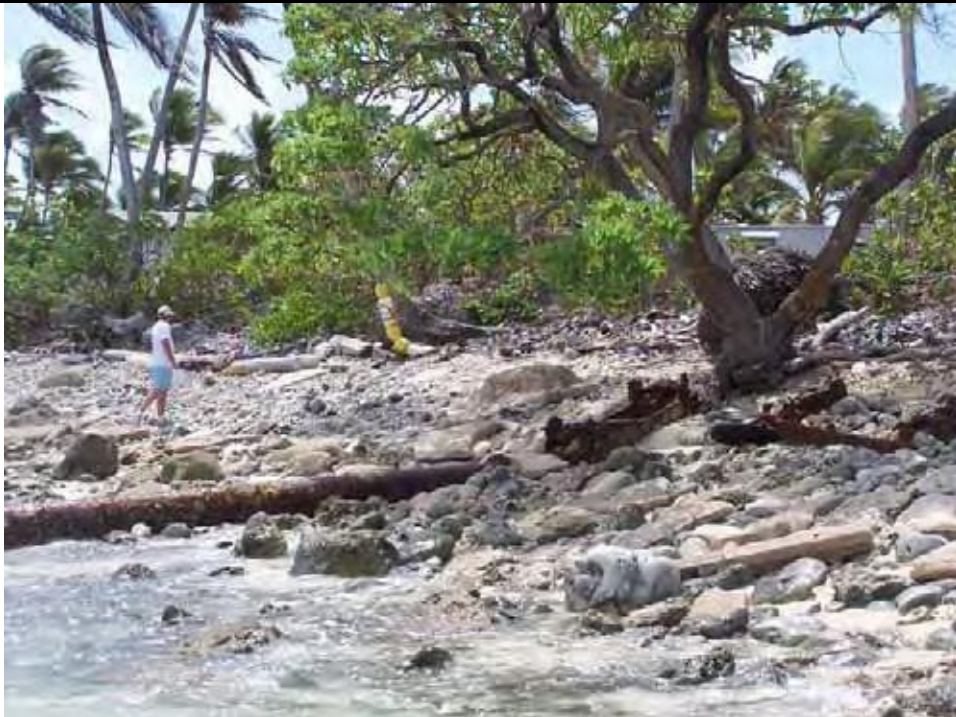
12

Low potential for natural resource impact

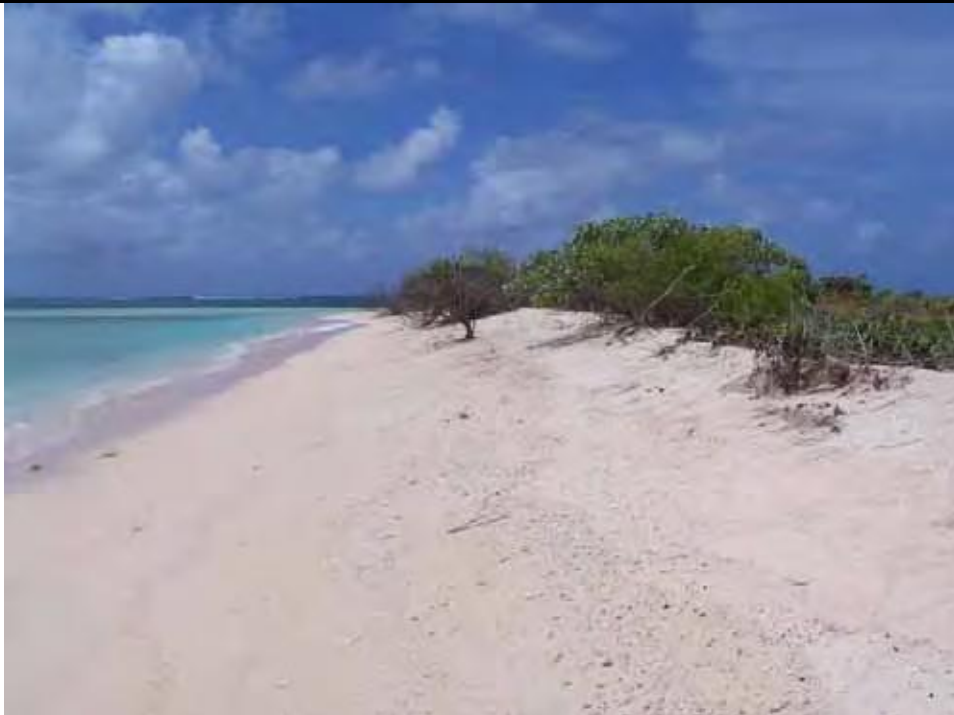
42

Low potential for cultural resource impact  
Loss of beach will impact turtle nesting area

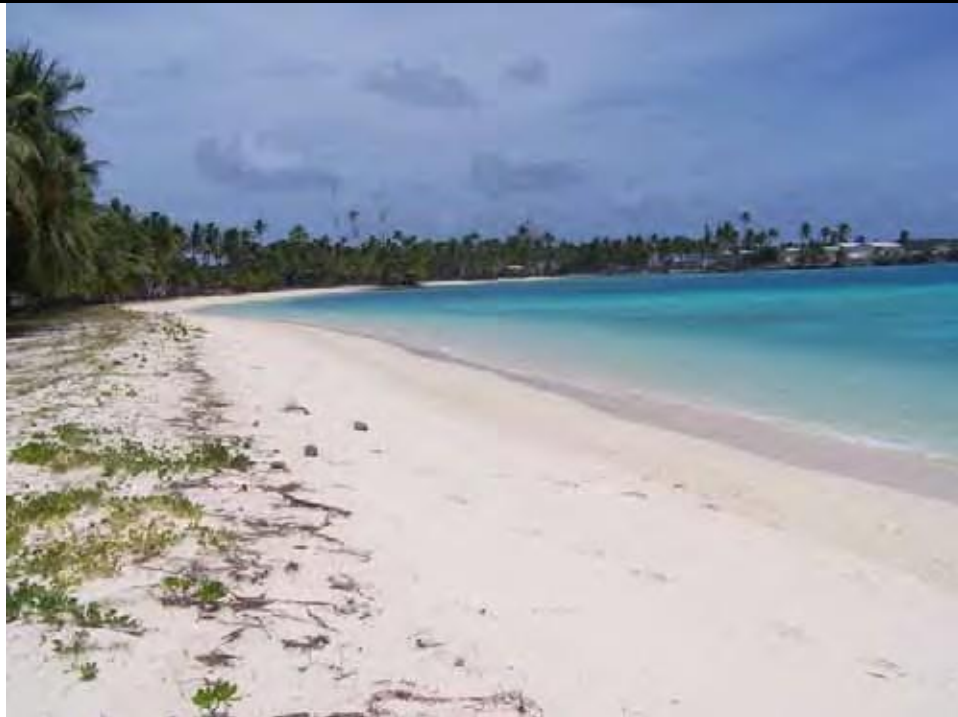
46

Impacts to turtle nesting and haulout area

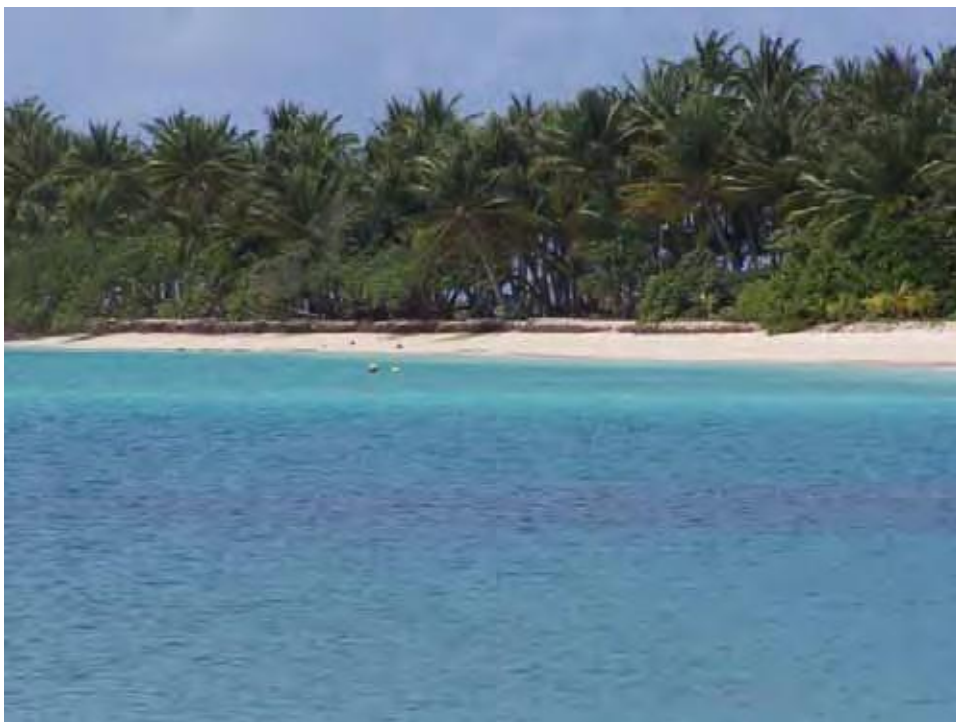
47

Turtle nesting and haulout area

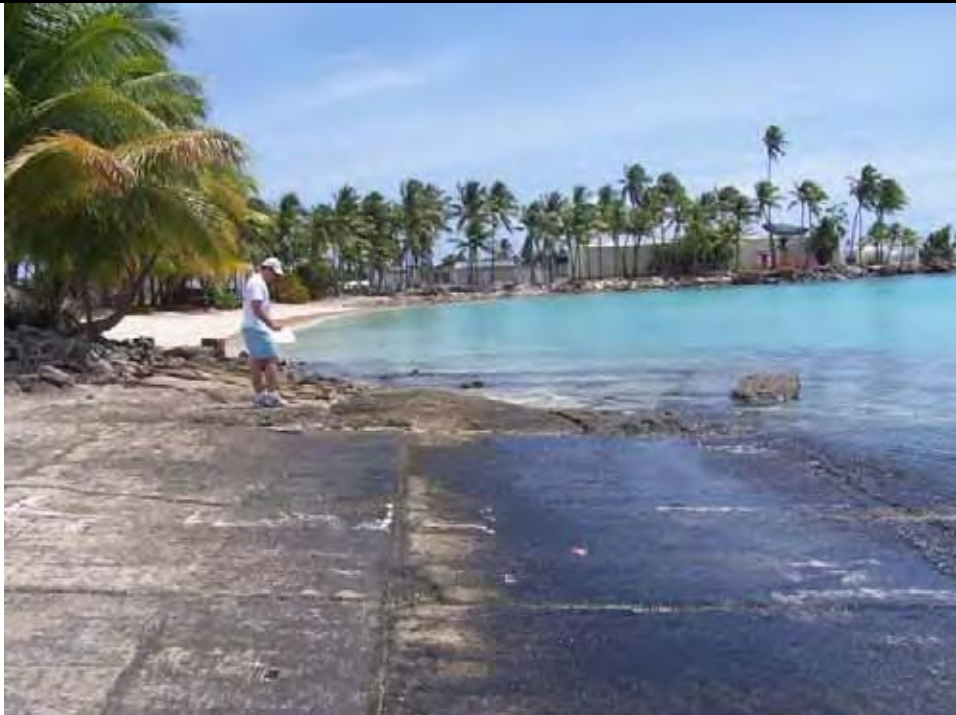
48

Loss of habitat for turtle nesting and haulout

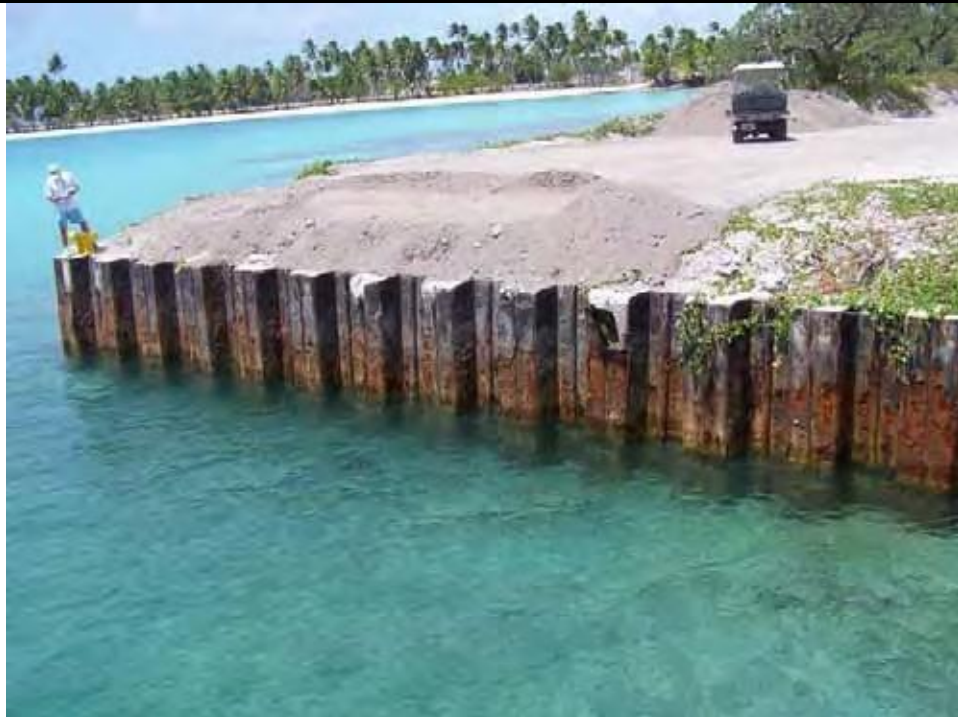
52

Description: Barge dock and mooring area. Sheet piling is corroding.

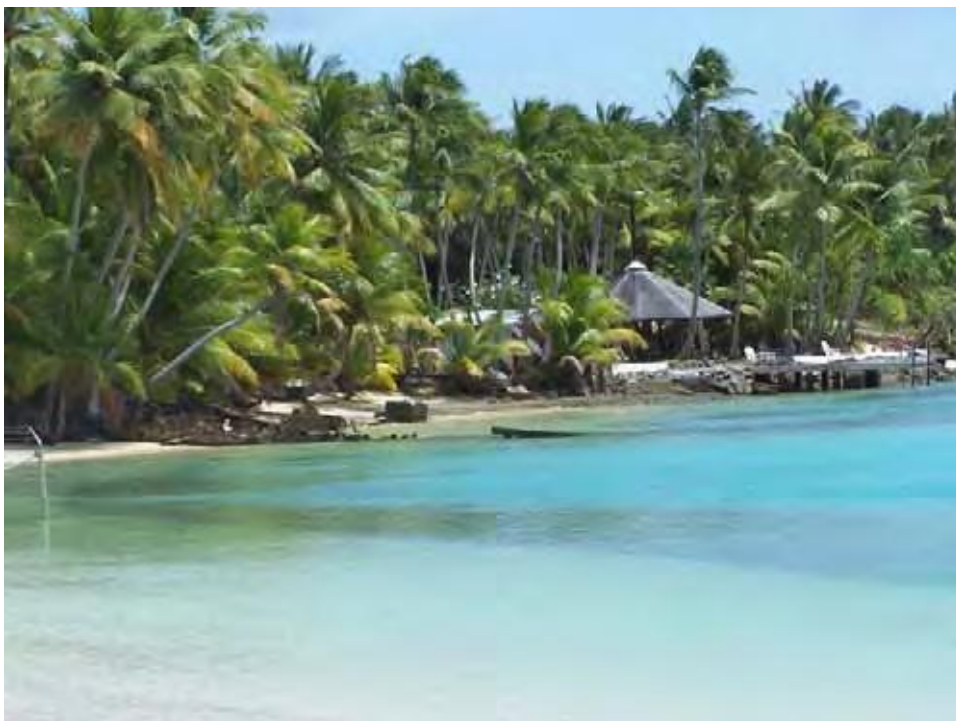
63

Description: East of the Yokahoma Pier looking towards the Dive Club. Rusted out ship is in the water

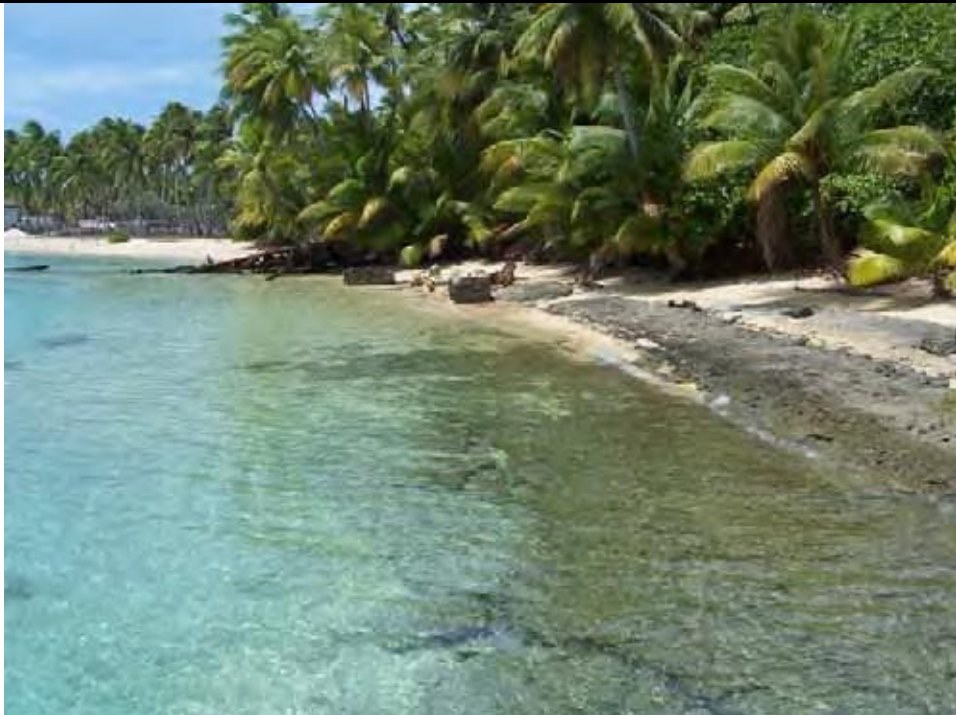
64

Description: Looking west towards Yokahoma Pier; natural reef and sand beach; some concrete debris and a rusted out ship on shoreline

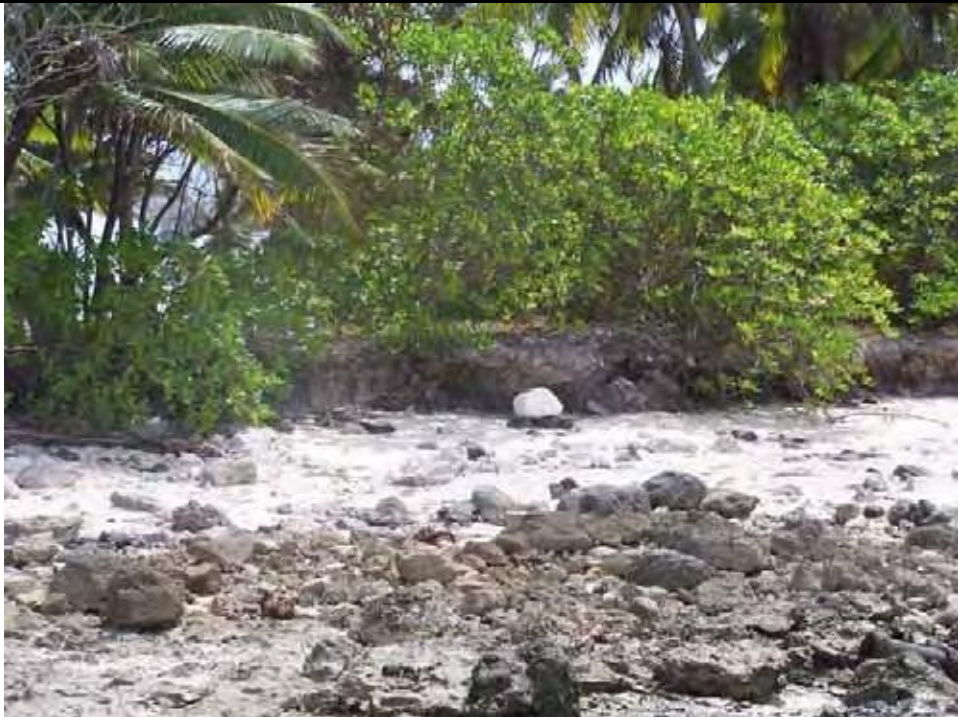
86

Description: Close-up picture of ledge caused by erosion

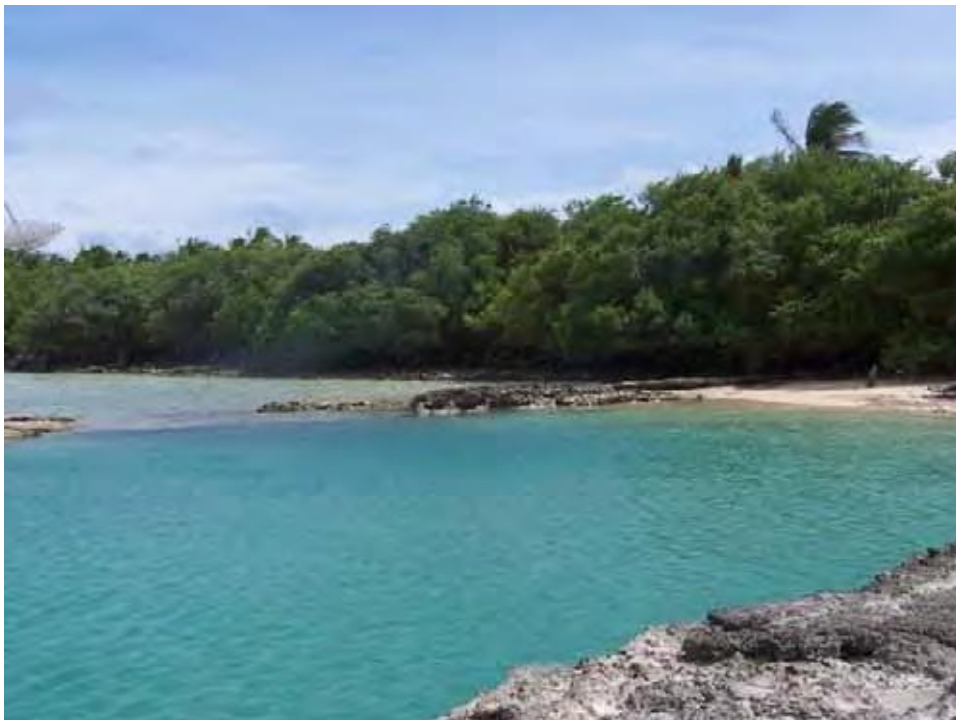
89

Low potential for natural resource impact

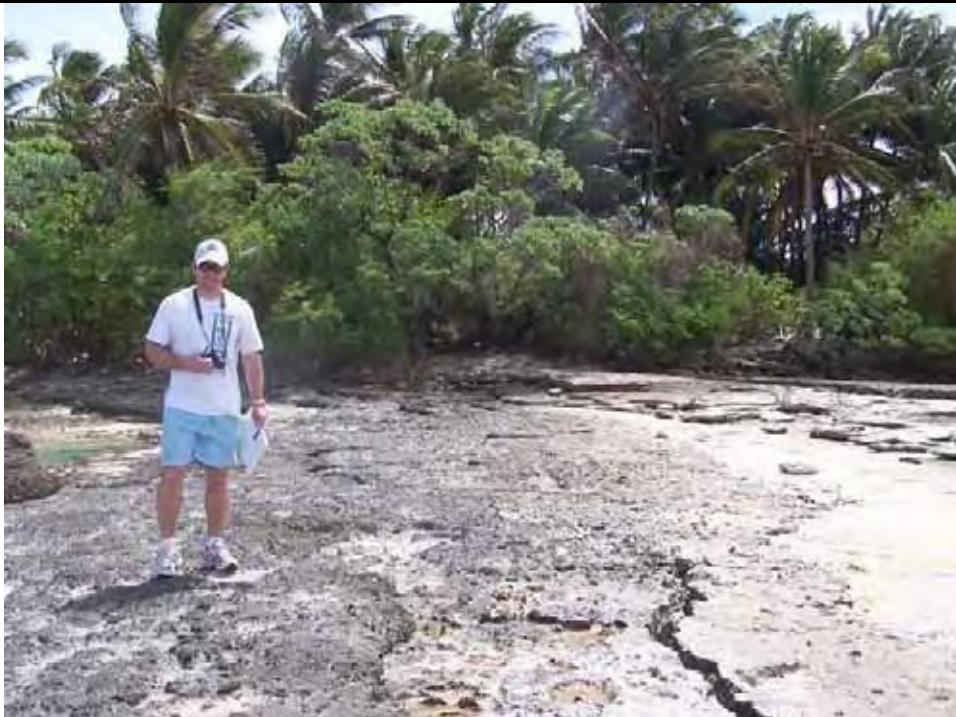
90

Low potential for natural resource impact

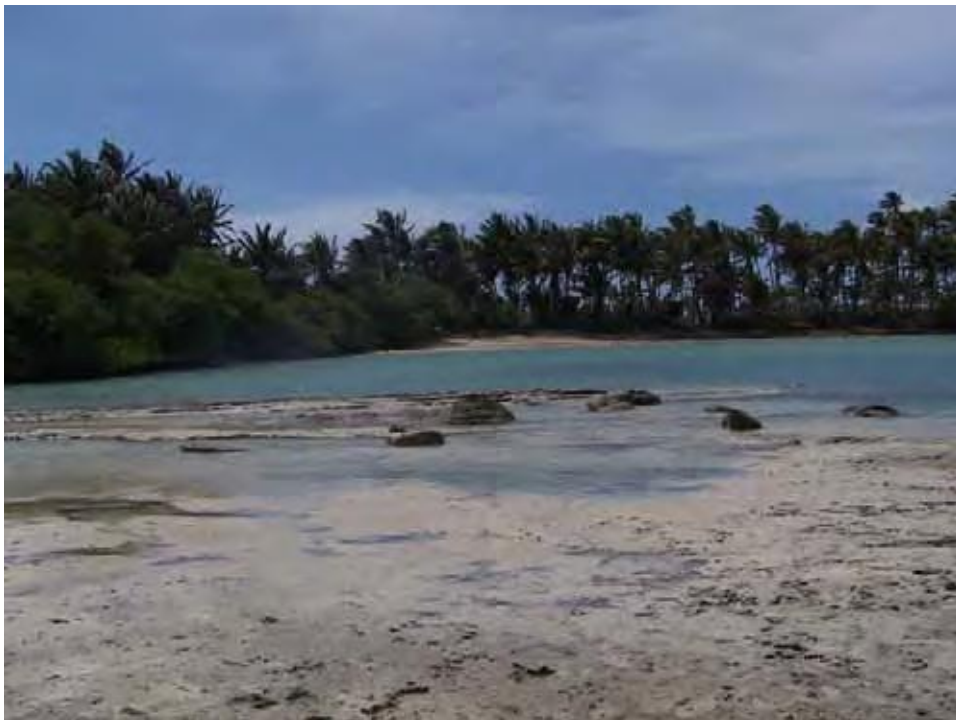
91

Low potential for natural resource impact

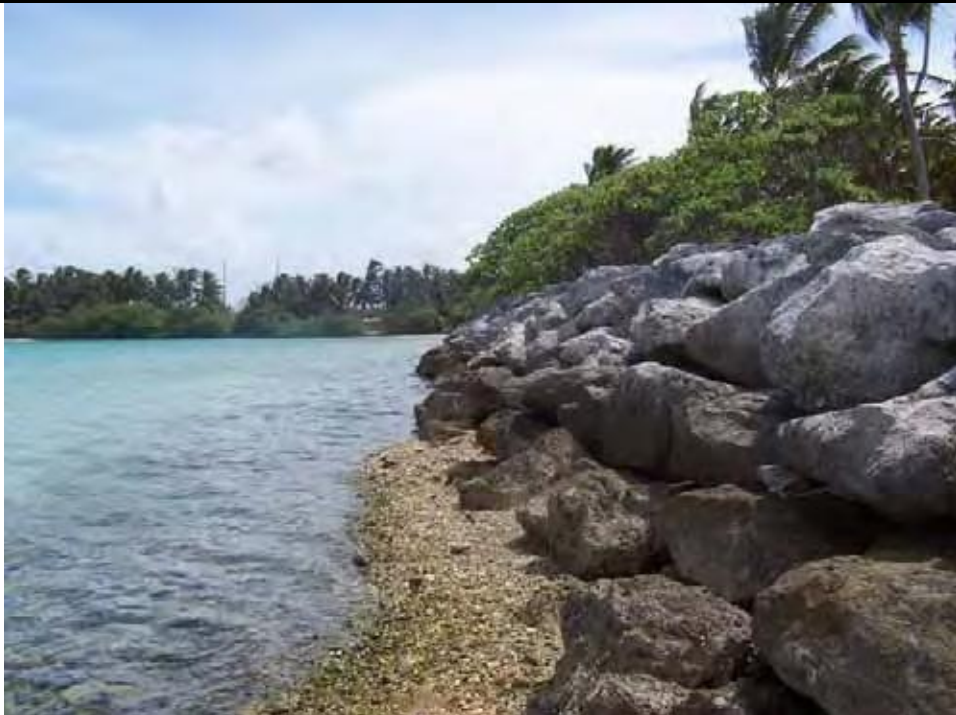
92

Low potential for natural resource impact

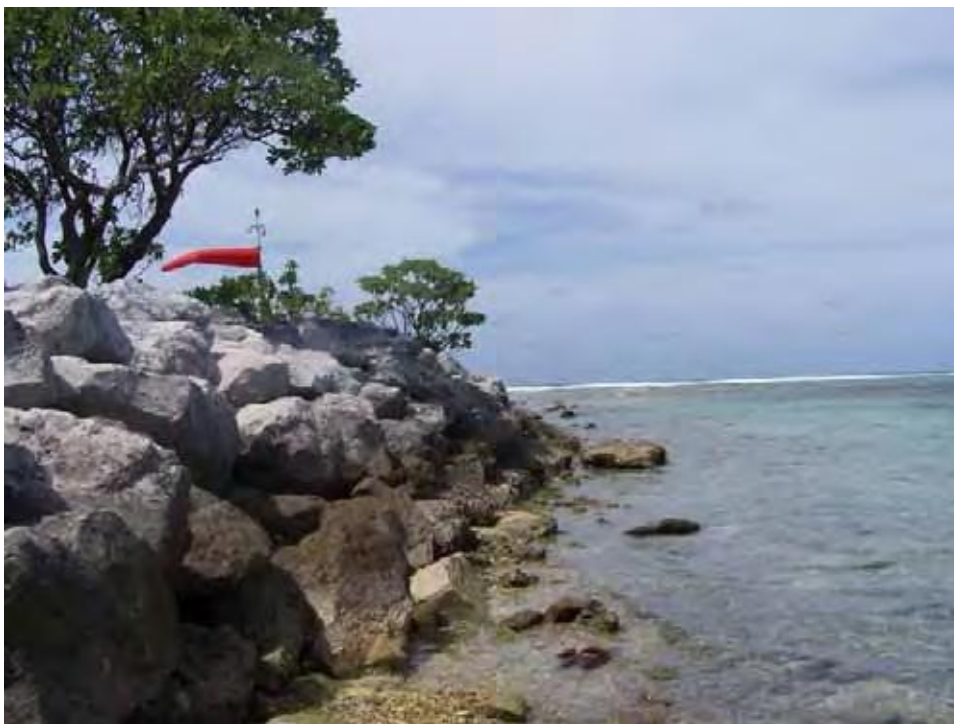
93

Low potential for natural resource impact
