**DOCUMENT OF  
ENVIRONMENTAL PROTECTION**

**ACTIVITY:  
DREDGING AND FILLING**

**CONTROL NUMBER DEP-16-001.0**

**UNITED STATES ARMY GARRISON - KWAJALEIN ATOLL/  
RONALD REAGAN BALLISTIC MISSILE DEFENSE TEST SITE  
IN THE  
REPUBLIC OF THE MARSHALL ISLANDS**

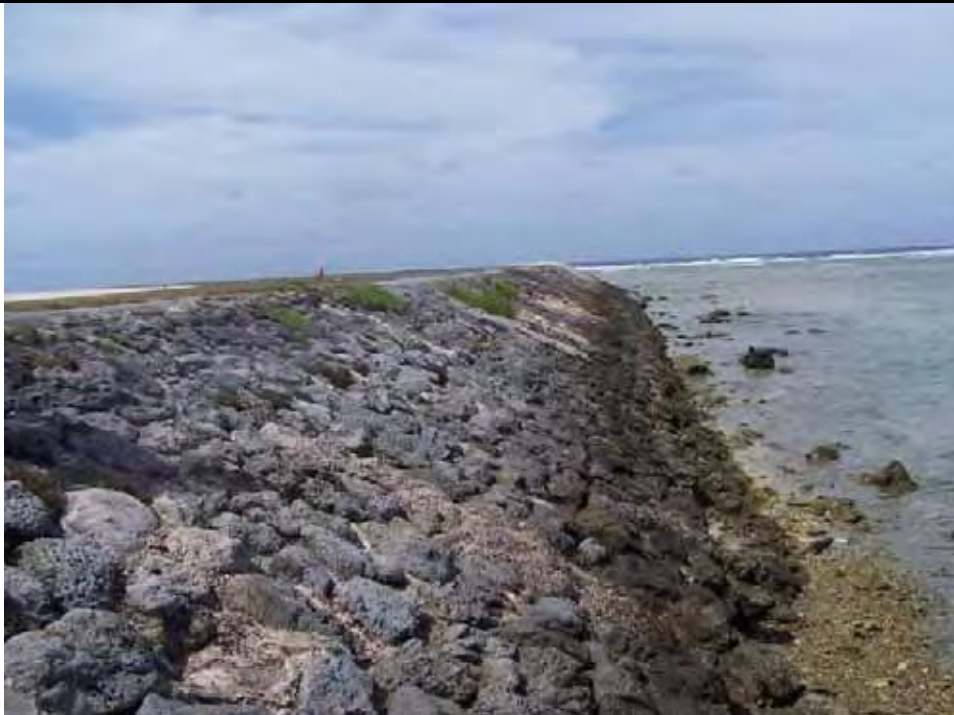
- RN-1, Photo 12 – Non-critical erosion evident at tree line
- RN-3, Photo 30 – Northwest shore with evidence of erosion; 30 inch ledge has formed due to loss of soil
- RN-4, Photo 44 – Seawall with some erosion evident
- RN-4, Photos 45 & 47 – Non-critical erosion at tree line
- RN-4, Photos 49 - 51 – Shoreline west of main port terminal
- RN-5, Photo 59 – Erosion at beach east of Yokahoma pier
- RN-9, Photos 85 & 86 – North shore of Namur looking southwest; ledge caused by erosion
- RN-9, Photos 94 - 97 – North shore near end of runway; bottom of seawall undercut

Low potential for natural resource impact

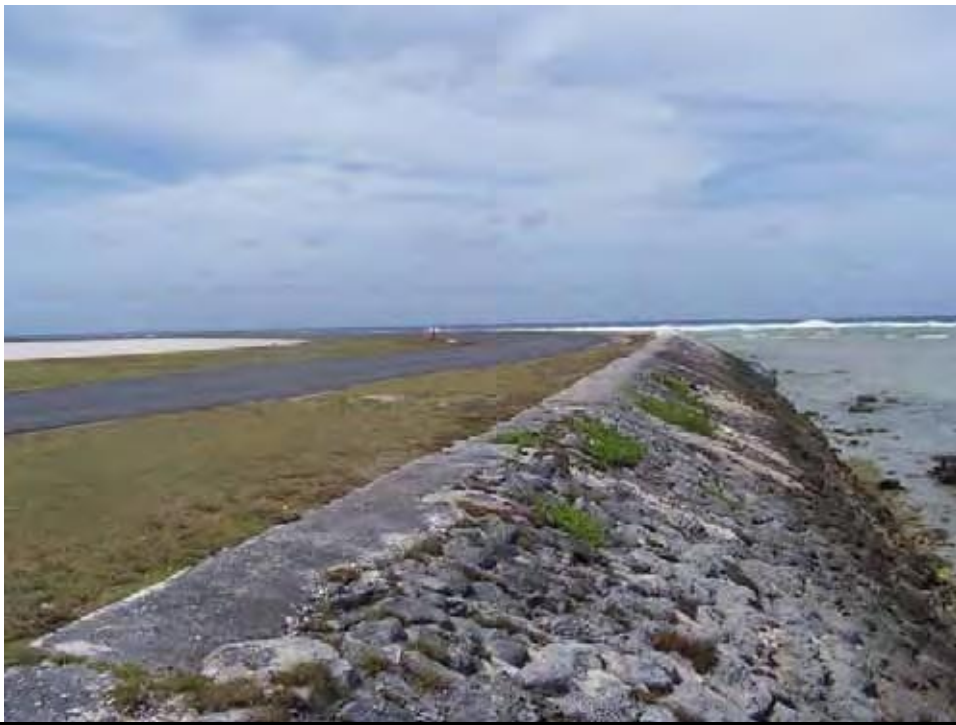
95

Low potential for natural resource impact

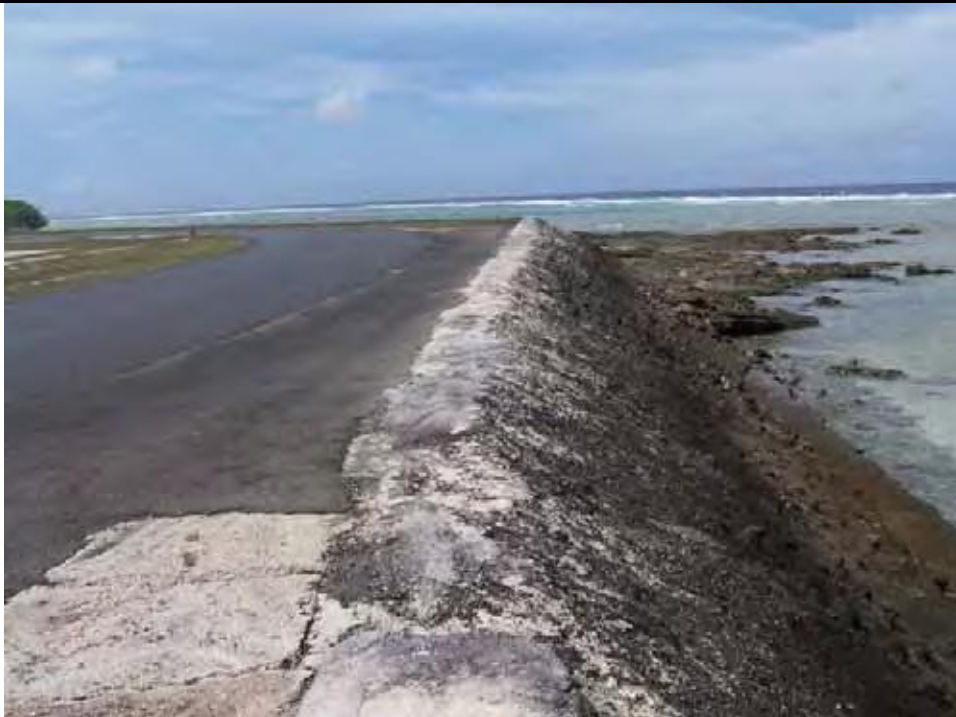
96

Low potential for natural resource impact

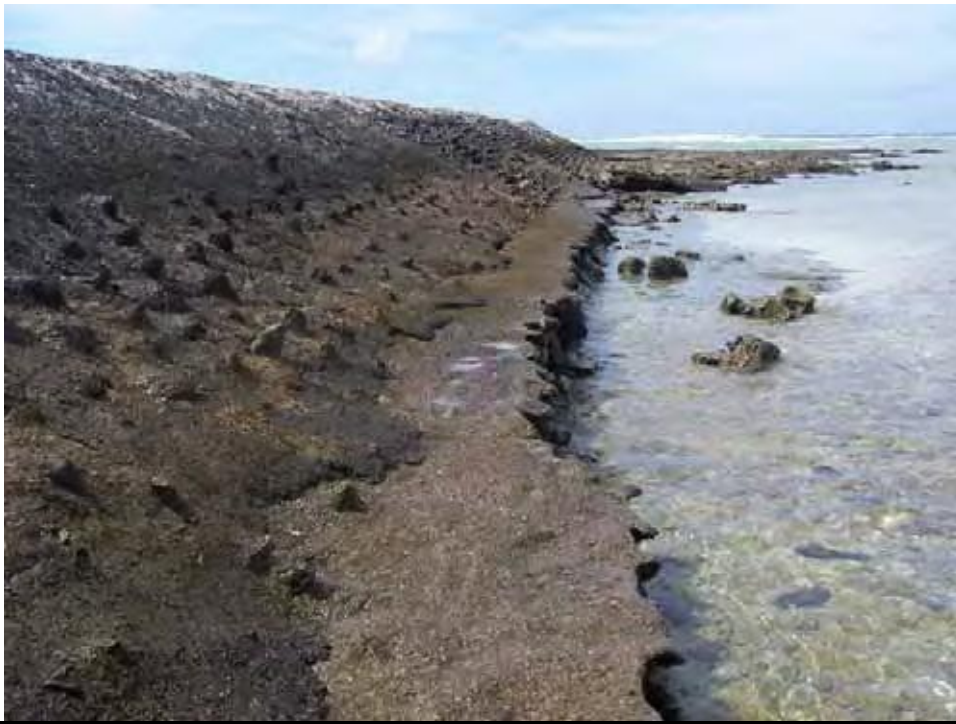
97

Low potential for natural resource impact

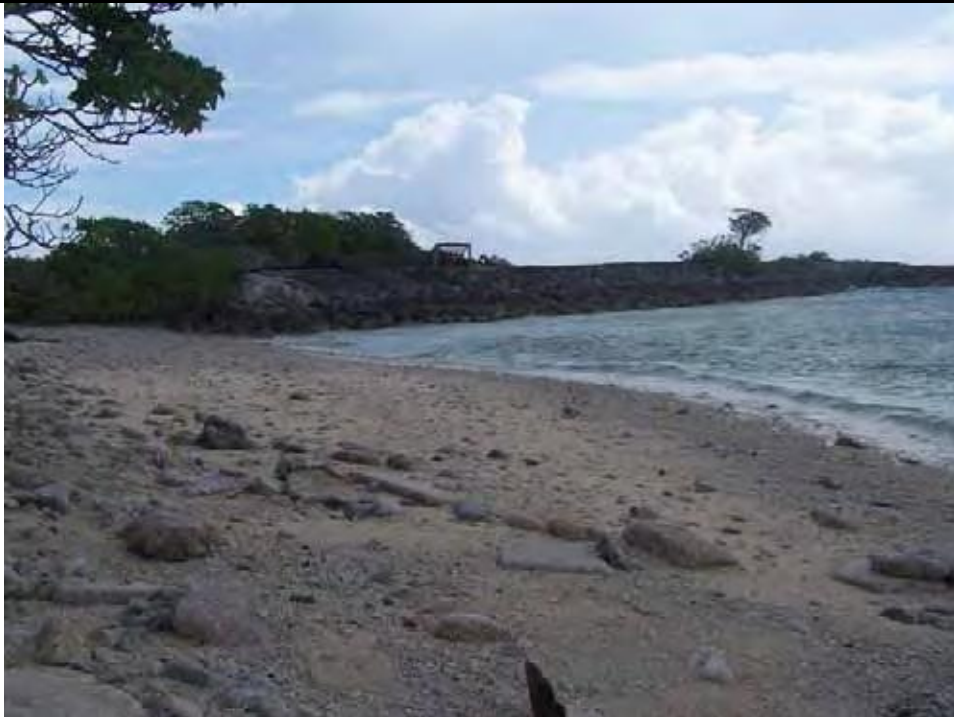
11

Potential for natural resource impact due to turtle haulout and nesting

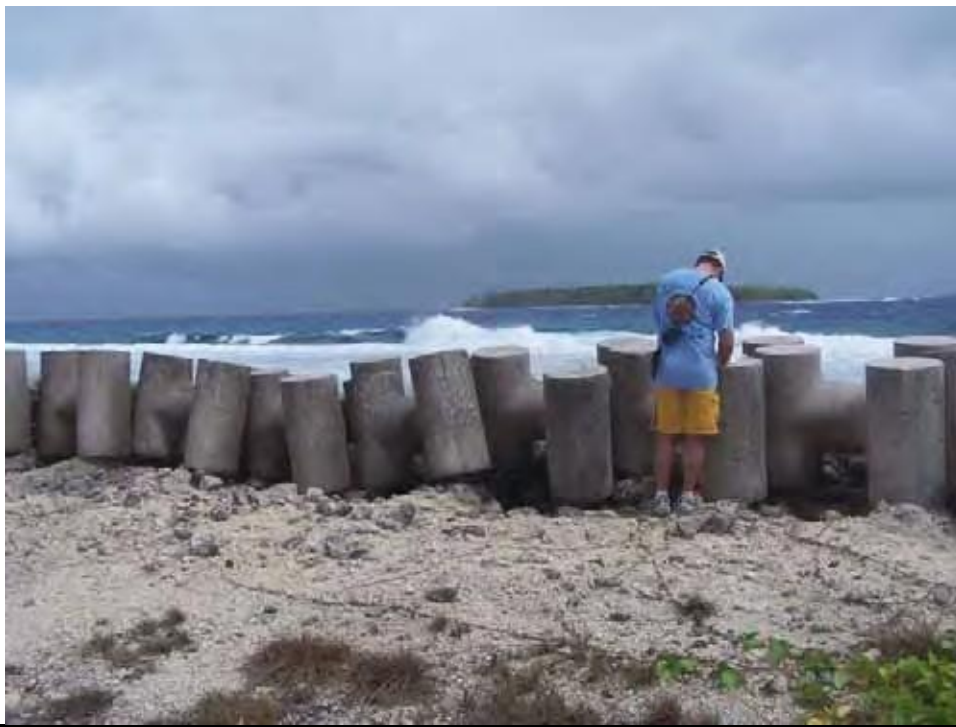
28

Facility could be threatened if seawall fails

Low potential for natural resource impact

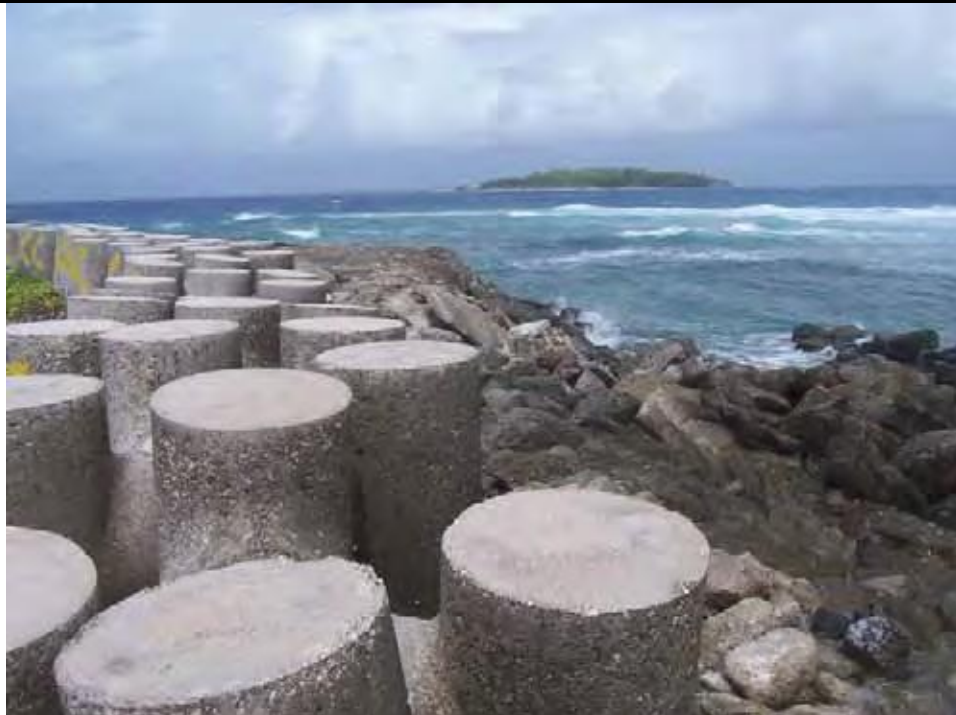
29

Facility could be threatened if seawall fails

Low potential for natural resource impact

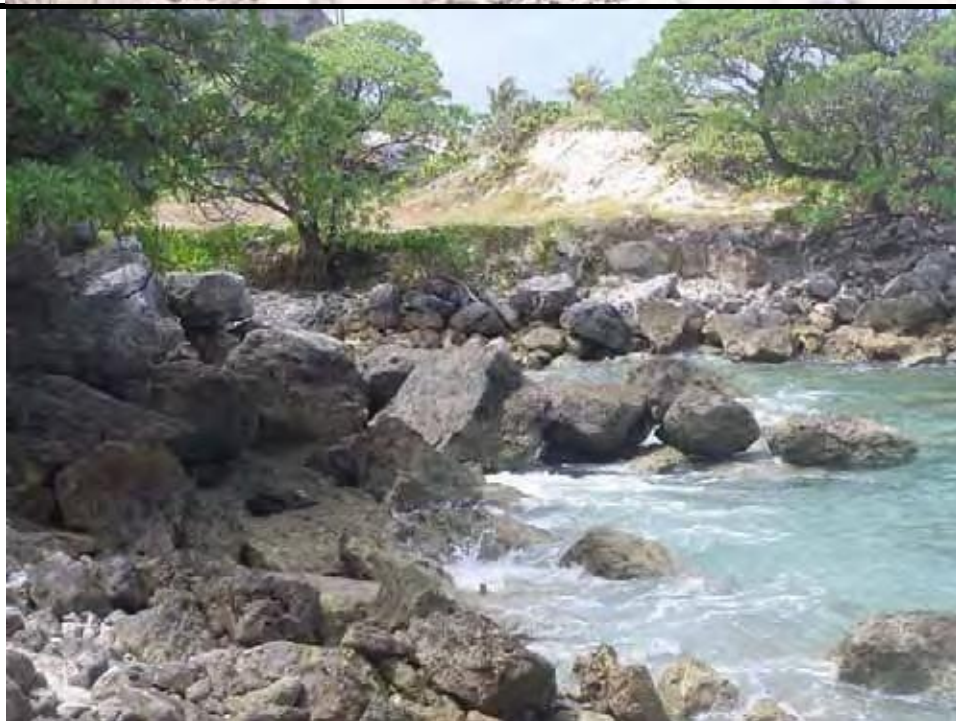
36

Potential for natural resource impact due to turtle nesting and haulout area

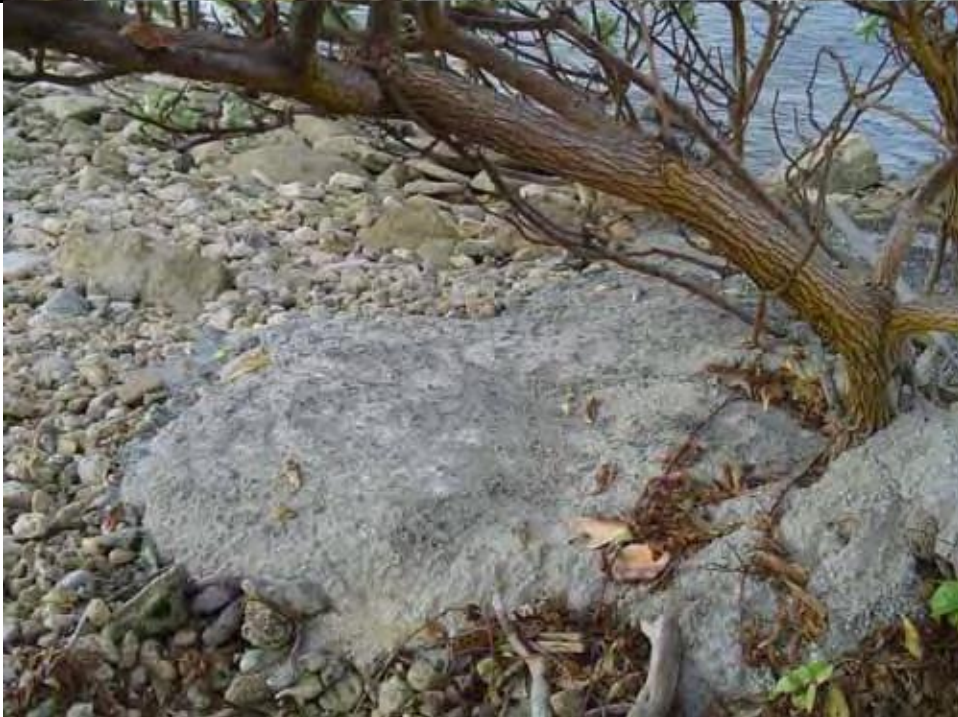
MK-05      Lagoon Side

Potential for natural resource impact

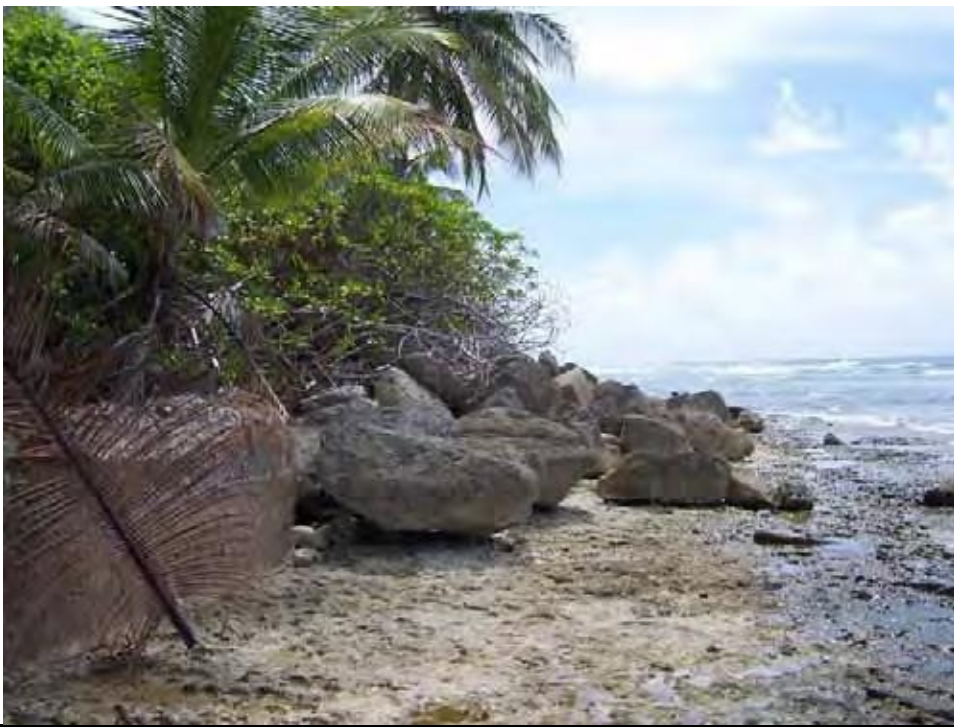
23

Description: Loose, large armor stone atop natural reef

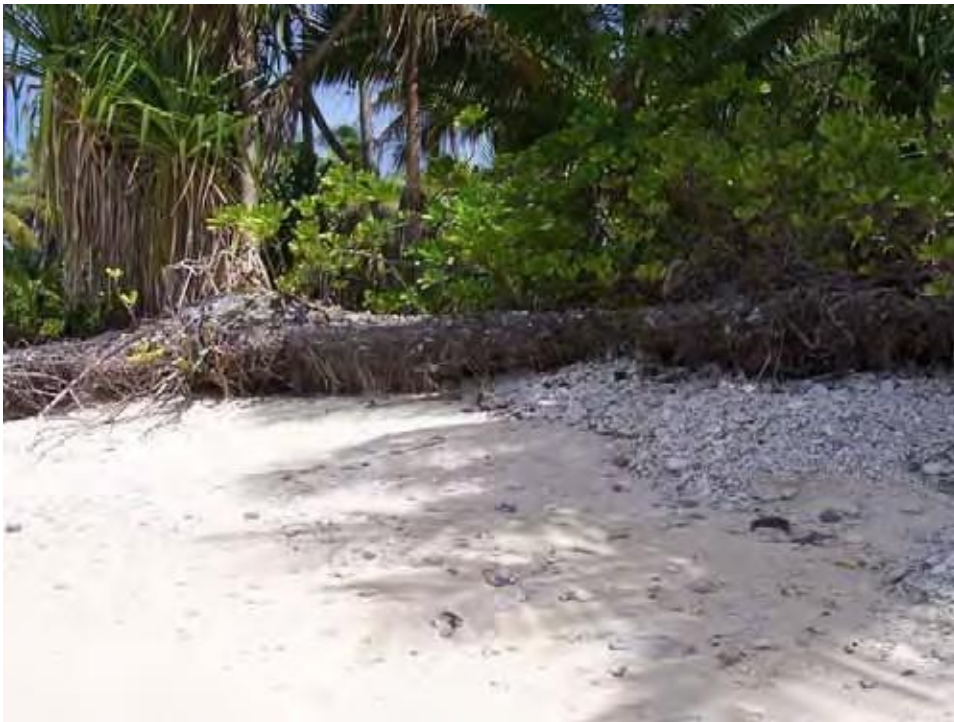
25

Erosion threatens turtle nesting and haulout area

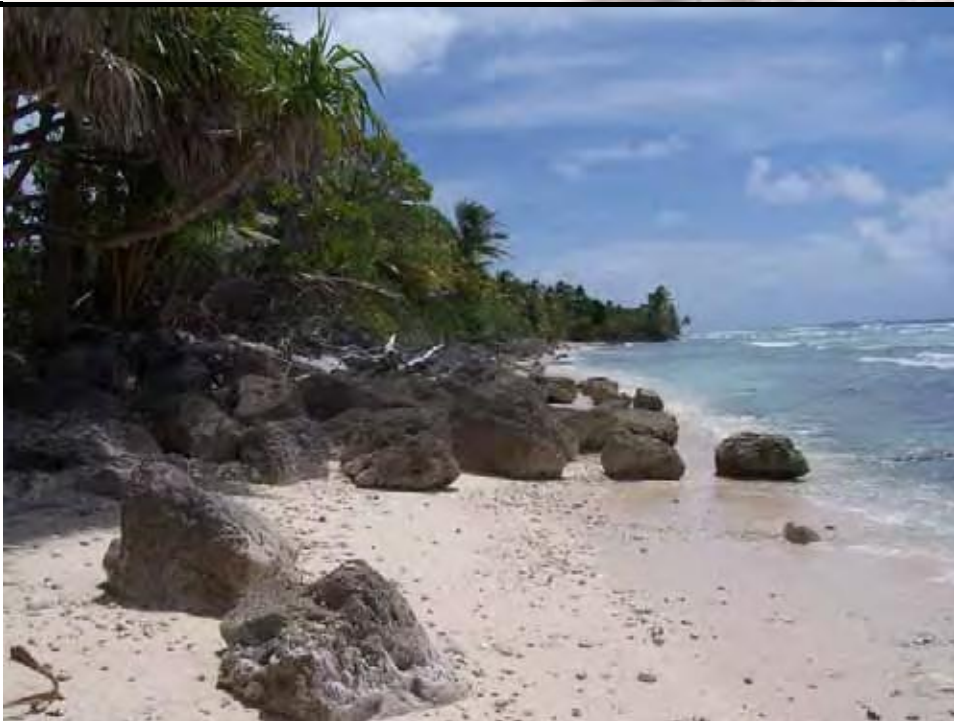
26

Shoreline protection: Loose armor stone

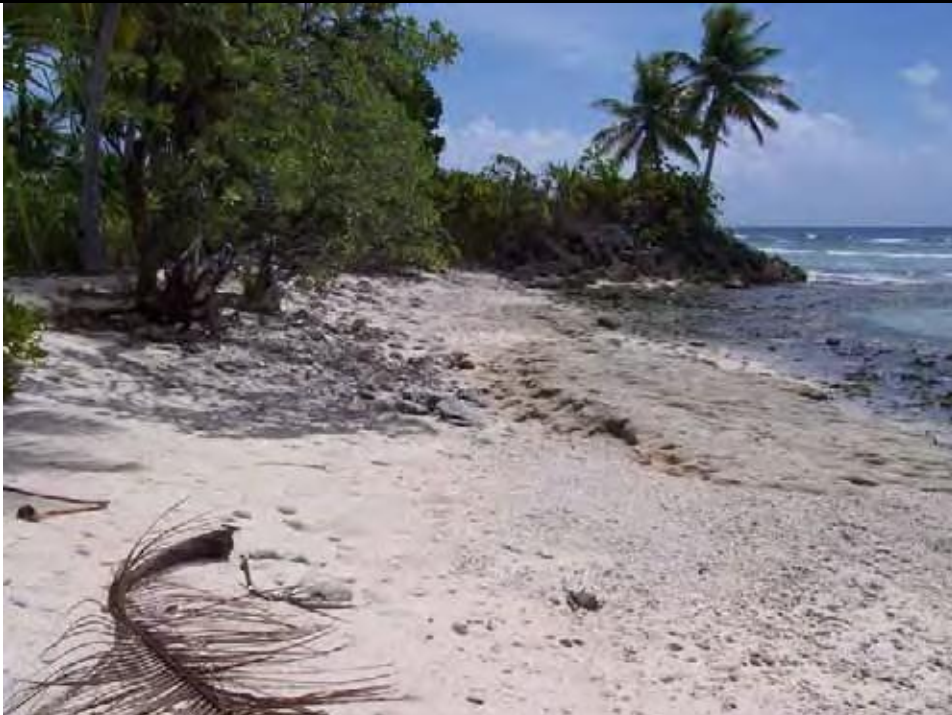
28

Erosion would threaten turtle nesting and haulout area

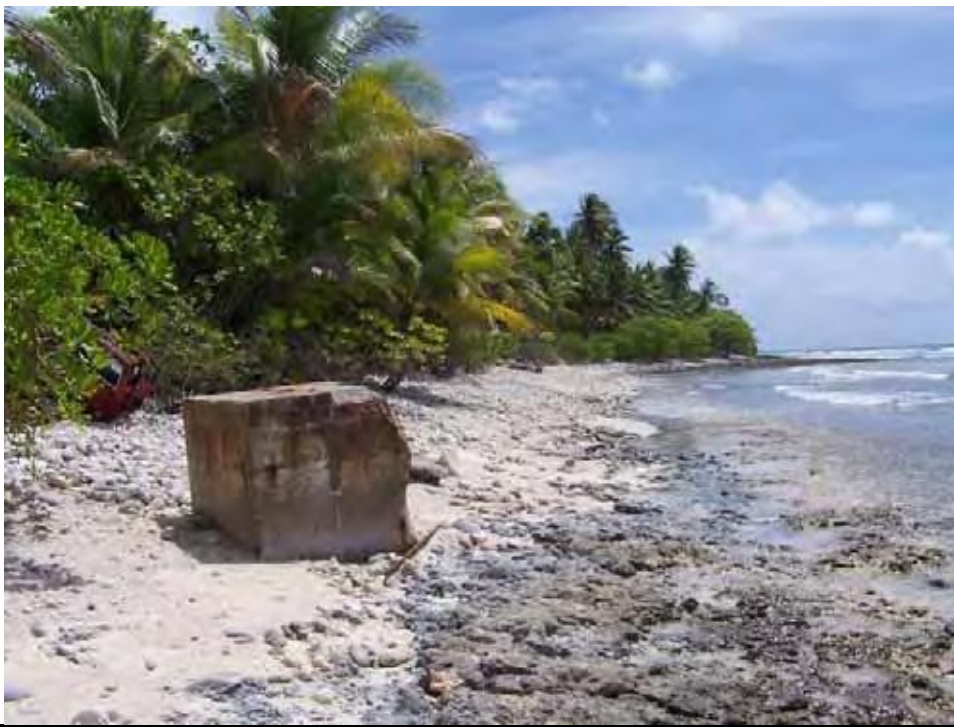
33

EL-03A Ocean Side

Description: South end of leased part of island.  
Old concrete foundation disposed of on beach

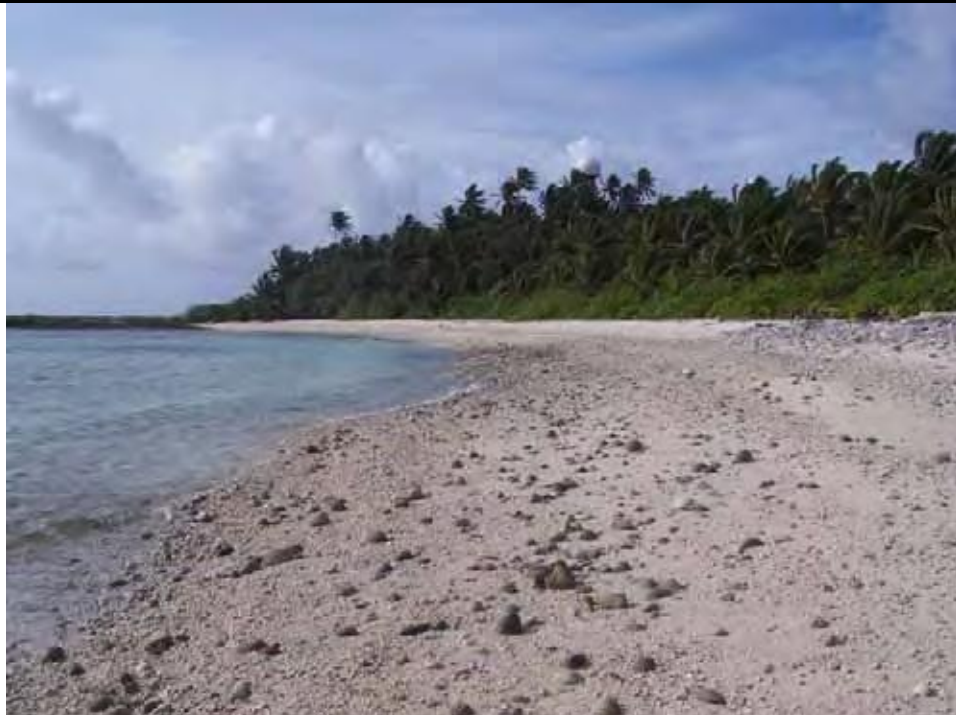
24

LG-01 Lagoon Side

Sand erosion could impact the turtle nesting and haulout area

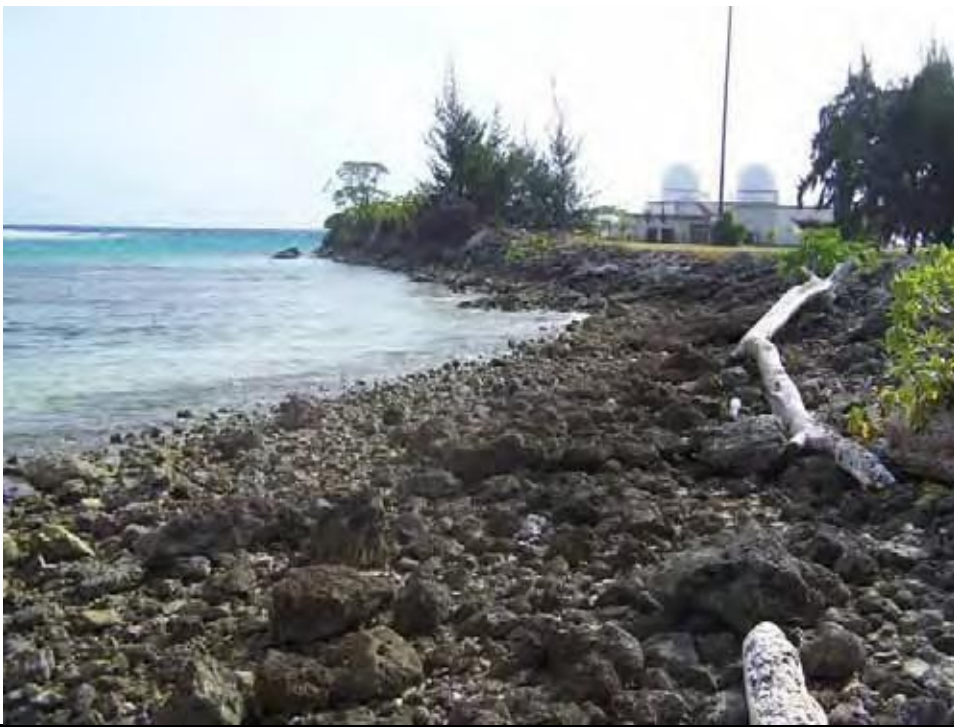
- LG-1, Photos 25 & 26 – Shoreline just north of helipad looking east

LG-01 Lagoon Side

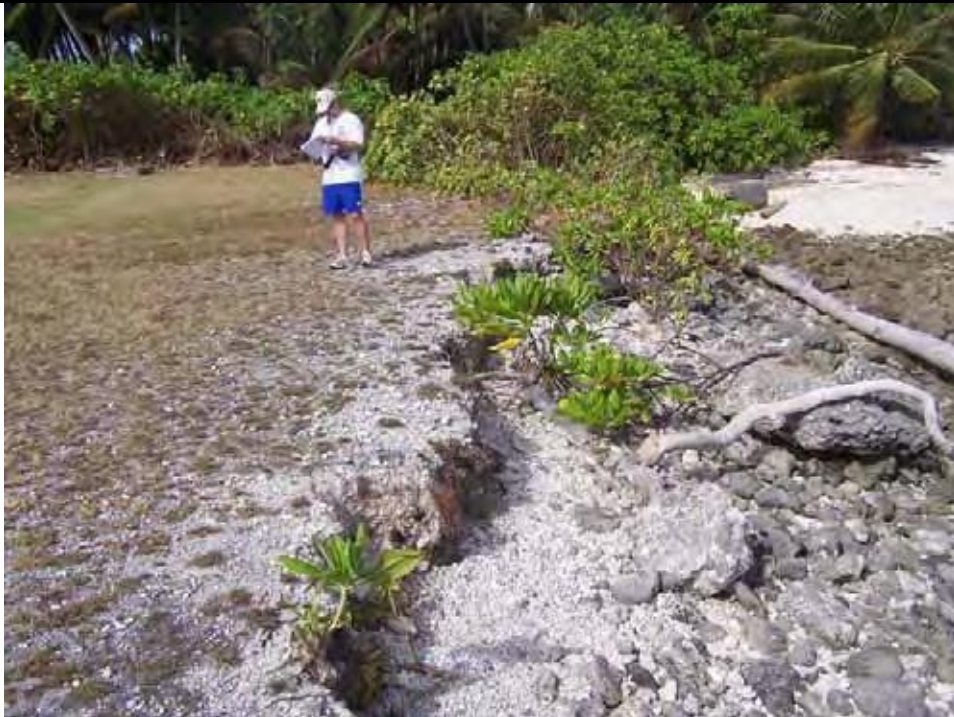
26

LG-01 Lagoon Side

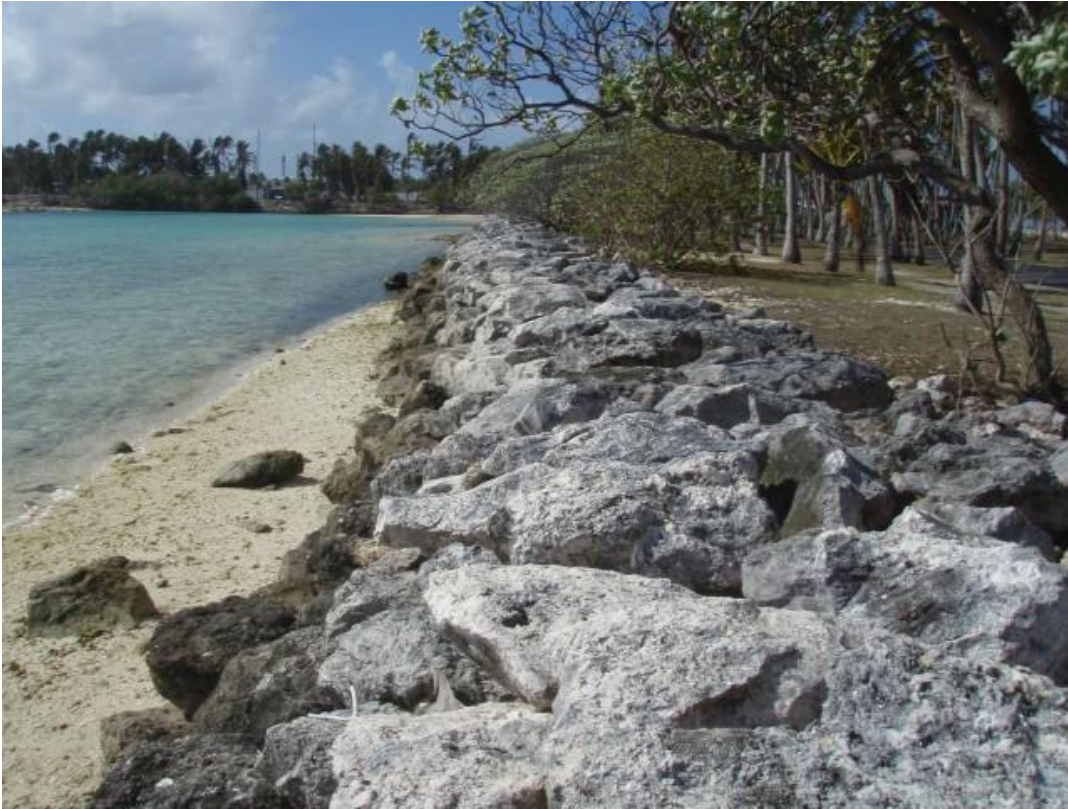
28. Figure A4 is a photograph of the existing rock revetment that extends along a portion of the embayment on the north coast of Roi-Namur. This revetment consists of 3 ton to 5 ton armor stone and appears to have functioned adequately since its construction. The limestone armor stones have been properly sized for the incident wave climate. If suitable armor stone is available, it is recommended that similar structures be considered for construction along critical shoreline reaches identified in this report. If limestone is not available, the concrete armor units displayed in Figure A5 and Figure A6 could be utilized. Figure A5 shows a Samoa Stone revetment that was recently constructed in the village of Vatia on the island of Tutuila, American Samoa. That project was the first application of Samoa Stone, but physical model tests and initial project performance indicate that these units would be suitable for the present application. Figure A6 displays a tribar revetment also located on Tutuila. Tribars have a rich history of satisfactory performance and can also be used for breakwater applications similar to the harbor breakwater on Meck. The tribar revetment cross section used to develop the cost estimates for this report was modeled after the Tutuila structure and is provided in Figure A7.

Figure A4: Revetment with rock armor stones located on Roi-Namur.

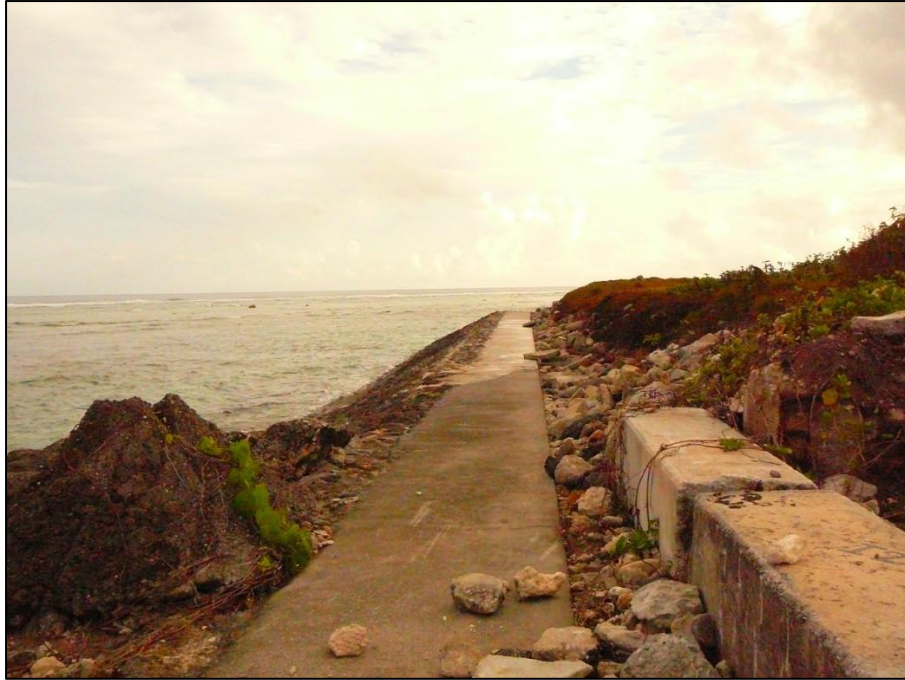
**Figure 6 – Inundation occurred here as evidenced by the washed ashore rocks.**

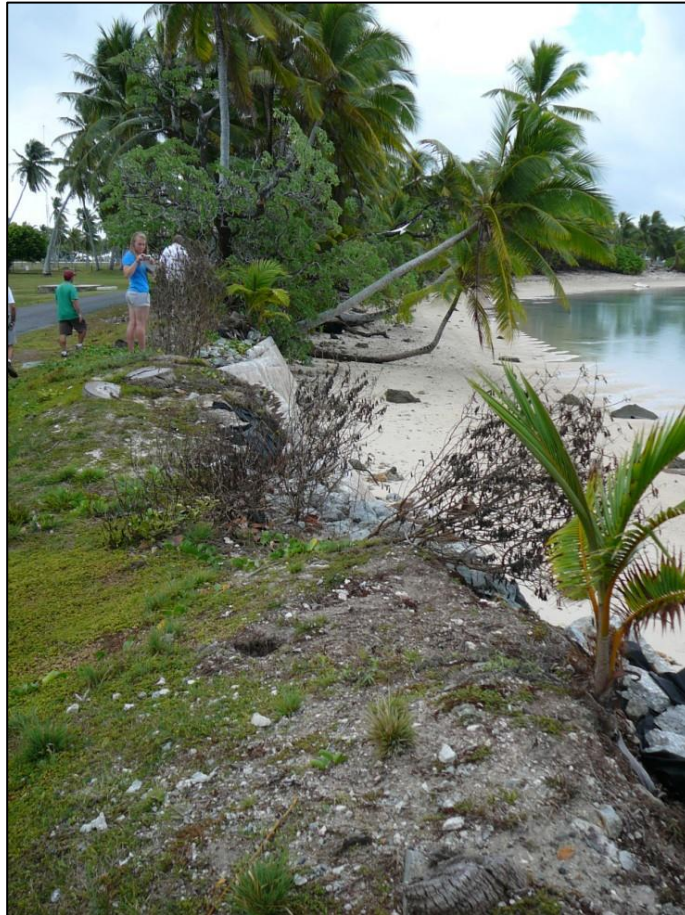
**8) East of the Historic Japanese Air Operations Building**

Although some rip rap was present, the height was insufficient so as to allow seawater to breach over the shoreline.

**Figure 10 – Insufficient rip rap allows seawater breaching onto the road.**

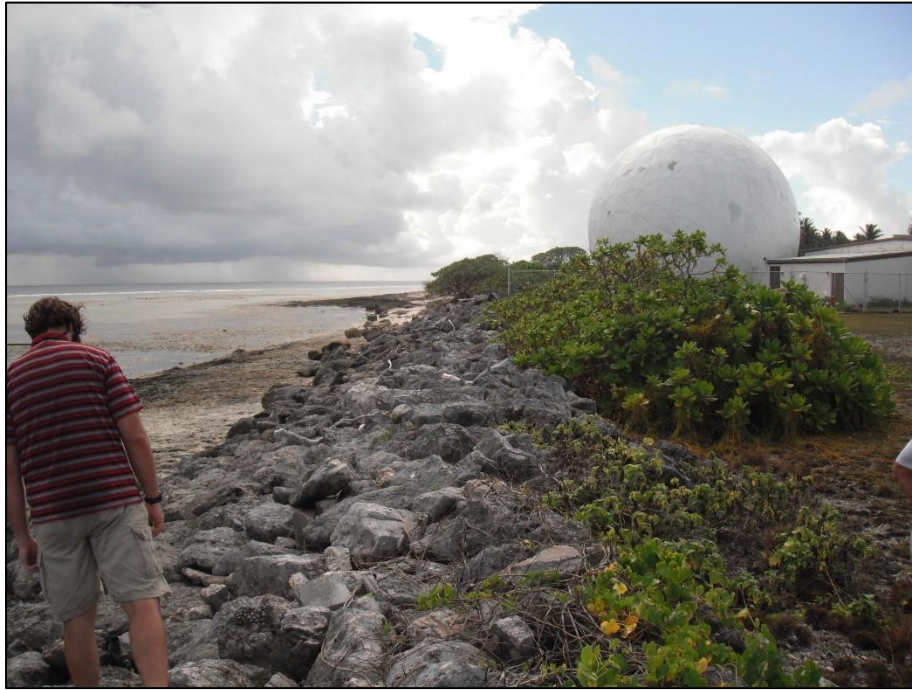
**9) Northwestern Shore of Namur, West of TRADEX**

The small rip rap in place on the shoreline was insufficient and allowed seawater breaching.

**Figure 11 – Insufficient shoreline protection allows seawater breaching.**
